# Some Comments on Assembly and Performance of pre-series RE2/2 chambers

The 3 Chambers were received at CERN on the 2nd June 2005.

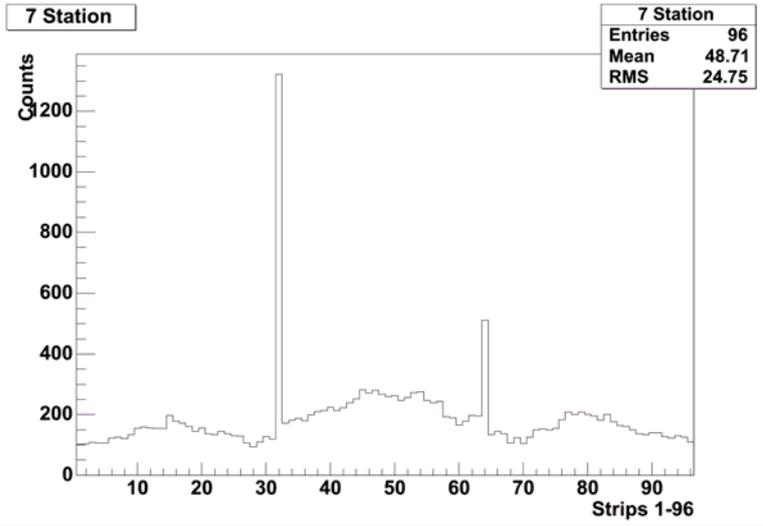
Three sectors TDC spectrum with 9.4 kV

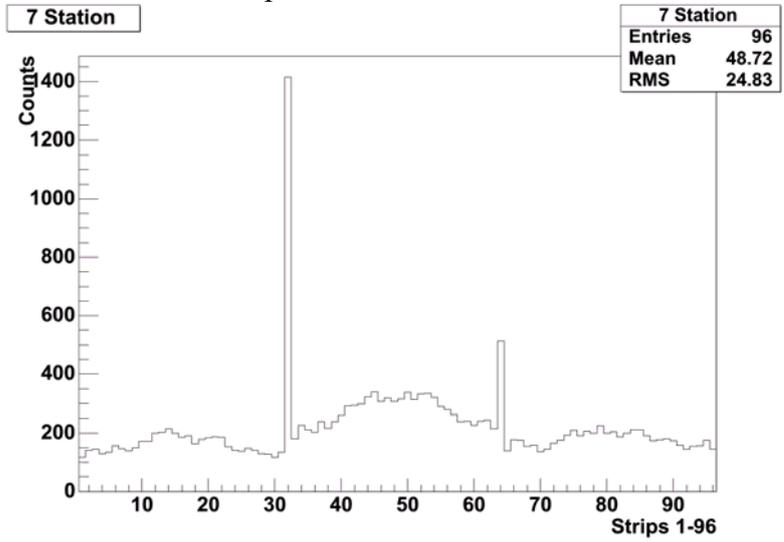
HV 9.5 kV

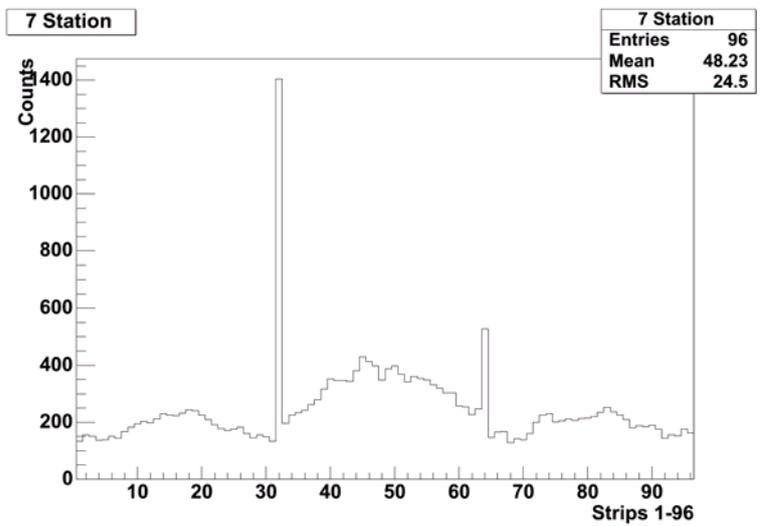
HV 9.6 kV

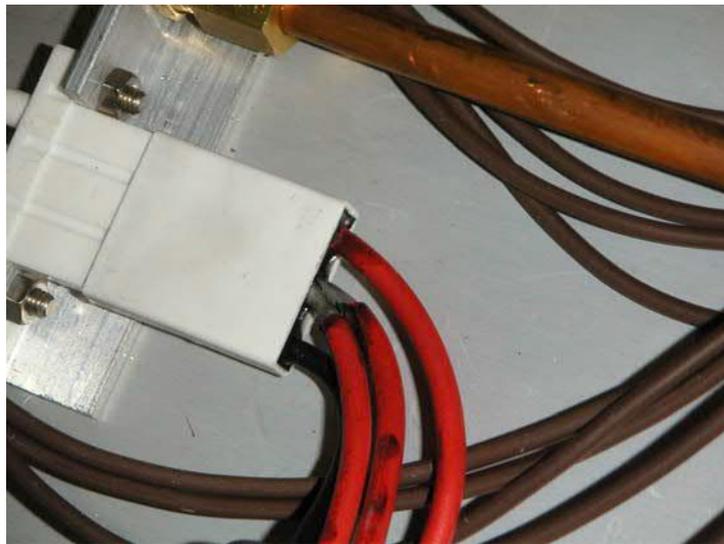
Great care must be taken in removing the insulation from the Cable leads. Here the insulation has been removed outside the connector, so compromising the HV breakdown strength.

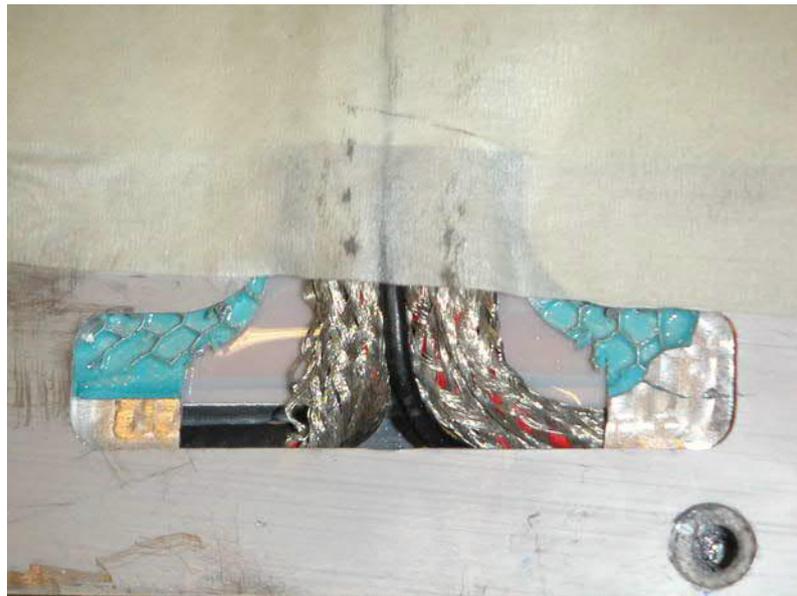
Sharp edges could compromise the insulation of the Faraday cage Cu shield wrt the chamber structure. Tape (polyester) is a solution. Hot melt run along the edges is more laborious but gave some reasonable results requiring additional refining in the procedure.

The opening for these cables is well calculated and executed.

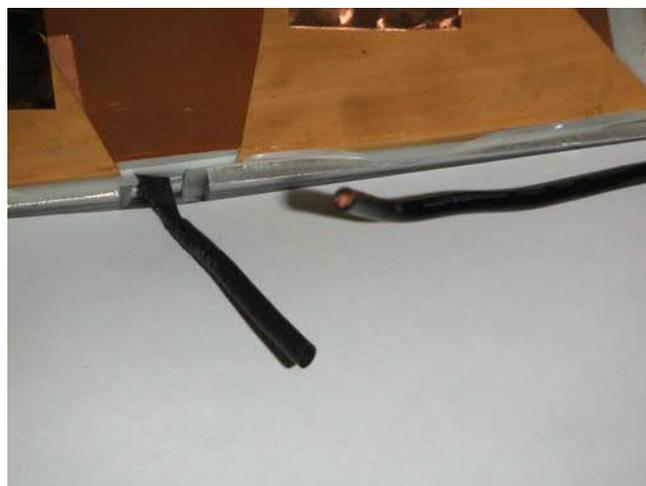
Some of the 0V return lines for the gaps were of thicker section ( $2\text{mm}^2$ ) than those used on the RE1 chambers ( $0.75\text{mm}^2$ ). This makes cable routing more difficult, HV connector assembly is not possible with both wires and more critically it weakens the 0V connection on the gap. This is already a weak point and may explain the failure that we found. There is no solder on this failure! Similar failures have occasionally been identified on RE1 gaps.

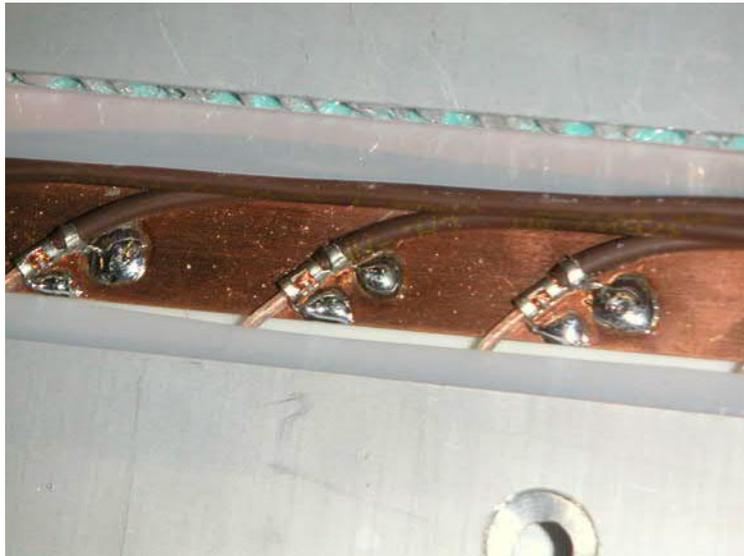
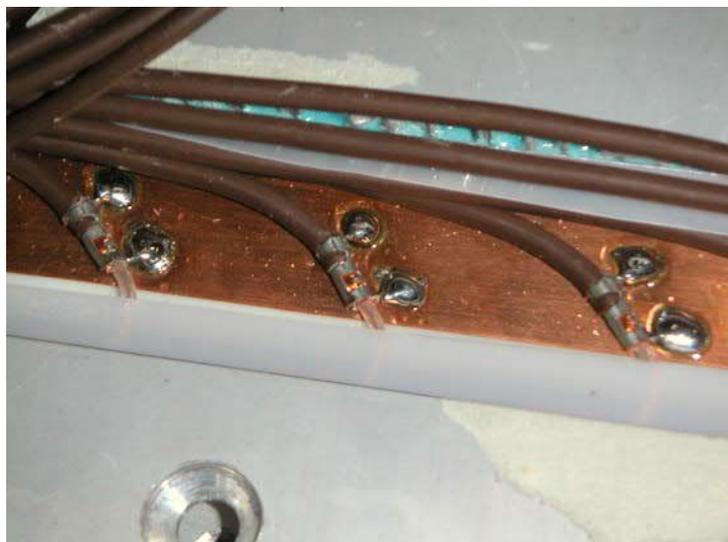
The soldering of the ferrule to the thick copper sheet is done well considering the difficult conditions. Thermal damage to the insulation of the centre conductor is minimal, amazingly.

However the wetting of the surface is not optimal and should improve considerably with the arrival of the Cu from Italy. If additional flux has been used then this should be washed off with acetone and isopropyl alcohol.

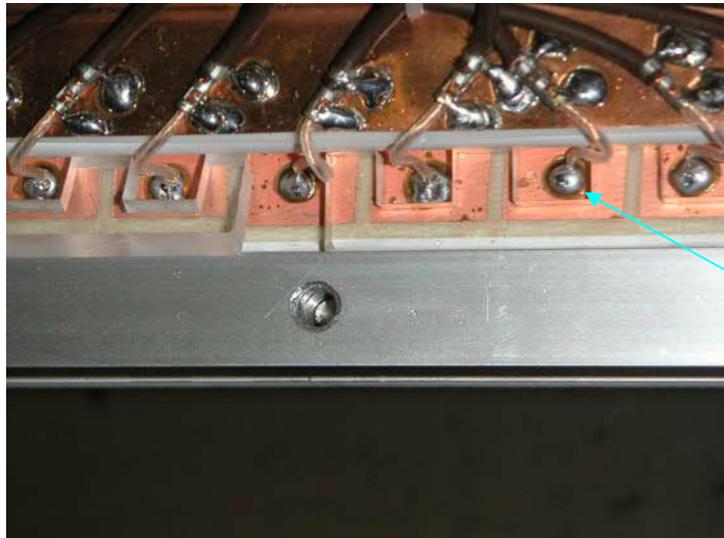
The soldering to the strips ( 35 $\mu$ m Cu ) is generally good but there is room for improvement in consistency.

The cut out to access this solder point is a better concept than in RE1

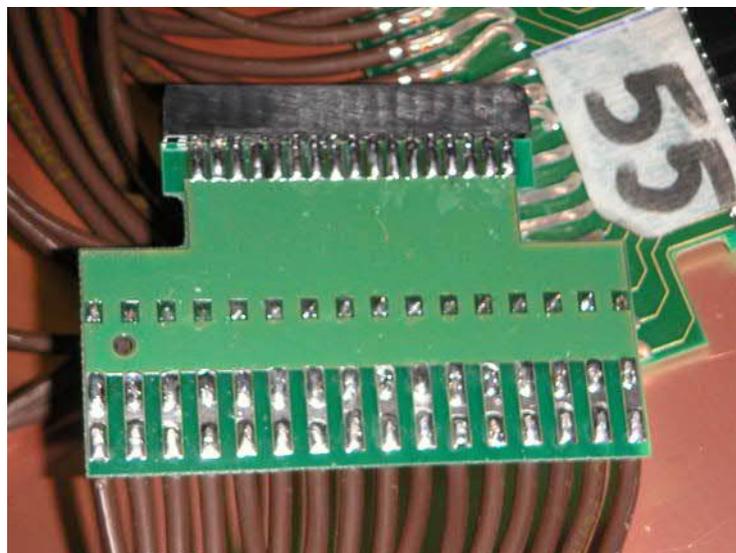
The soldering to the adaptor boards appears well done .

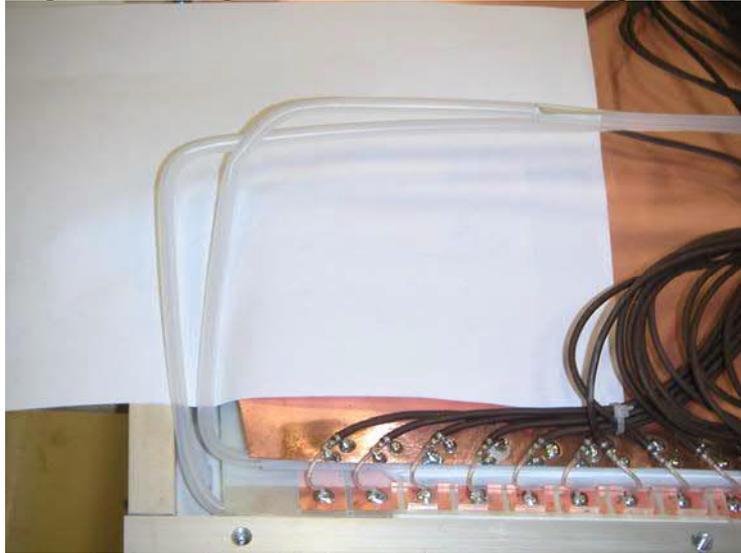
Securing the cables is good as is the orientation of the ferrules upon soldering to the Cu sheet. This angle is most important as it dictates the routing .

We recommend revisiting the routing to obtain a more repeatable result as illustrated below on these RE1 chambers.

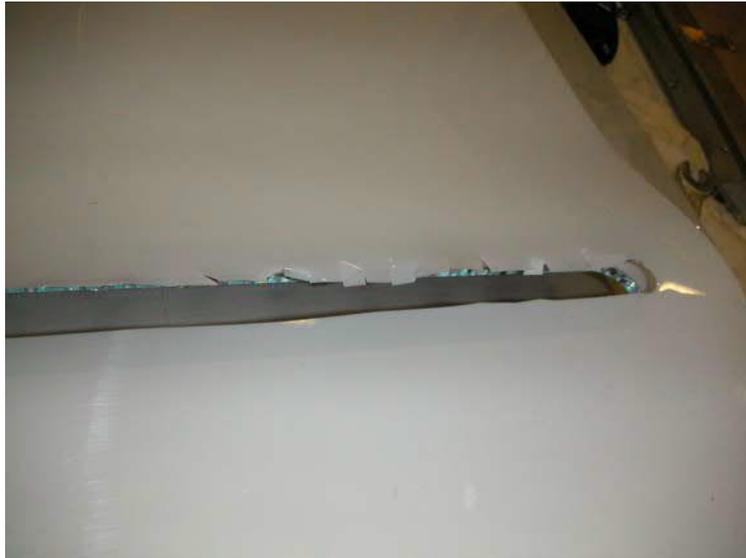
The Mylar film has been cut back as little as possible so that it acts as a protection to the coaxial cables, this is good solution and could be extended to cover both the lower and upper sharp edges of the HCP.( Honey comb Panel). However where the cables must run along inside the channel before exiting, an additional solution is required.

If this solution is retained, then the positioning of the Mylar is critical to avoid modifications being needed later in assembly process (as evidenced by these irregular edges).

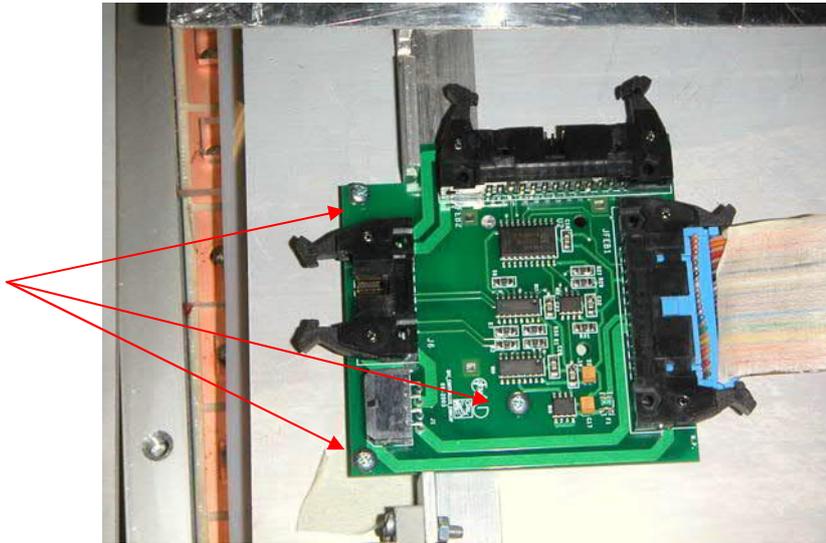
The LV Distribution Board was not fitted to these three pre-series chambers . This should be secured directly to the HCP using small and short (!! ) self tapping screws. A similar solution works extremely well on RE1 for securing the small Alu panels covering the coaxial cables outside the shield box. Here 8mm long PA stand-offs have been envisaged with self tapping screws of 2.9 x 13mm. The lower screw will require an insulating washer as it is very close to a conductor trace.

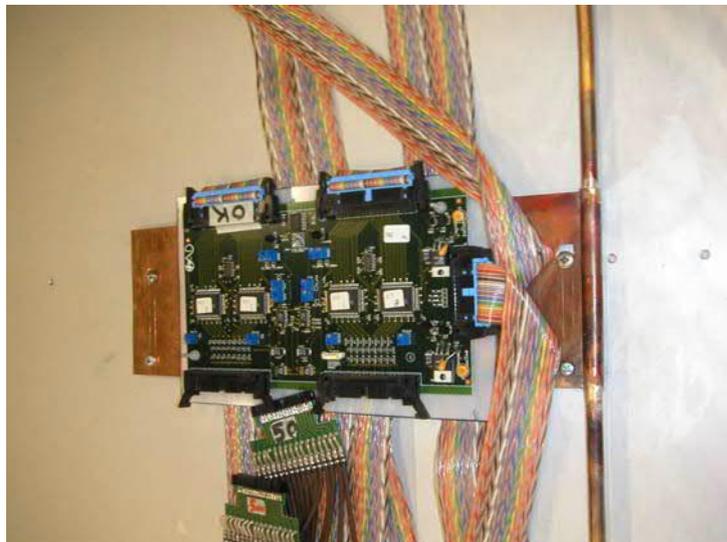
Little advantage can be obtained by folding the cable at a traditional 90 degrees. Here a slight reduction in length is obtained with a consequent lose in esthetic appeal !

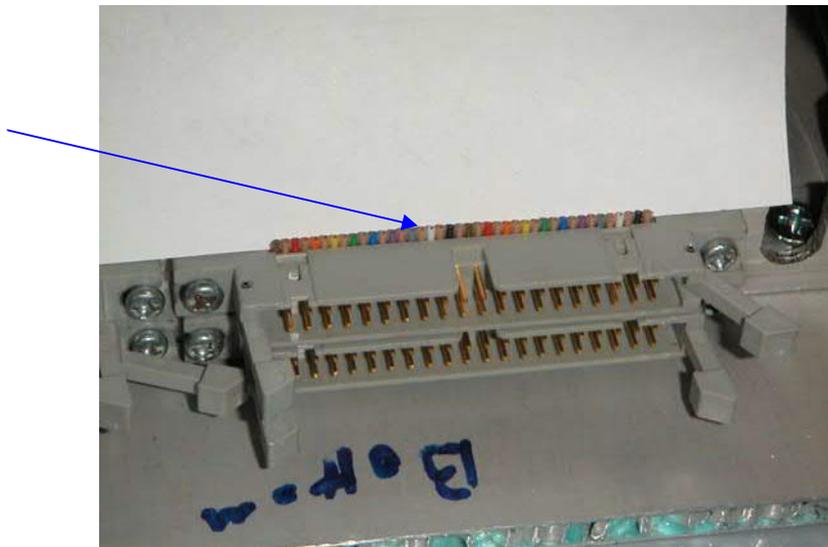
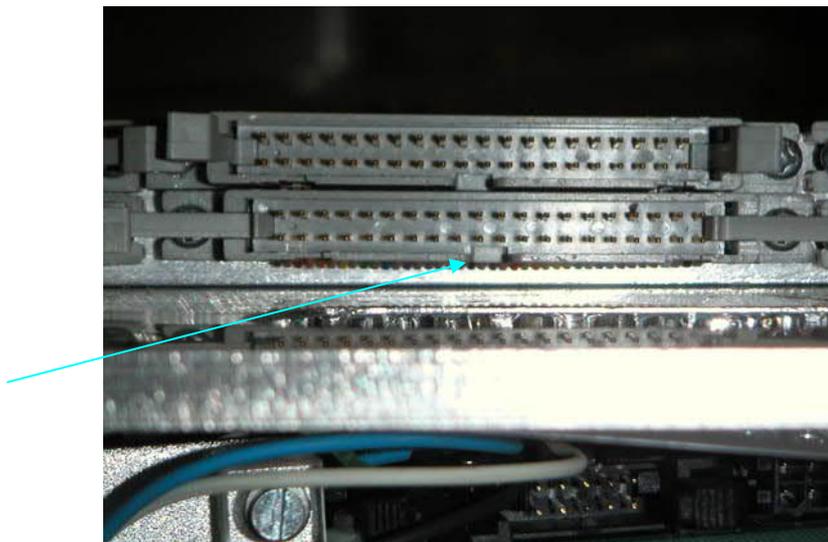
The cable should be cut off flush with the connector as in some cases shorts could occur. Possibly to the HCP or an adjacent connector.

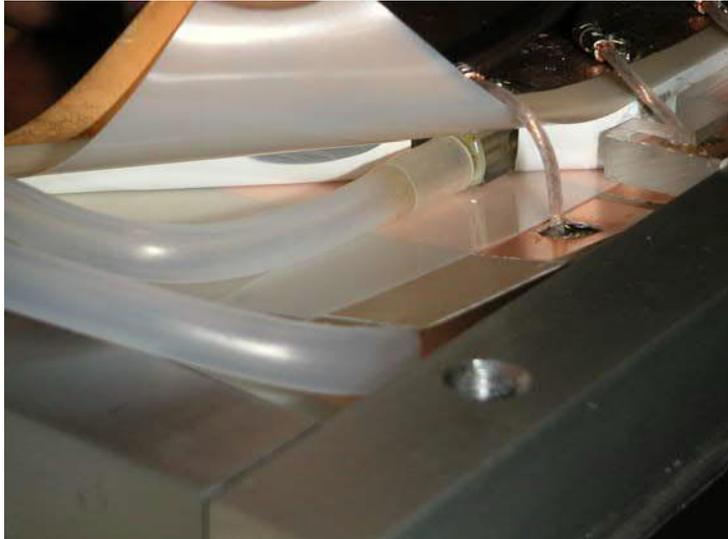
The connections to the gaps seem to be well done. Heat should be used in moderation if not the insert can be weakened.

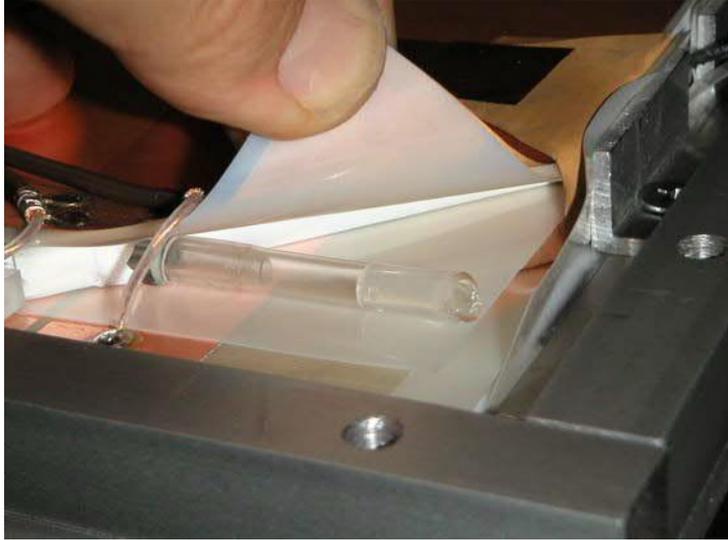
Plugging up of the unused gap connexions should preferably be done with the PE pipe used else where and not PVC. The PVC will resist chemically but may be more liable to hardening in time.

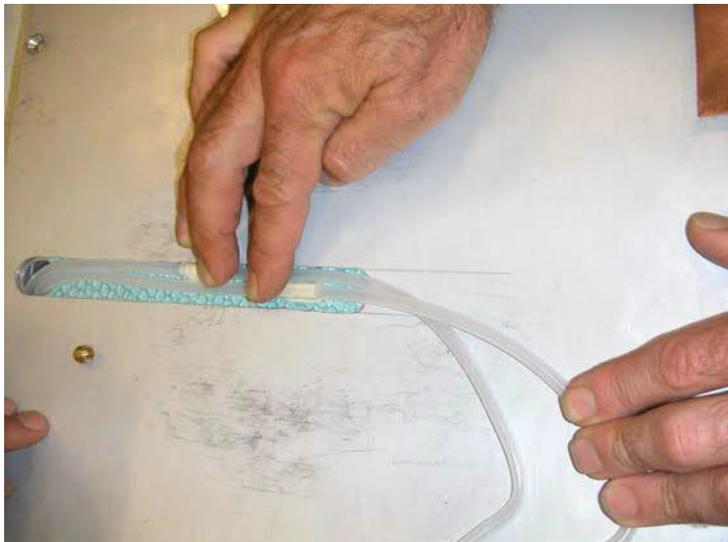
The cut outs in the panel are not deep enough and so leave a rough surface for the pipes to be damaged upon. Taping, remilling or filling with a low viscosity caulking compound should be considered.

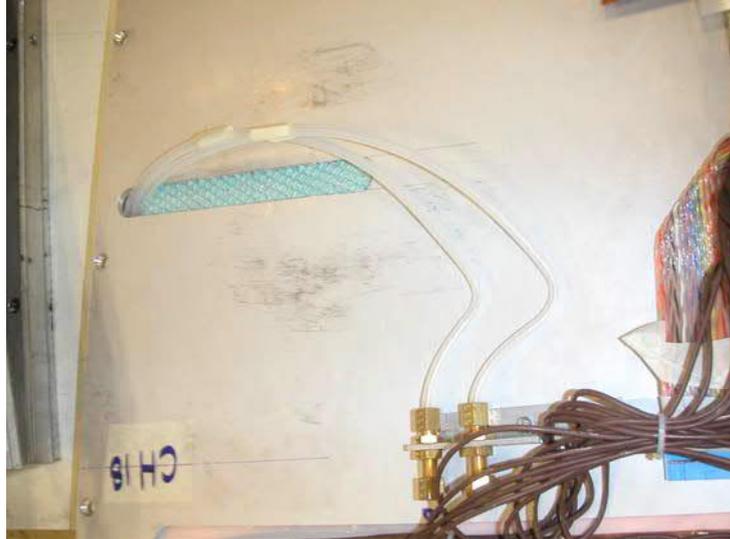
The routing and thermo forming of the gas pipes must be done so that the routing is facilitated. This is not such a good example. Numerous iterations will be needed to obtain a good repeatable result. Tooling is essential for each model of pipe.

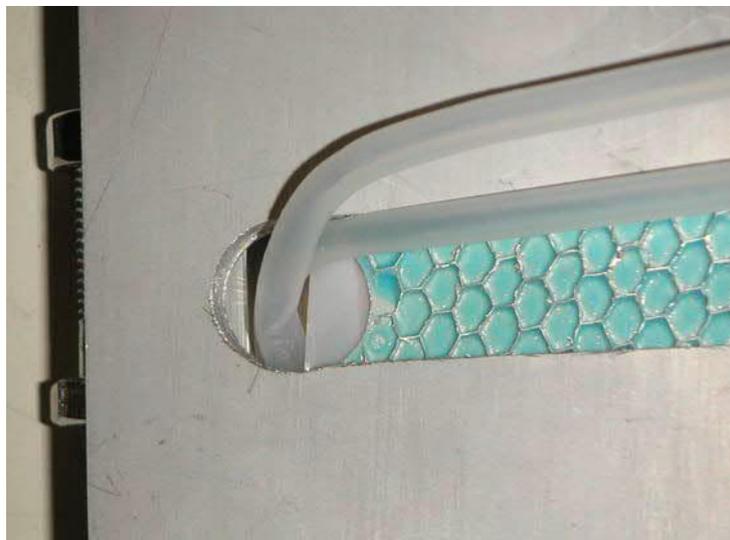
Coming back to cut outs, here the gas pipe can easily be kinked if the hole is too small as is the case in the picture below. (The HV cutout is a good example ). Flow should not be obstructed. The kink will be unlikely to relax and alleviate the problem

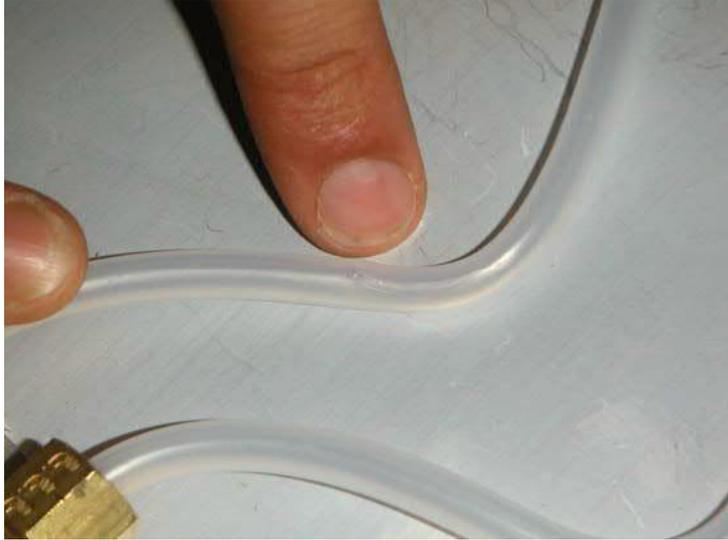
The pre-forming of the pipes must be done according to a pre-established method, using standard tooling (to guarantee the right temperature for the correct length of time). In the case illustrated, the pipe has melted and is damaged.

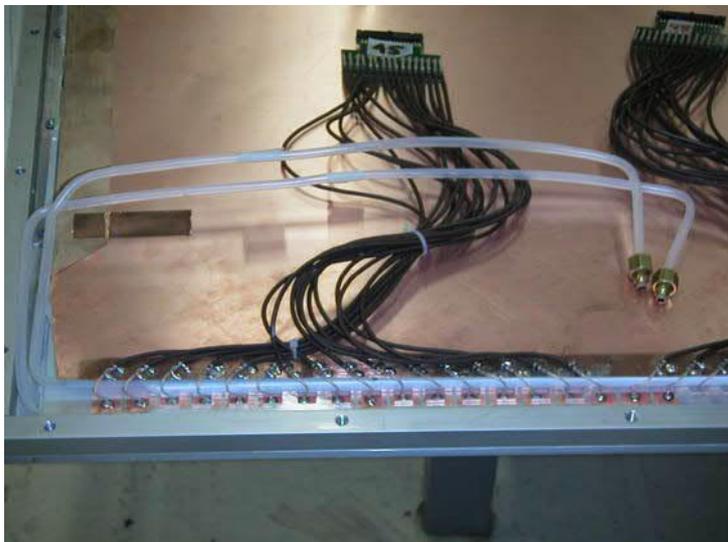
The routing has to be simplified, avoiding unnecessary crossovers

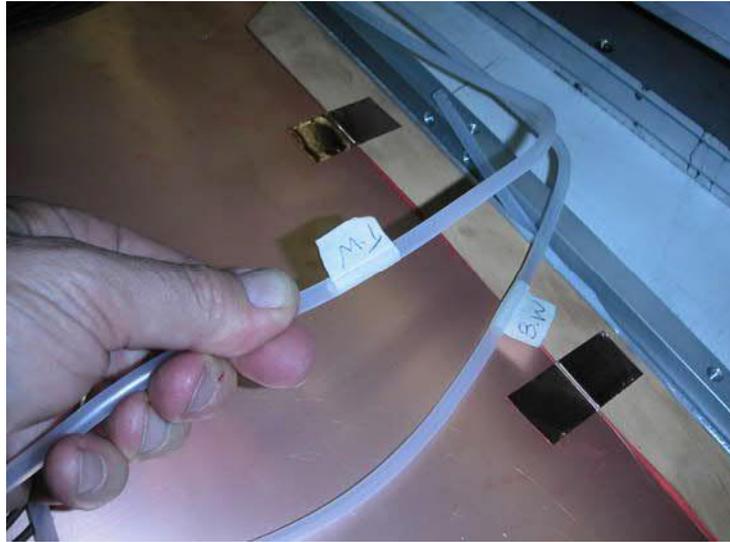
Labeling the pipes is good practice to prevent mistakes.

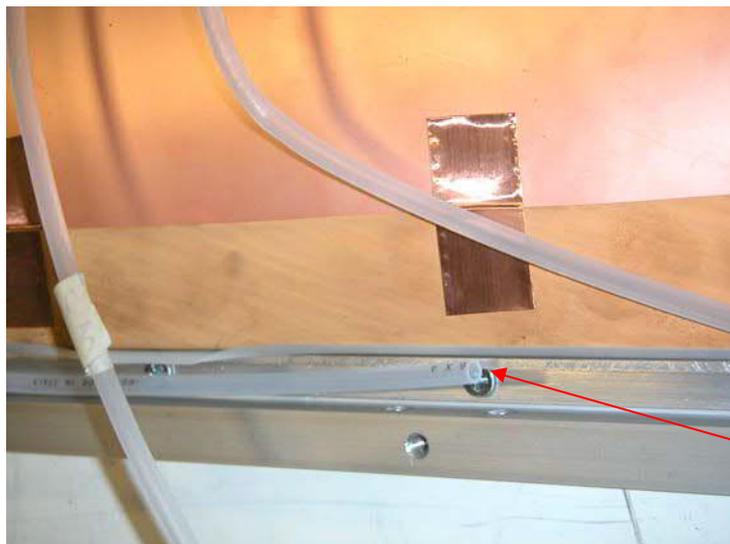
Leaving spare pipe in the chamber is not really useful.

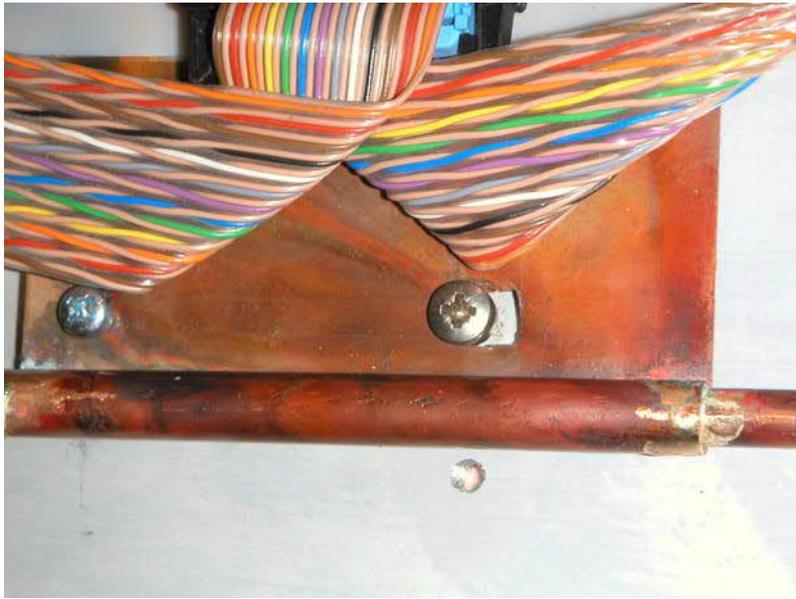
Brazing the pipe to the cooling plate is unnecessary. 'Soft' Solder is sufficient ( Pb & Sn )

The design of the FEB support plate to 8mm pipe can be simplified by a simple overlay. Sufficient strength will be achieved. The pipe between bulkheads must be a continuous piece to ensure a leak free system. The copper pipe should be hard, not annealed, for reasons of long term leak tightness at the union .

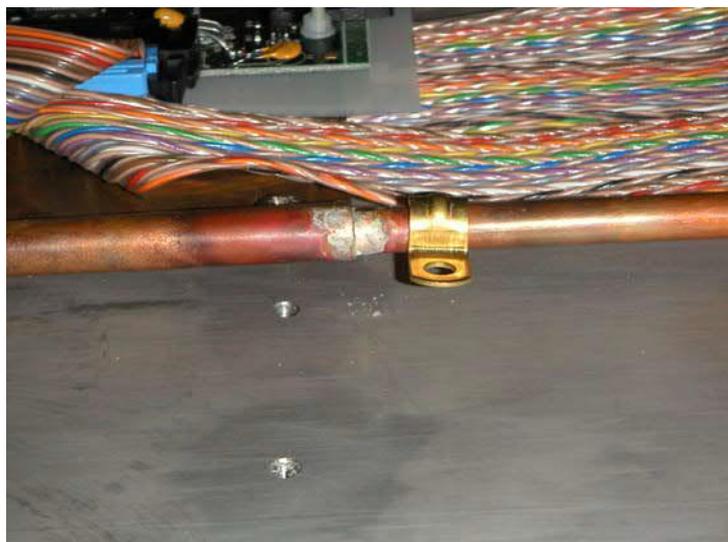
Two M5 inserts have been provided in the HCP for pipe mounting using the clamp shown and an additional one on the far side of the Cu cooling plate. In the RE1 case M6 nuts are used to increase clearance. There seems to be a design error in the RE2 case as one more hole should have been provided on the 'far side', giving a '3 point ' mounting scheme. If hard quality pipe is used, soldered to the cooling plate, the assembly may be rigid enough without modification.

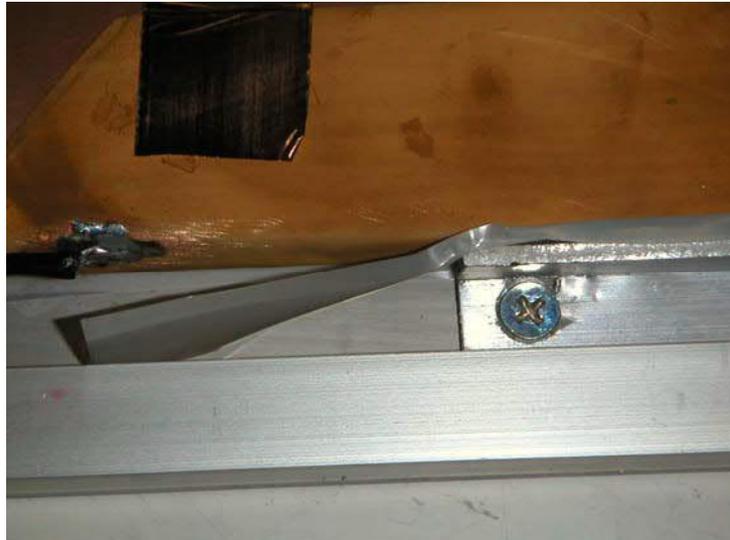
- Space is tight but it all fits ! Perhaps the insulating band on the gap locator could be incorporated into the bottom Mylar layer. In both RE1 and RE2, the gap insulation at the 'R' ends of the structure should be reviewed.

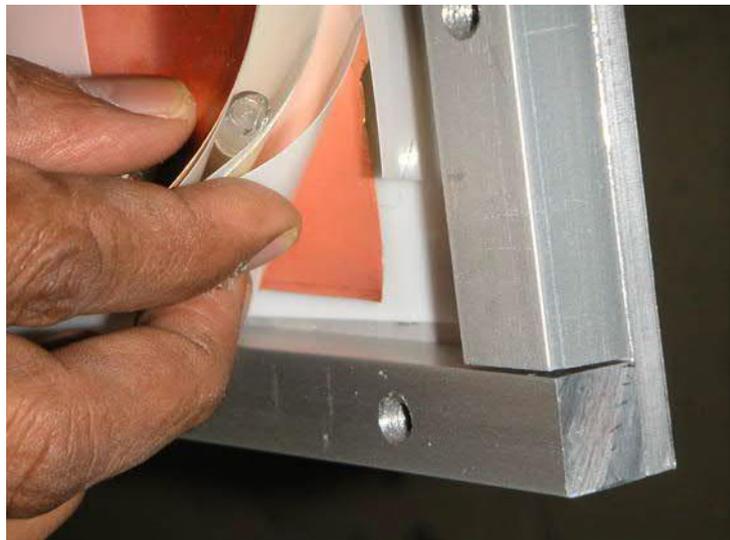
The bottom copper foil must be insulated from the chamber chassis. Since the chambers are vertical the copper film may shift, thus the edges should be insulated with tape. Tape used to retain pieces in place during assembly is insufficient. Some additional positive location is needed.

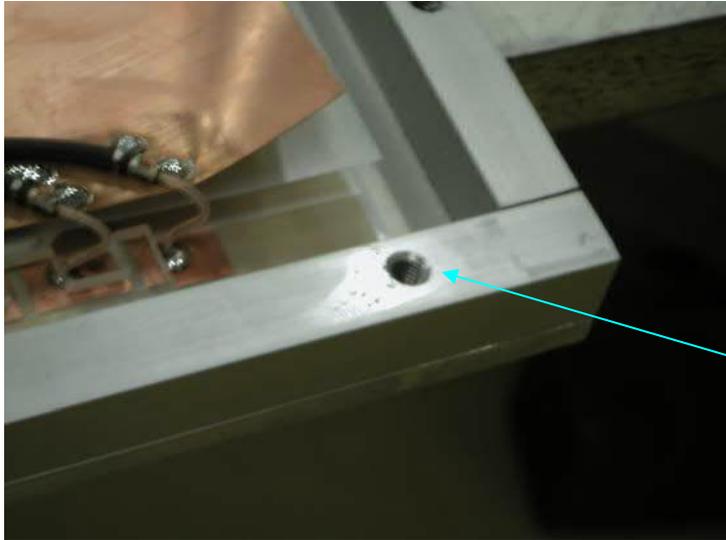
- Overall the structure of the chamber appeared fine but it would be preferable to remove traces of oil.

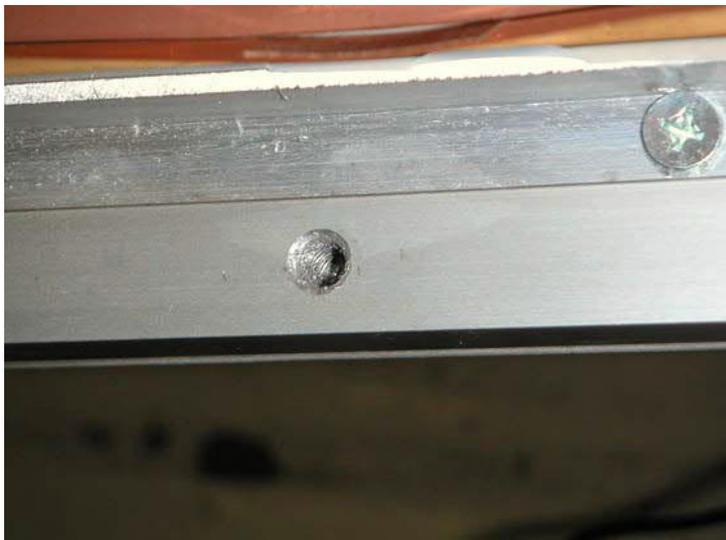
- More importantly any metallic swarf should be removed as it will tend to move under the influence of the 'E'(and or 'B') fields and finally end up giving a breakdown problem.

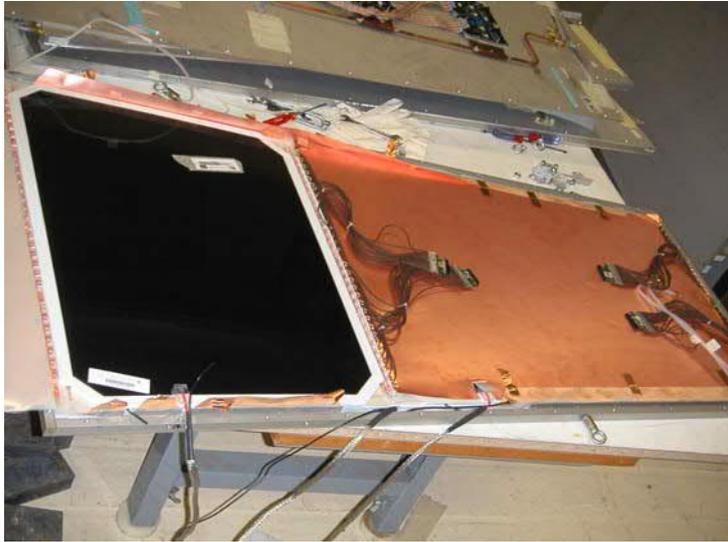
- The gaps had been well cleaned as no finger marks were visible.. The gap showed considerable curvature ( $>10\text{mm}$ ).

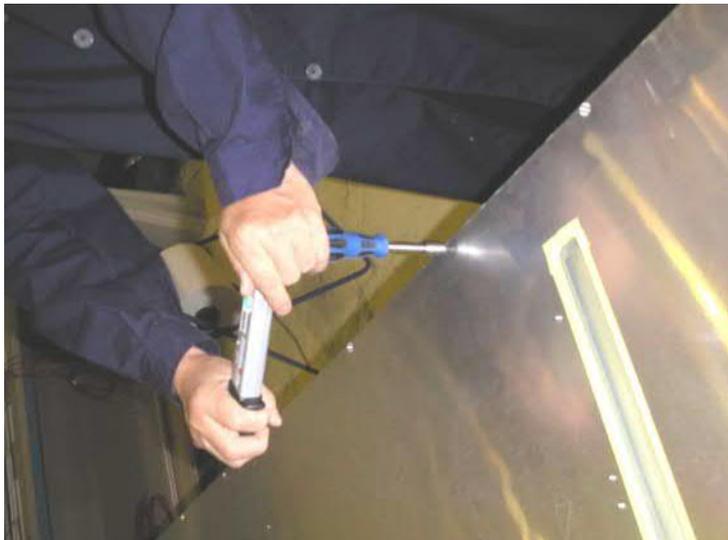
- The torque of the screws securing the HCPs to the alu. bars ( structure ) should be controlled and tight to ensure the two HCPs work together to form a rigid assembly. Torques of 2-4Nm were measured, where 7-9Nm were expected.

Mr Chai torquing up the frame screws. A torque wrench is required for this operation.

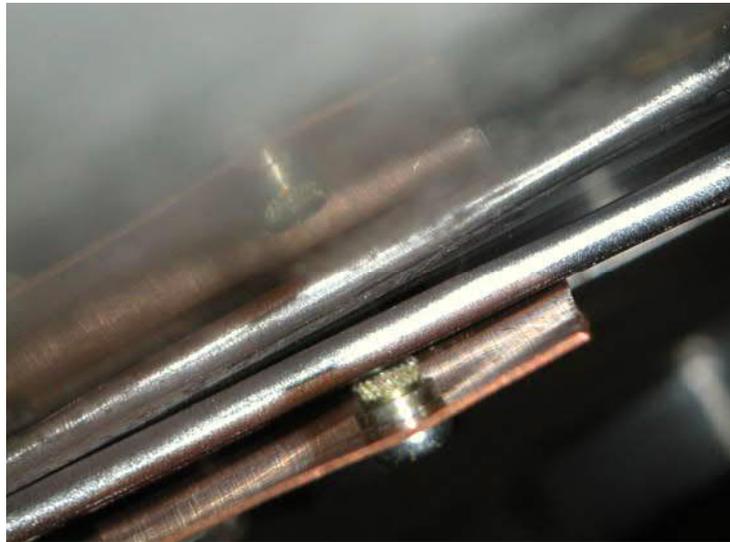
- The FEB should be mounted in a secure manner to the copper cooling system. It is electrically insulated from it.

The spacer necessary should be kept to a minimum so as to keep overall thickness of the chamber to a minimum. This one can be reduced to the thickness of 2 flat cables.

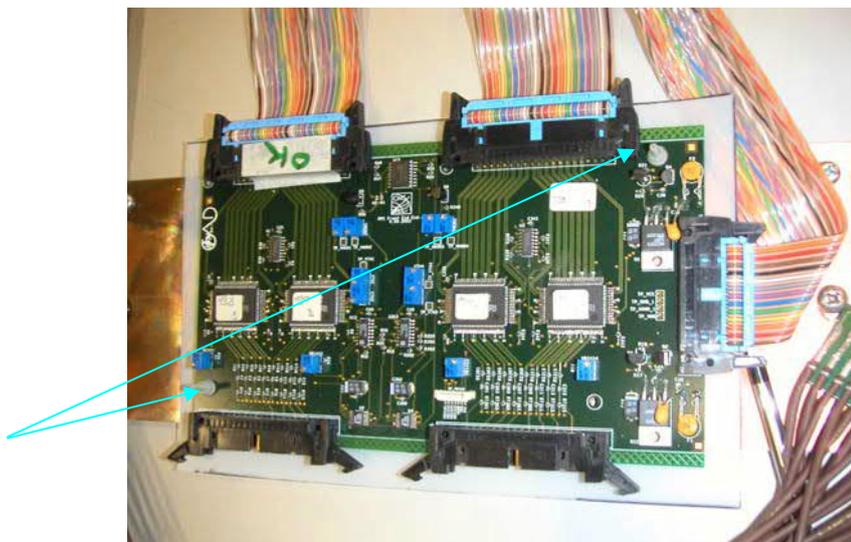
The rigidity of the assembly could be improved .

The very small plastic screws used in attaching the FEB to the cooling plate are fine but insufficient in number (2) and tightness. There must be 3. The holes have to align somewhat better. Mounting the male part to the Cu sheet is a good idea and ensures an easier assembly than in RE1.

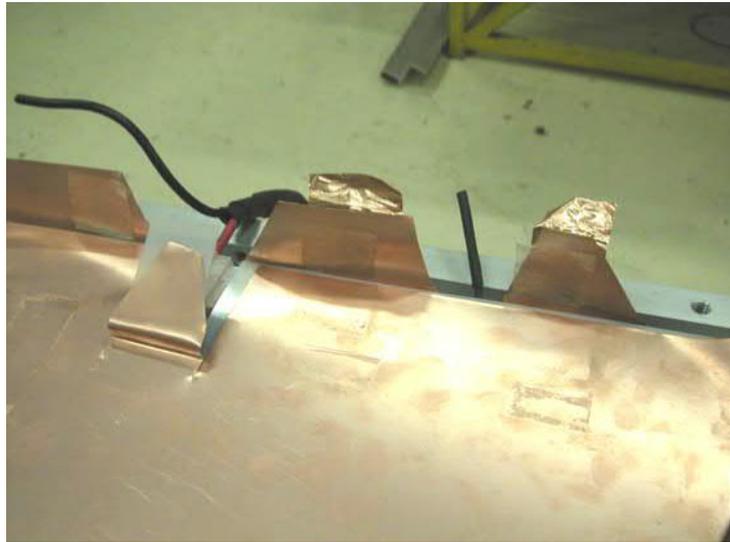
The use of double stick is not sufficient to ensure electrical conductivity in building a Faraday cage but of course it does ensure a close proximity of the two Cu sheets which is also a pre-requisite of same. The tape was tested to be nonconductive.

Soldering of small points along the edge are a good addition to ensure good long term conductivity, once thinner copper sheet is available.

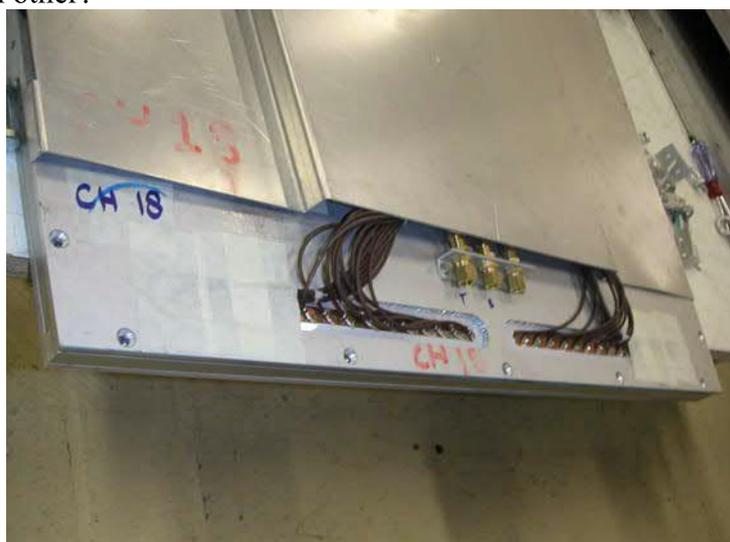
At the low 'R side the patch panel is relatively simple. This could be extended to reduce noise. Javed has suggested an intermediate panel covering/joining the shield covers of RE2/2 and RE2/3 which would be a good solution. For the inner edge of RE2/2, an alternative, temporary solution is needed pending the arrival of RE2/1. Small aluminum panels 0.5mm thick, self tapped to the HCP might suffice to cover the channel areas outside the existing shield cover.

Can the bottom patch panel be reversed so that the cooling and gas pipe do not crossover each other?

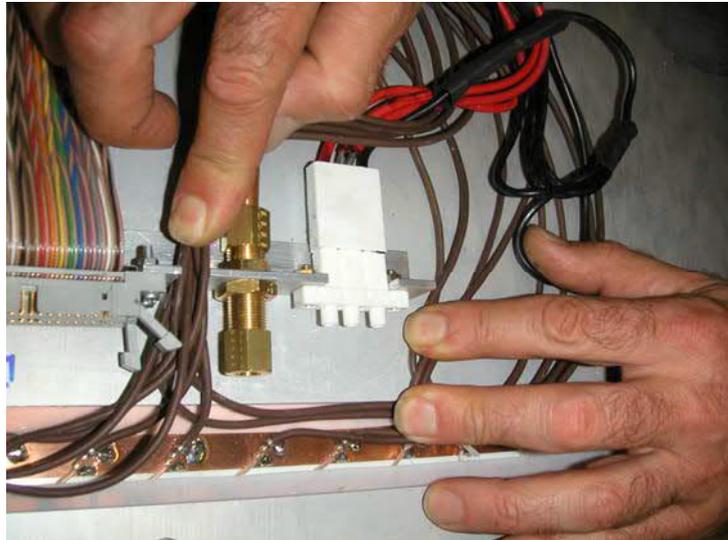
However at the outer 'R' end the situation is more complex. Here the obstruction/hindrane of connectors appears to be a problem. The solution may be to redirect more coaxial cables through the slot already milled next to the cooling union., as shown.

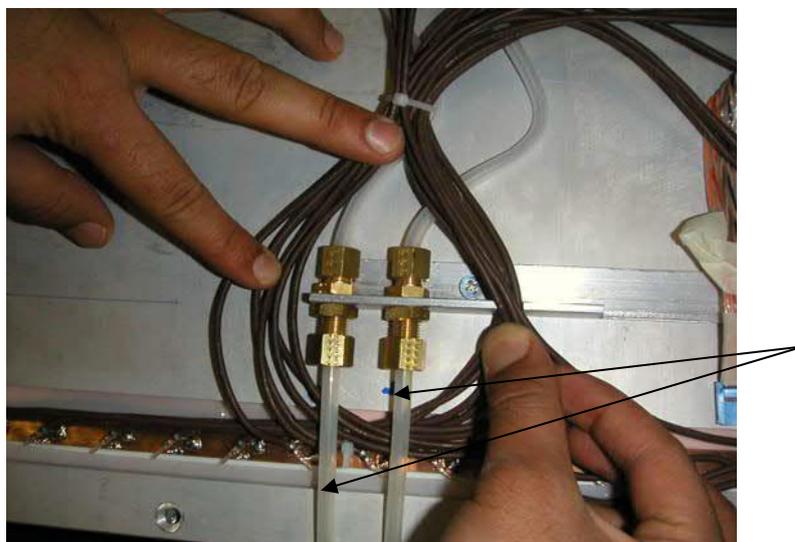
A similar argument can apply to the other side. Note the external gas pipes.

All unions and their respective lock nuts must be tight, otherwise twisted gas pipes and leaks can result.

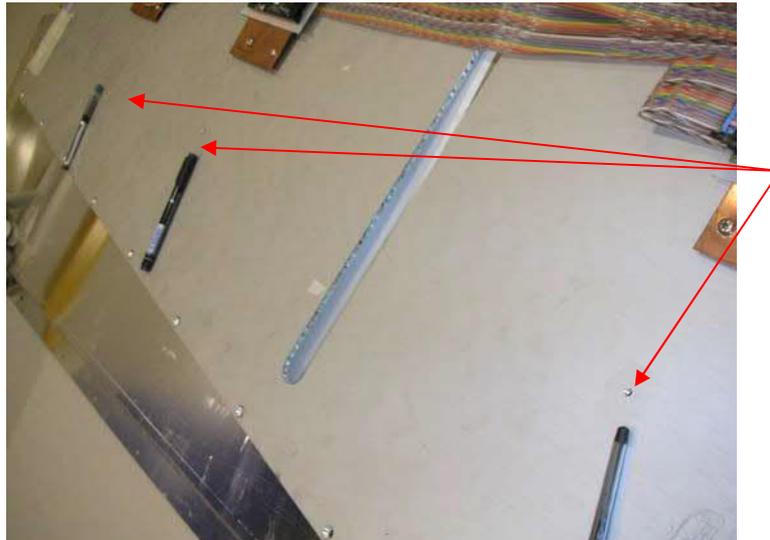
The shield cover had been intended to be mounted on the 6 x M5 threaded inserts indicated in the photo below. The use of a full span shield cover has some advantages, such as immediate full access, but will inevitably increase the occupation in 'Z' due to the flexibility of itself. Primarily, however, the access to the electronics/chamber of the on yoke chambers requires the 2 adjacent chambers to be removed beforehand. This mistake has been made by the CSCs, we should not limit our access, especially since the decision to have the CSCs on one yoke and the RPCs on the opposite was made in part for this reason

Note the 3 pens indicating the positions of the mounting inserts.

The shield cover was designed to be attached at six points along 'R' each side of the FEB's. Taking the cover to the outside edges increase the occupation in 'Z'. The cover is 25 mm deep and should be decreased to ~20mm as is achieved in RE1/2. & 3. The total chamber thickness is between 56.4 and 55.4mm.

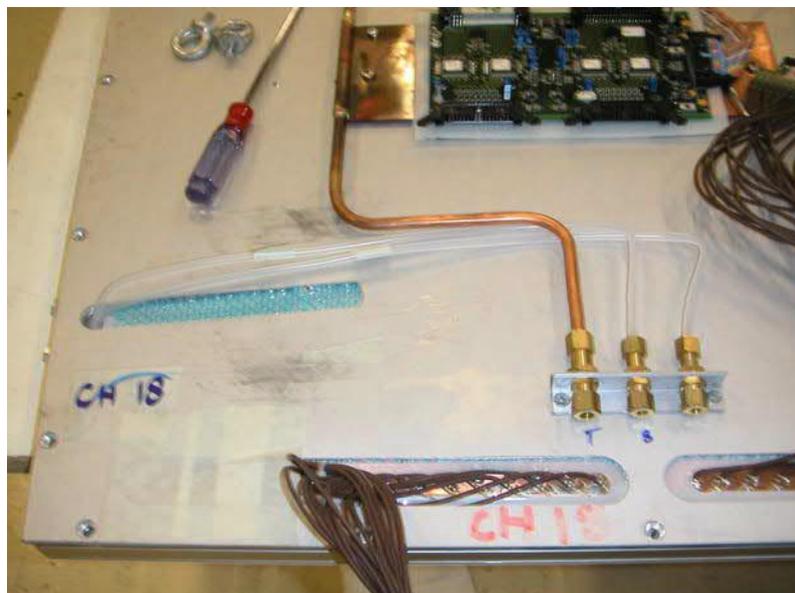
Crossing of services introduces unnecessary increase in ' $\Delta Z$ ', the thickness. Here the gas pipes are crossed and both cross with the cooling pipe.

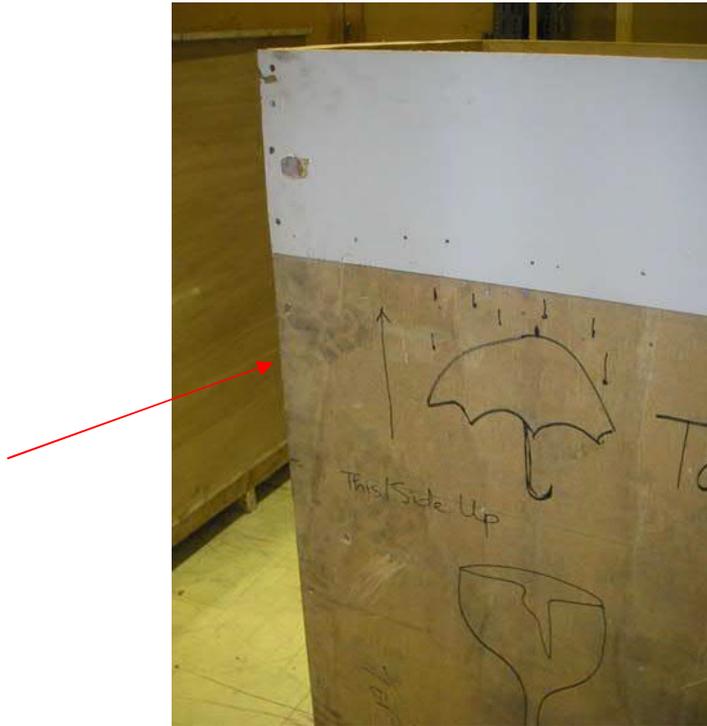
The ever present problem of damage that may occur during transport has occurred yet again. Note the 'heavy' foot prints on only one side of the now upright box, indicating that the box, and its contents, spent at least some time horizontal. With packing for more chambers this will be less likely to occur as the base of the box will increase in width so imparting greater stability and thus a lesser likelihood of tilting over. The box naturally ended up in its most stable condition that is with its largest surface on the ground!

'This side up' could be interpreted as meaning the side it is written on not where the arrow points.

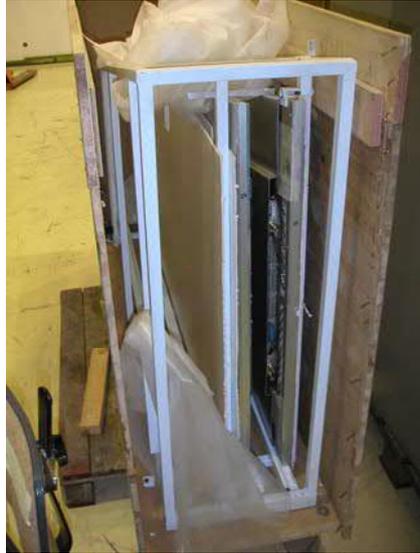
The steel frame is a good feature which provides rugged support for the chambers and in particular the space left around the structure gives some protection against fork lift perforation. This space could well be increased to >10cm.
