# **Some Comments on Assembly and Performance of pre-series RE2/2 chambers**

With input and comments from colleagues in the ISR lab and PH-CMM

The 3 Chambers were received at CERN on the 2nd June 2005.

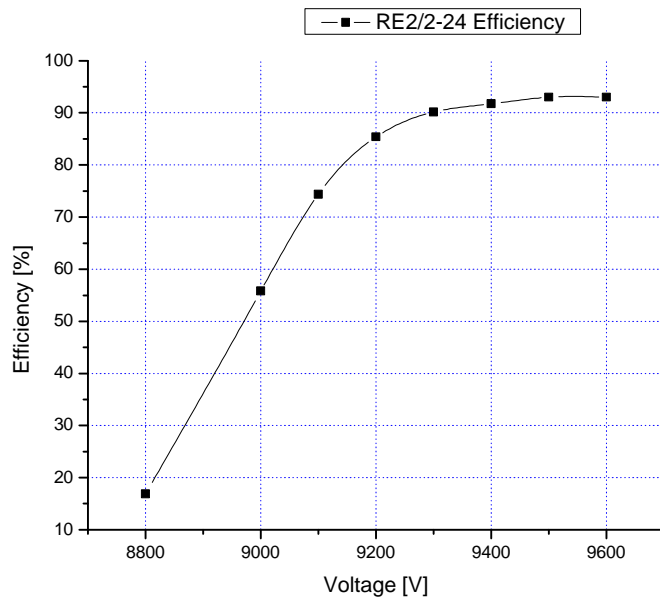
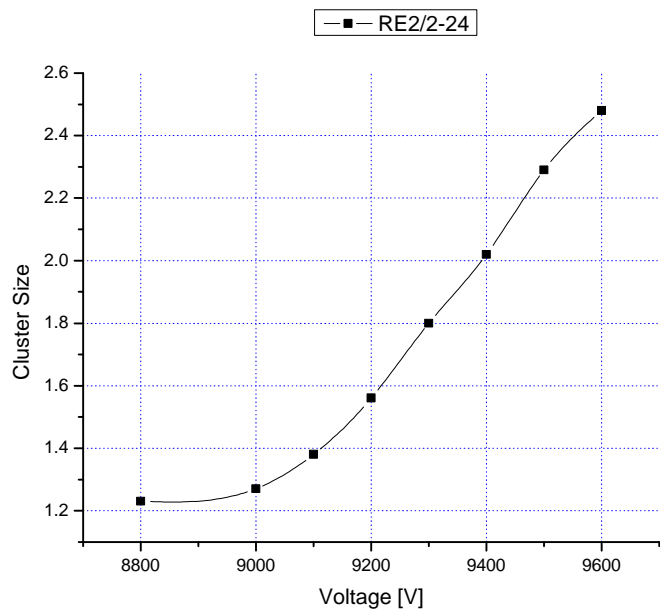
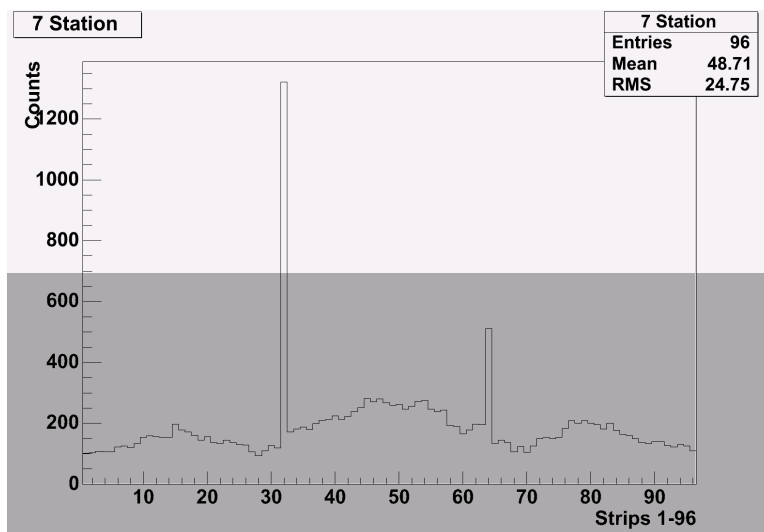
Three sectors TDC spectrum with 9.4 kV

After some corrections and improvements of grounds in preparation for the cosmic stand we can report that the RE22 chamber number 24, is at least 92-93%.efficient  
The low value may be due to geometrical acceptance which has been optimized for RE1/2 and RE1/3. Overall, the chamber is fine and behaves just like any RE1 chamber. Some plots are shown below. Strips 32 and 64 (edges) are noisy, as is the case of RE1 and RB chambers.

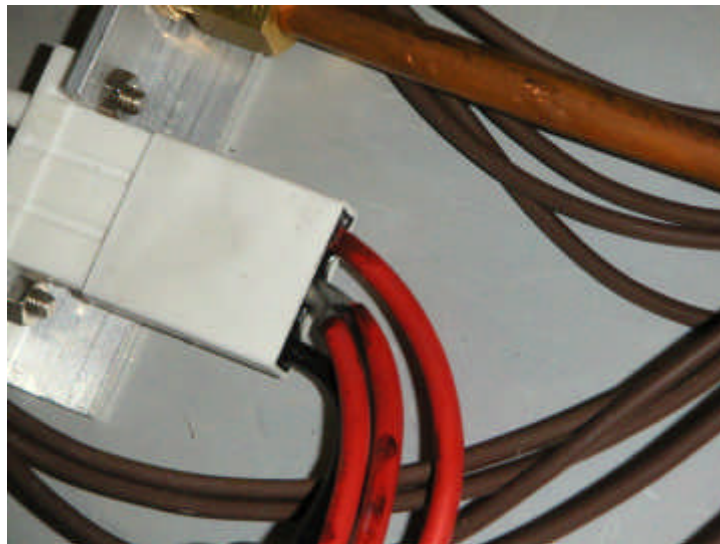
Great care must be taken in removing the insulation from the Cable leads. Here the insulation has been removed outside the connector, so compromising the HV breakdown strength.

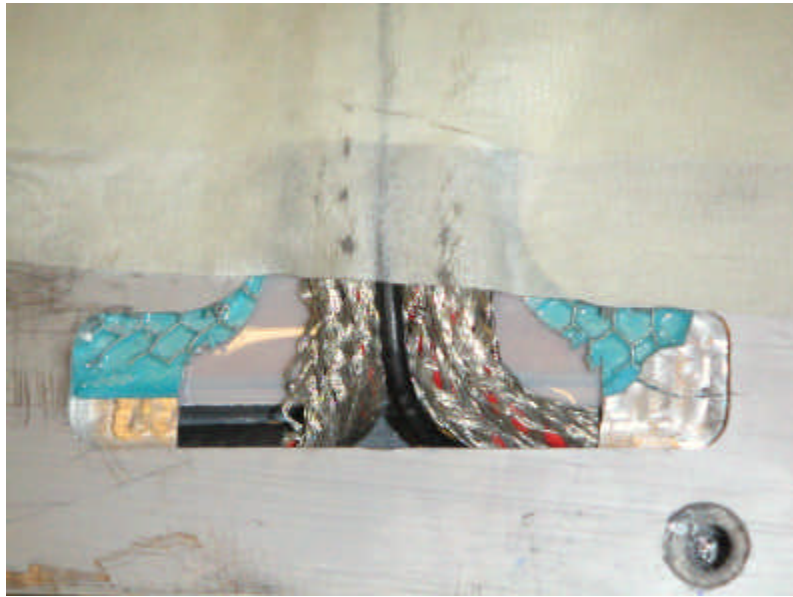
Sharp edges could compromise the insulation of the Faraday cage Cu shield wrt the chamber structure. Tape (polyester) is a solution. Hot melt run along the edges is more laborious but gave some reasonable results requiring additional refining in the procedure.

(NB. The insulation between the chamber ground and the signal reference/Faraday cage is in fact very good on this chamber.)

The opening for these cables is well calculated and executed.

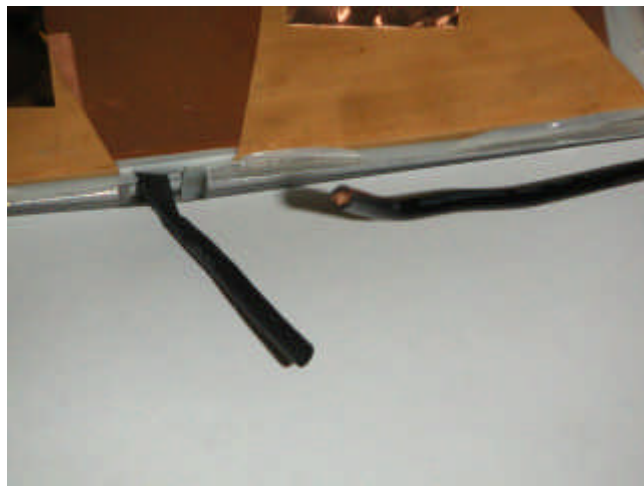
Some of the 0V return lines for the gaps were of thicker section ( $2\text{mm}^2$ ) than those used on the RE1 chambers ( $0.75\text{mm}^2$ ). This makes cable routing more difficult, HV connector assembly is not possible with both wires and more critically it weakens the 0V connection on the gap. This is already a weak point and may explain the failure that we found. There is no solder on this failure! Similar failures have occasionally been identified on RE1 gaps.

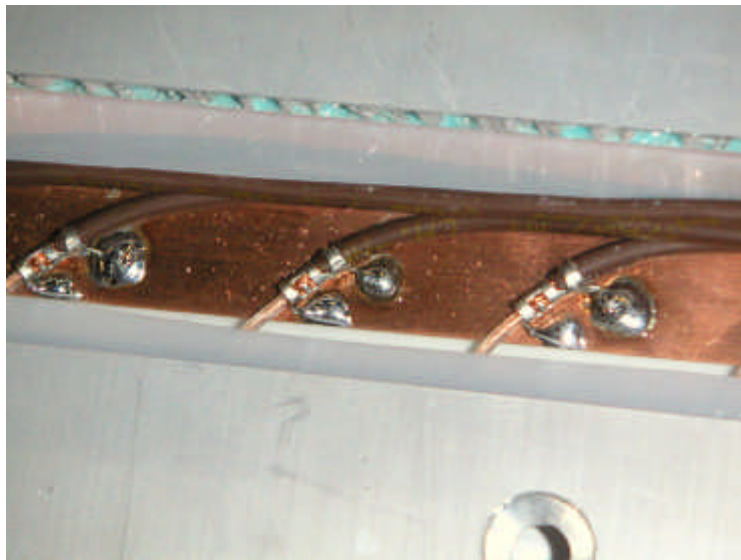
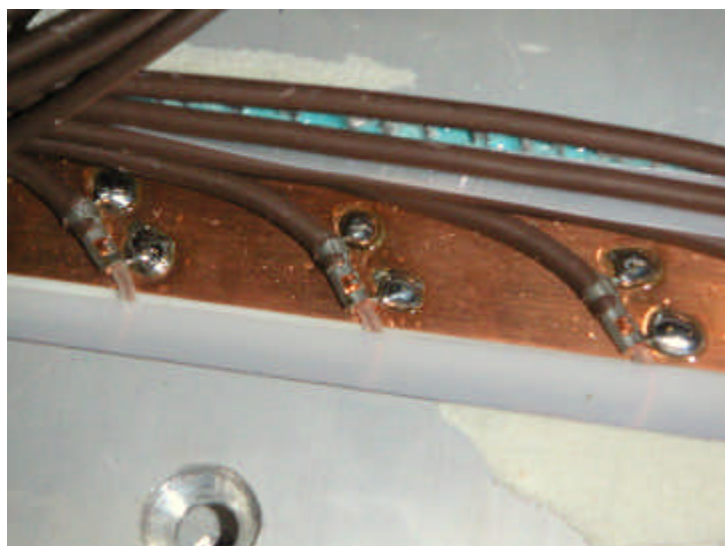
The soldering of the ferrule to the thick copper sheet is done well considering the difficult conditions. Thermal damage to the insulation of the centre conductor is minimal, amazingly.

However the wetting of the surface is not optimal and should improve considerably with the arrival of the Cu from Italy. If additional flux has been used then this should be washed off with acetone and isopropyl alcohol.

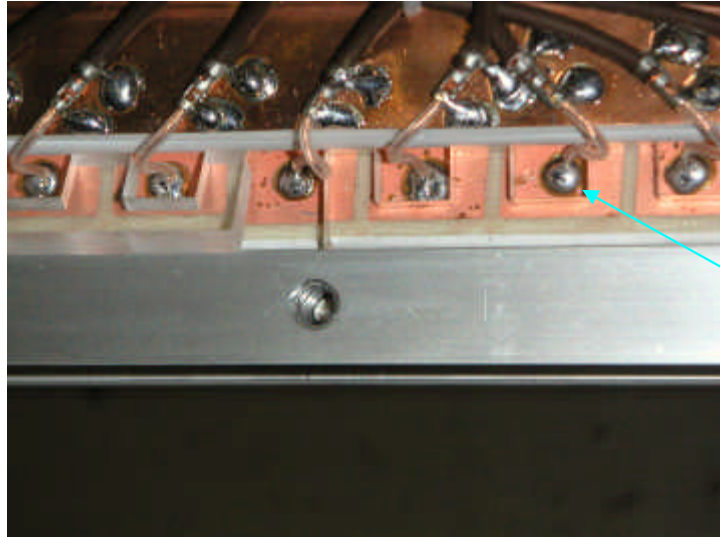
The soldering to the strips ( 35 $\mu$ m Cu ) is generally good but there is room for improvement in consistency.

The cut out to access this solder point is a better concept than in RE1

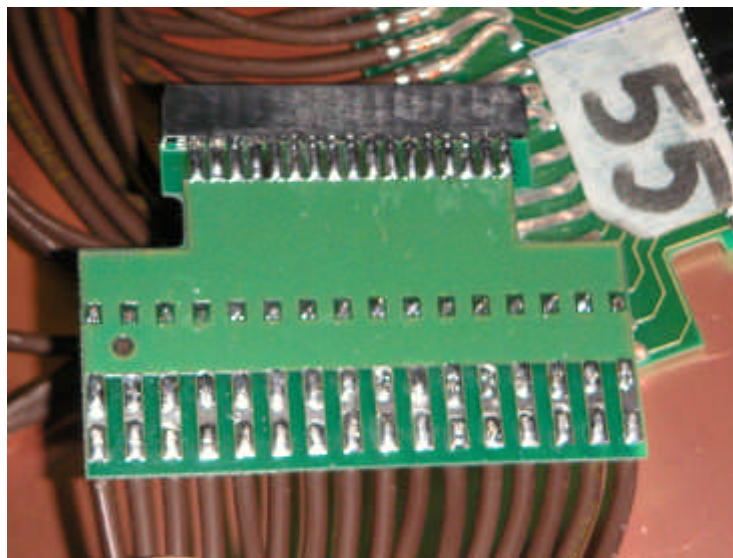
The soldering to the adaptor boards appears well done .

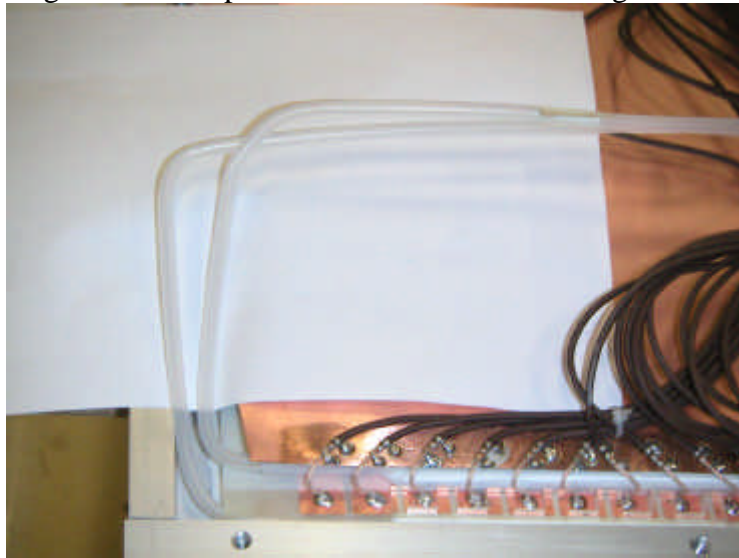
Securing the cables is good as is the orientation of the ferrules upon soldering to the Cu sheet. This angle is most important as it dictates the routing .

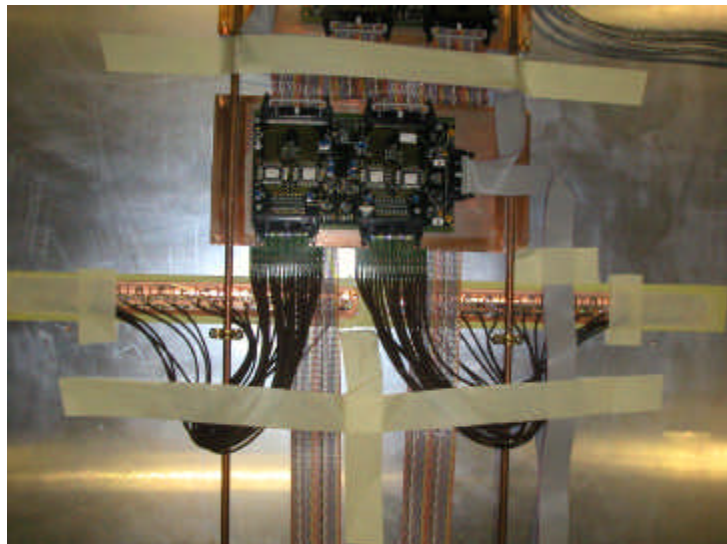
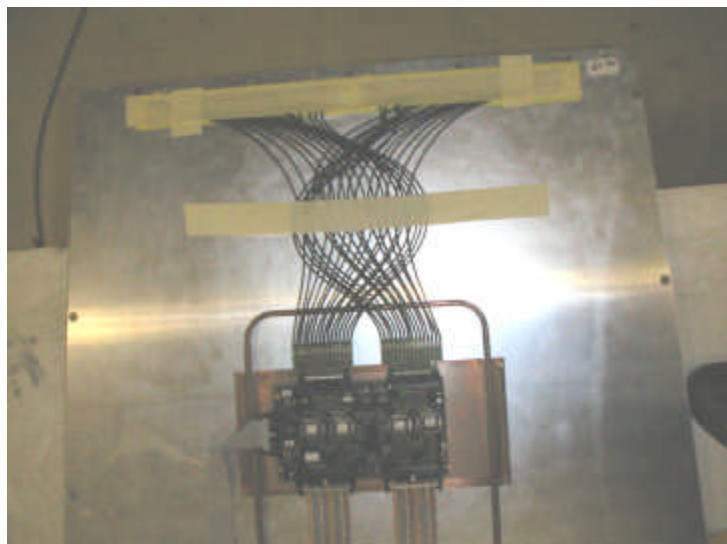
We recommend revisiting the routing to obtain a more repeatable result as illustrated below on these RE1 chambers.

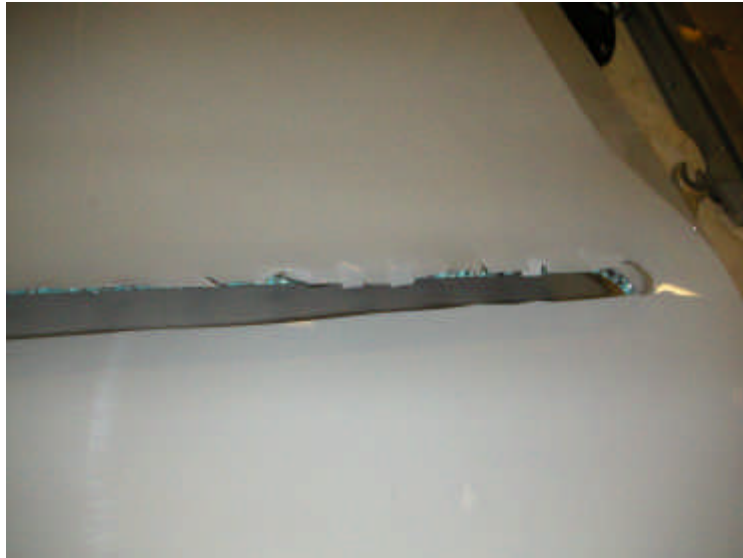
The Mylar film has been cut back as little as possible so that it acts as a protection to the coaxial cables, this is good solution and could be extended to cover both the lower and upper sharp edges of the HCP.( Honey comb Panel). However where the cables must run along inside the channel before exiting, an additional solution is required.

If this solution is retained, then the positioning of the Mylar is critical to avoid modifications being needed later in assembly process (as evidenced by these irregular edges).

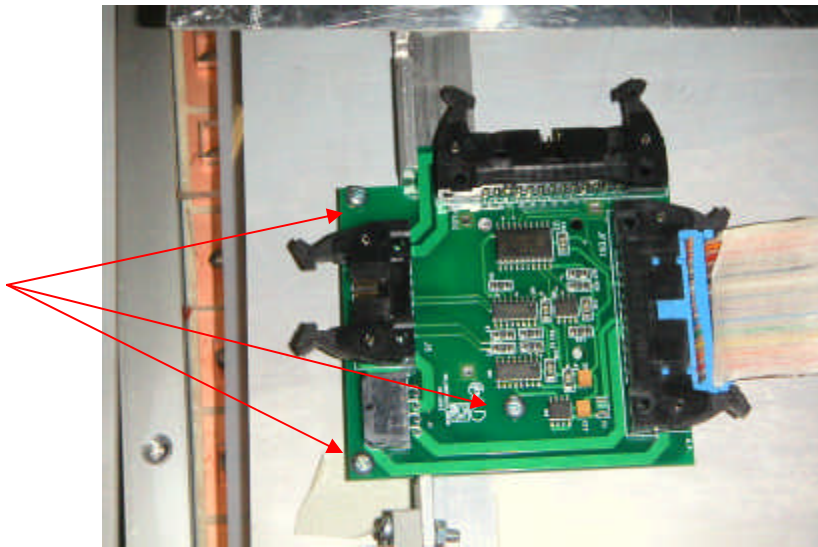
The LV Distribution Board was not fitted to these three pre-series chambers . This should be secured directly to the HCP using small and short (!!) self tapping screws. A similar solution works extremely well on RE1 for securing the small Alu panels covering the coaxial cables outside the shield box. Here 8mm long PA stand-offs have been envisaged with self tapping screws of 2.9 x 13mm. The lower screw will require an insulating washer as it is very close to a conductor trace.

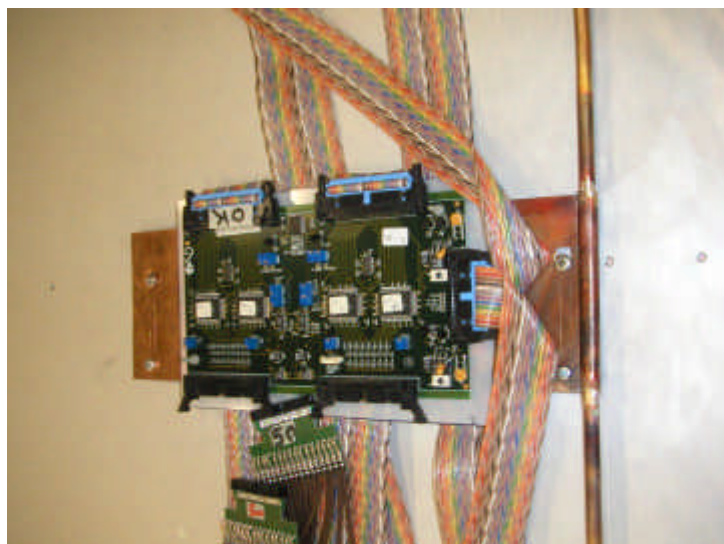
Little advantage can be obtained by folding the cable at a traditional 90 degrees. Here a slight reduction in length is obtained with a consequent lose in esthetic appeal !

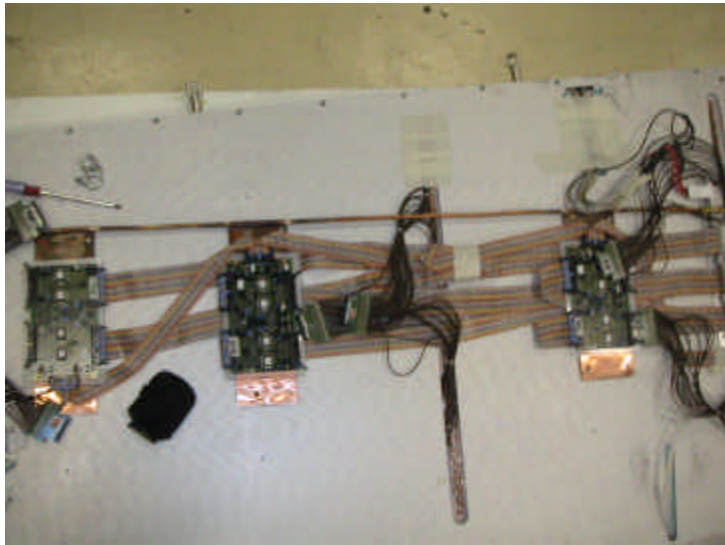
The placement of the FEB can be offset in phi so as to obtain parallel paths for the flat cables with no crossover and little excess length. This is the reason why the Cu cooling plates are so 'wide' in phi.

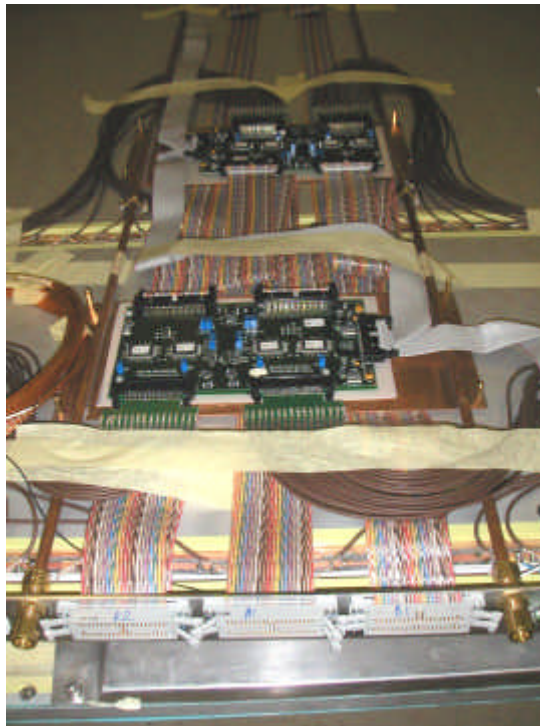
Here the cables run parallel with no crossing and only 2 thicknesses under the Cu cooling plates.

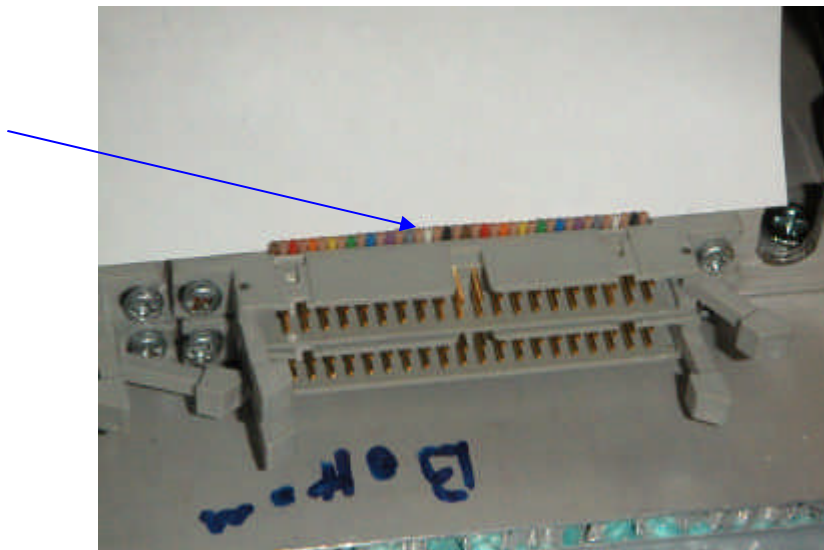
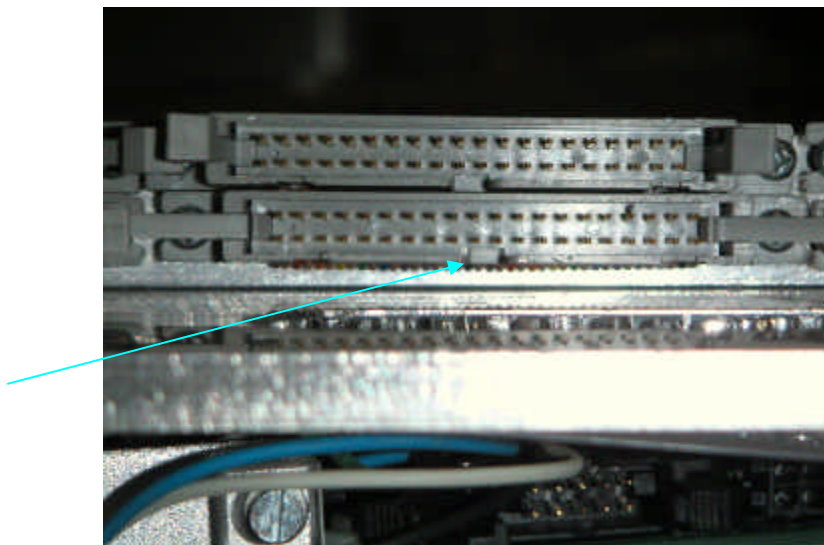
The cable should be cut off flush with the connector as in some cases shorts could occur. Possibly to the HCP or an adjacent connector.

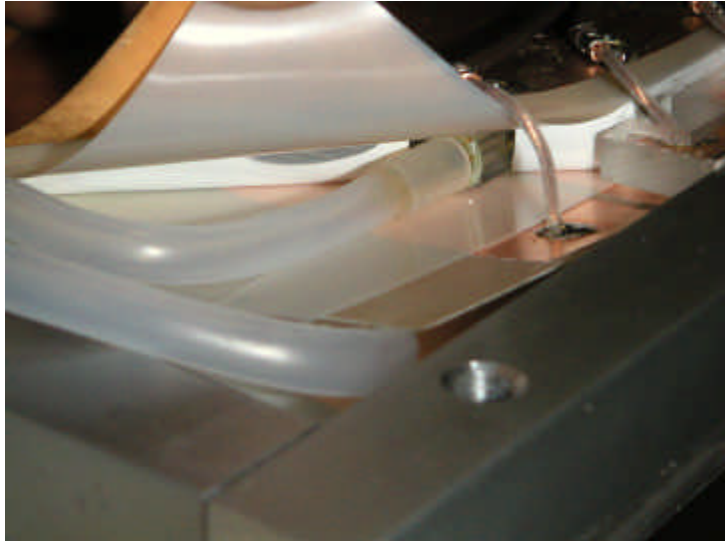
The connections to the gaps seem to be well done. Heat should be used in moderation if not the insert can be weakened.

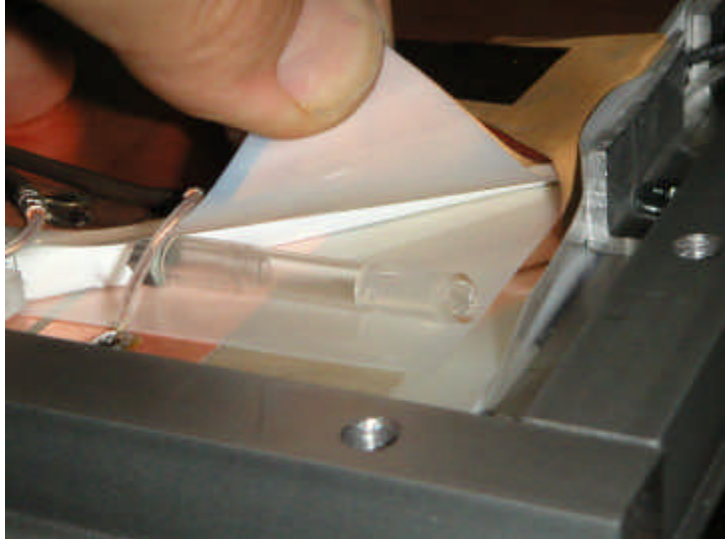
Plugging up of the unused gap connexions should preferably be done with the PE pipe used else where and not PVC. The PVC will resist chemically but may be more liable to hardening in time.

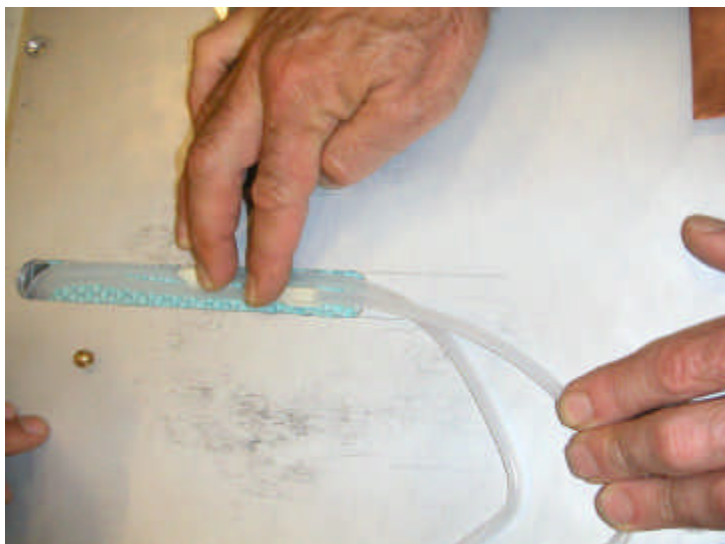
The cut outs in the panel are not deep enough and so leave a rough surface for the pipes to be damaged upon. Taping, remilling or filling with a low viscosity caulking compound should be considered.

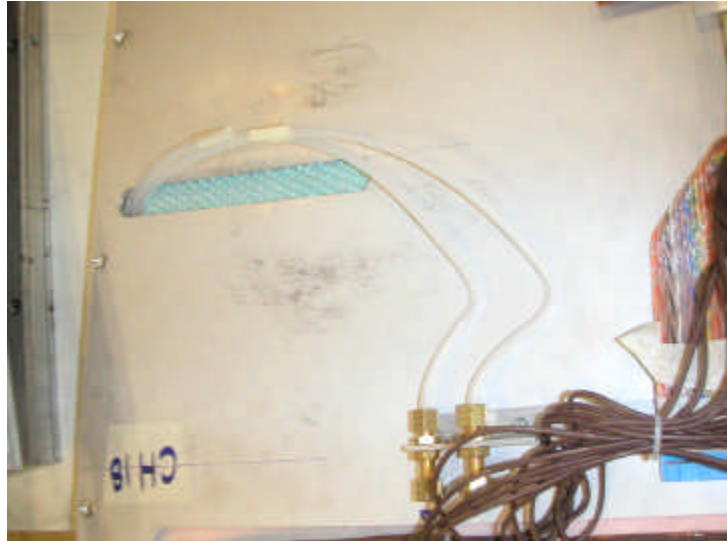
The routing and thermo forming of the gas pipes must be done so that the routing is facilitated. This is not such a good example. Numerous iterations will be needed to obtain a good repeatable result. Tooling is essential for each model of pipe.

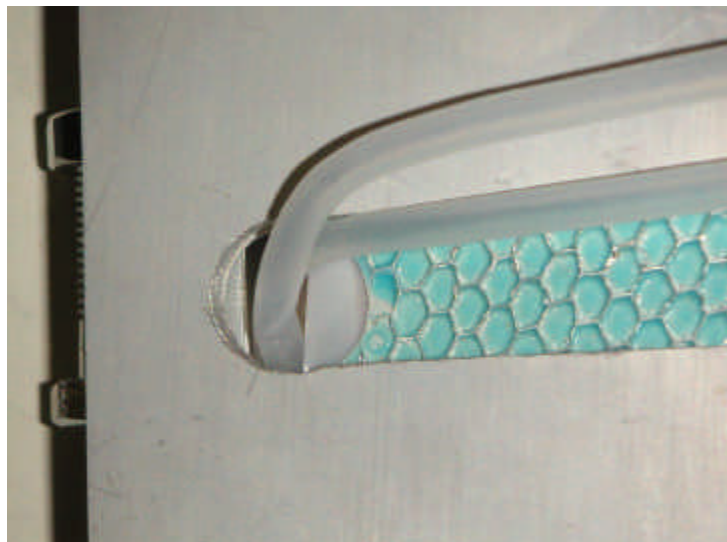
Coming back to cut outs, here the gas pipe can easily be kinked if the hole is too small as is the case in the picture below. (The HV cutout is a good example ). Flow should not be obstructed. The kink will be unlikely to relax and alleviate the problem

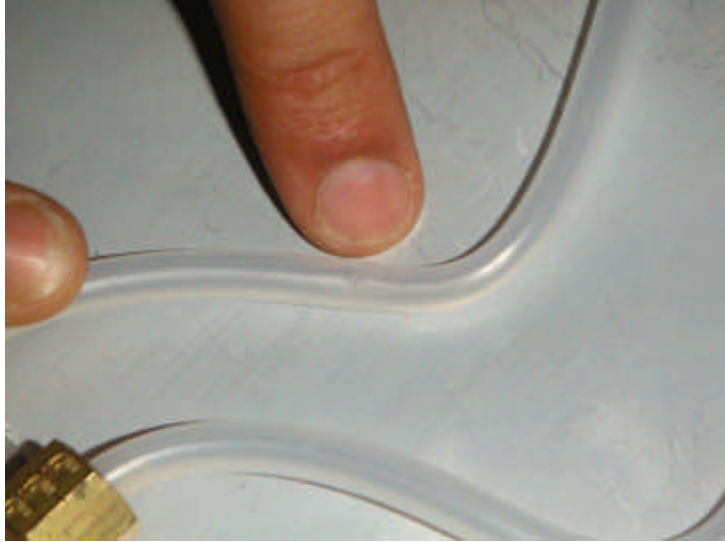
The pre-forming of the pipes must be done according to a pre-established method, using standard tooling (to guarantee the right temperature for the correct length of time). In the case illustrated, the pipe has melted and is damaged.

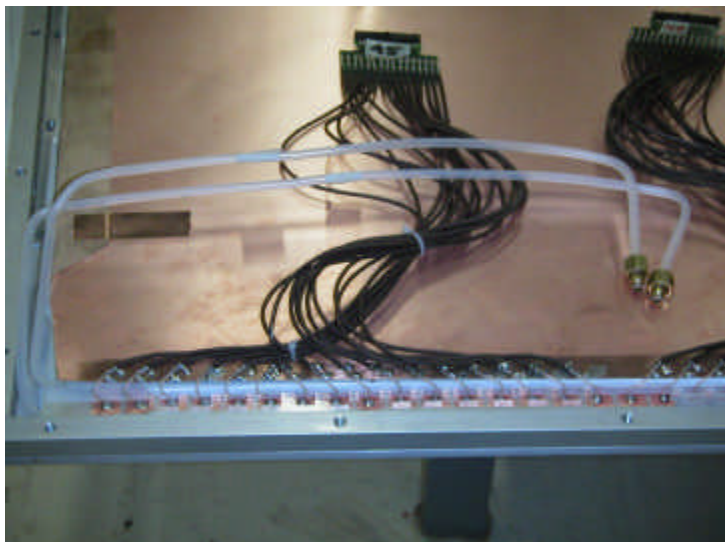
The routing has to be simplified, avoiding unnecessary crossovers

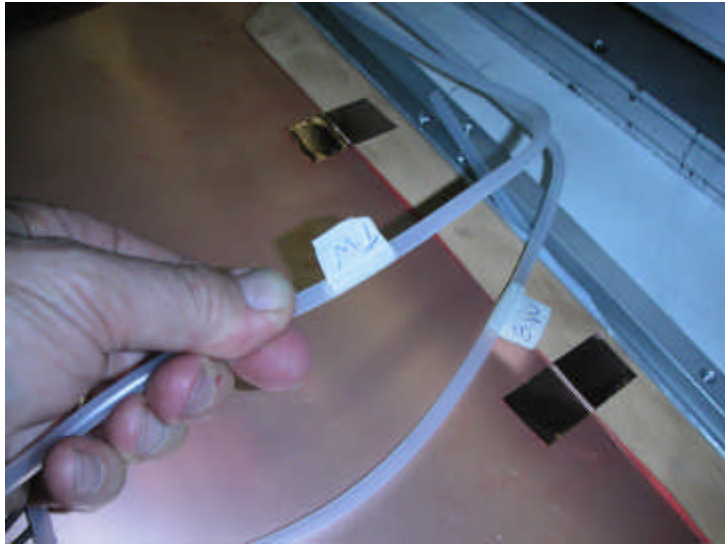
Labeling the pipes is good practice to prevent mistakes.

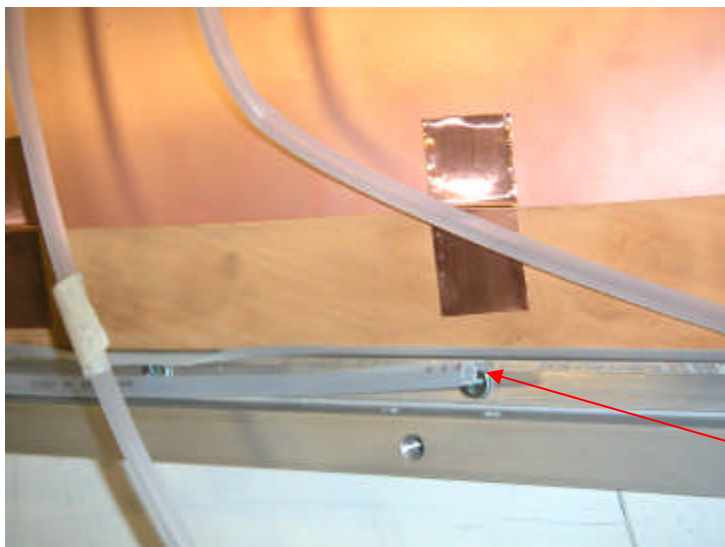
Leaving spare pipe in the chamber is not really useful.

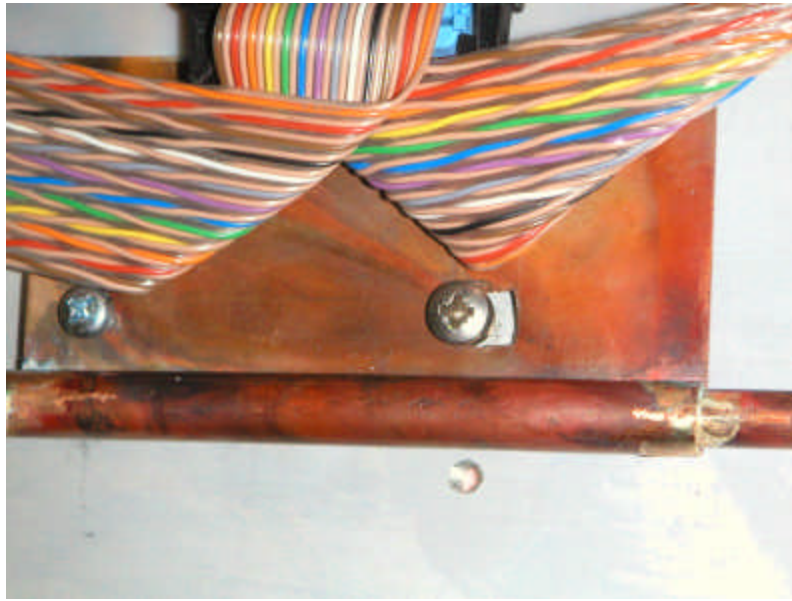
Brazing the pipe to the cooling plate is unnecessary. 'Soft' Solder is sufficient ( Pb & Sn )

The design of the FEB support plate to 8mm pipe can be simplified by a simple overlay. Sufficient strength will be achieved. The pipe between bulkheads must be a continuous piece to ensure a leak free system. The copper pipe should be hard, not annealed, for reasons of long term leak tightness at the union .

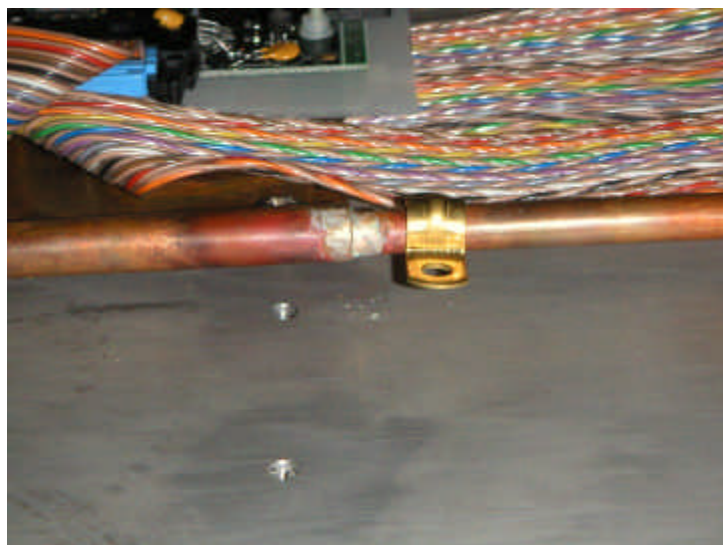
Two M5 inserts have been provided in the HCP for pipe mounting using the clamp shown and an additional one on the far side of the Cu cooling plate. In the RE1 case M6 nuts are used to increase clearance. There seems to be a design error in the RE2 case as one more hole should have been provided on the 'far side', giving a '3 point ' mounting scheme. If hard quality pipe is used, soldered to the cooling plate, the assembly may be rigid enough without modification.

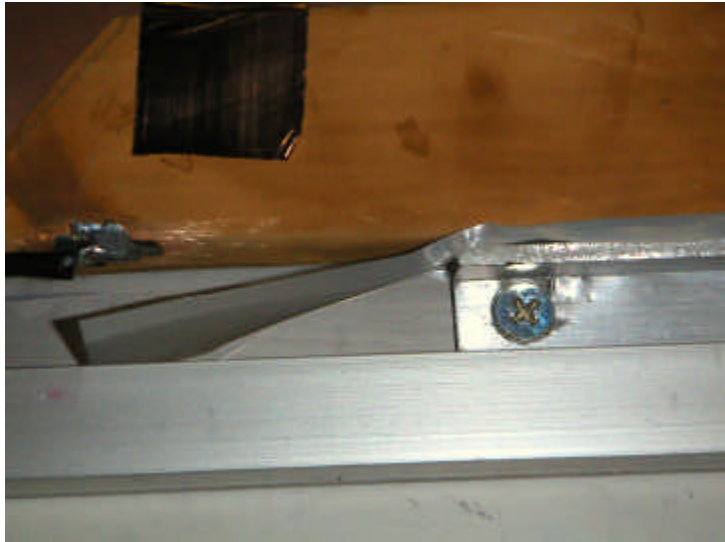
- Space is tight but it all fits ! Perhaps the insulating band on the gap locator could be incorporated into the bottom Mylar layer. In both RE1 and RE2, the gap insulation at the 'R' ends of the structure should be reviewed.

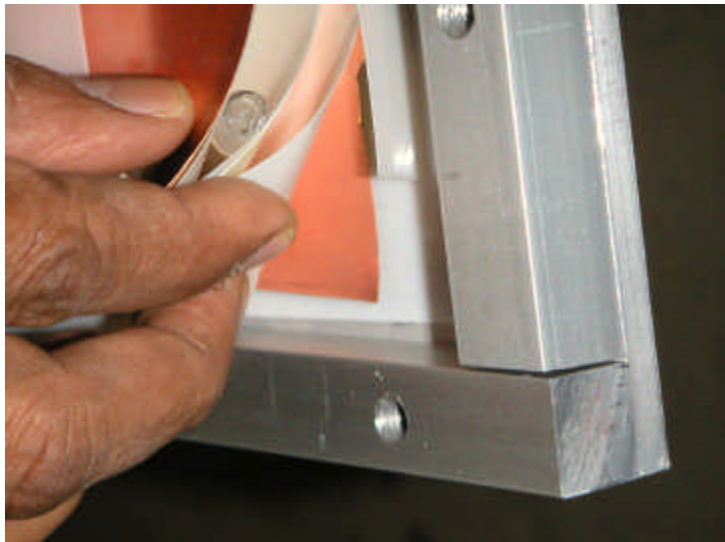
The bottom copper foil must be insulated from the chamber chassis. Since the chambers are vertical the copper film may shift, thus the edges should be insulated with tape. Tape used to retain pieces in place during assembly is insufficient. Some additional positive location is needed.

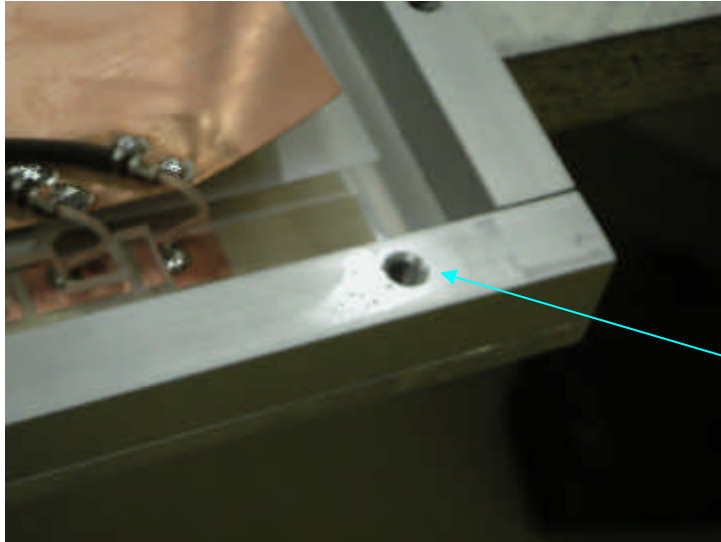
- Overall the structure of the chamber appeared fine but it would be preferable to remove traces of oil.

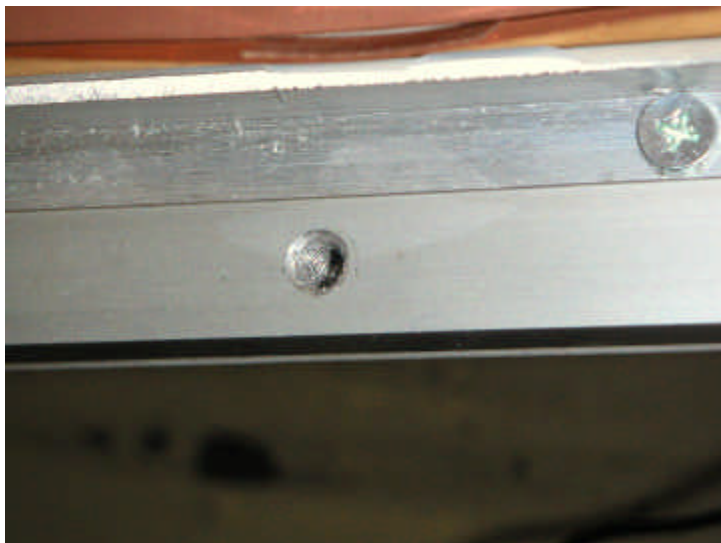
- More importantly any metallic swarf should be removed as it will tend to move under the influence of the 'E'(and or 'B') fields and finally end up giving a breakdown problem.

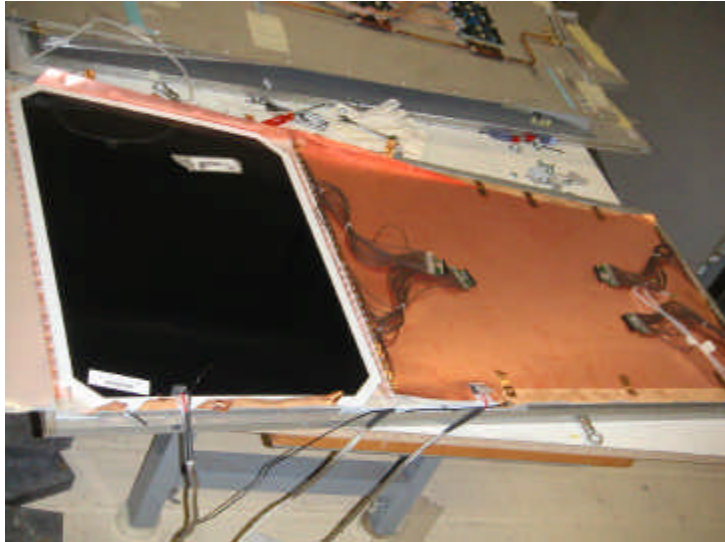
- The gaps had been well cleaned as no finger marks were visible.. The gap showed considerable curvature ( $>10\text{mm}$ ).

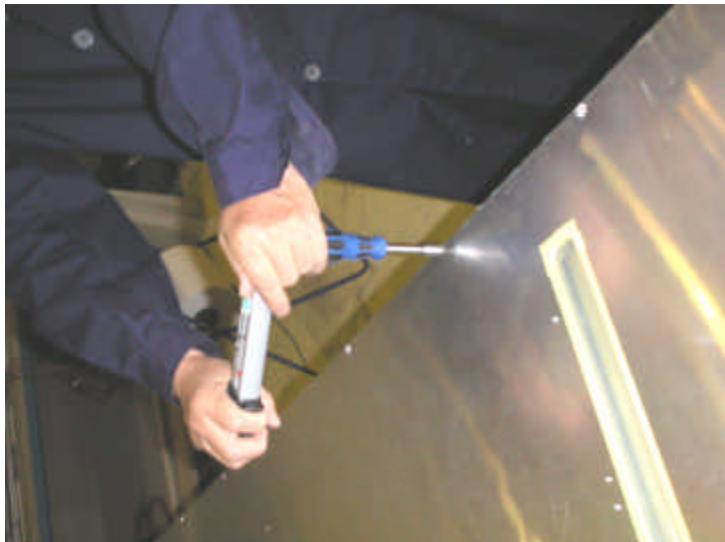
- The torque of the screws securing the HCPs to the alu. bars ( structure ) should be controlled and tight to ensure the two HCPs work together to form a rigid assembly. Torques of 2-4Nm were measured, where 7-9Nm were expected.

Mr Chai torquing up the frame screws. A torque wrench is required for this operation.

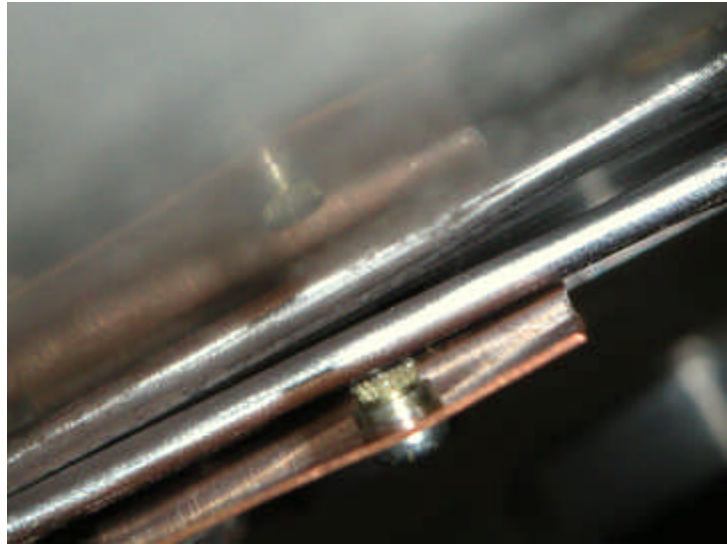
- The FEB should be mounted in a secure manner to the copper cooling system. It is electrically insulated from it.

The spacer necessary should be kept to a minimum so as to keep overall thickness of the chamber to a minimum. This one can be reduced to the thickness of 2 flat cables.

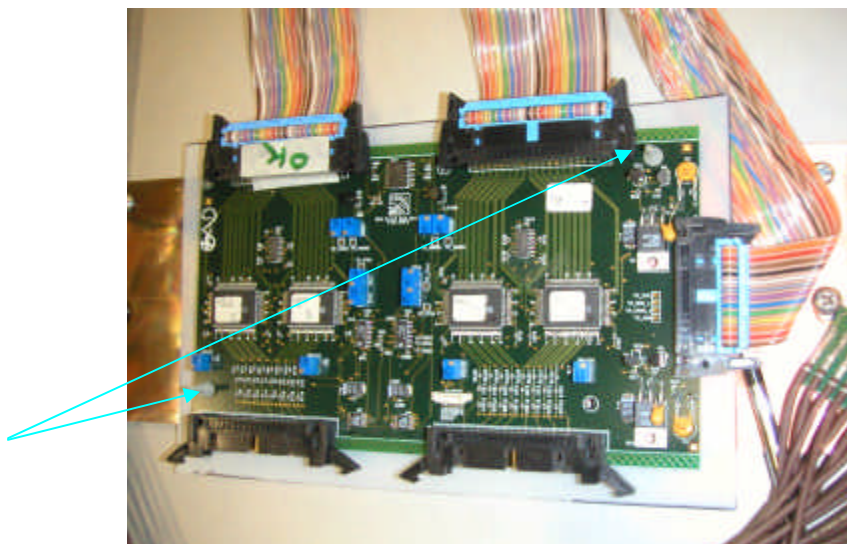
The rigidity of the assembly could be improved .

The very small plastic screws used in attaching the FEB to the cooling plate are fine but insufficient in number (2) and tightness. There must be 3. The holes have to align somewhat better. Mounting the male part to the Cu sheet is a good idea and ensures an easier assembly than in RE1.

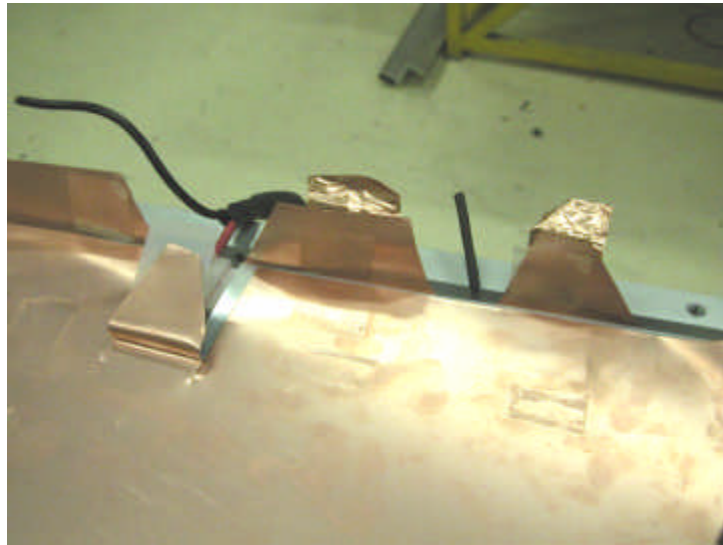
The use of double stick is not sufficient to ensure electrical conductivity in building a Faraday cage but of course it does ensure a close proximity of the two Cu sheets which is also a pre-requisite of same. The tape was tested to be nonconductive.

Soldering of small points along the edge are a good addition to ensure good long term conductivity, once thinner copper sheet is available.

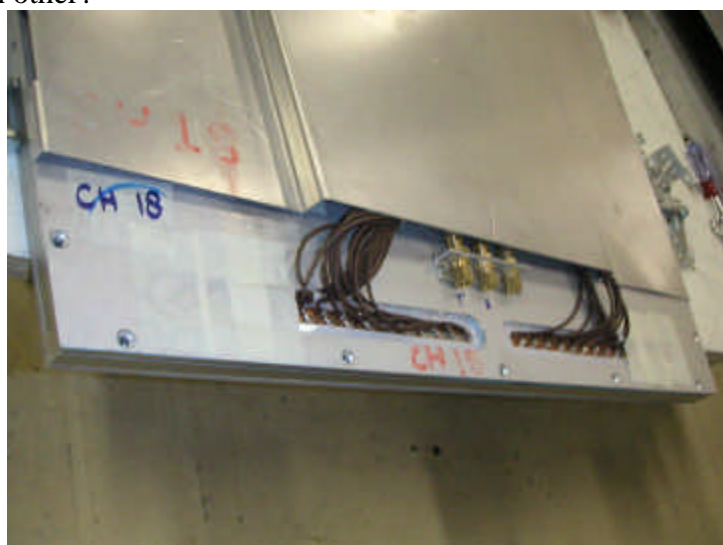
At the low 'R side the patch panel is relatively simple. This could be extended to reduce noise. Javed has suggested an intermediate panel covering/joining the shield covers of RE2/2 and RE2/3 which would be a good solution. For the inner edge of RE2/2, an alternative, temporary solution is needed pending the arrival of RE2/1. Small aluminum panels 0.5mm thick, self tapped to the HCP might suffice to cover the channel areas outside the existing shield cover.

Can the bottom patch panel be reversed so that the cooling and gas pipe do not crossover each other?

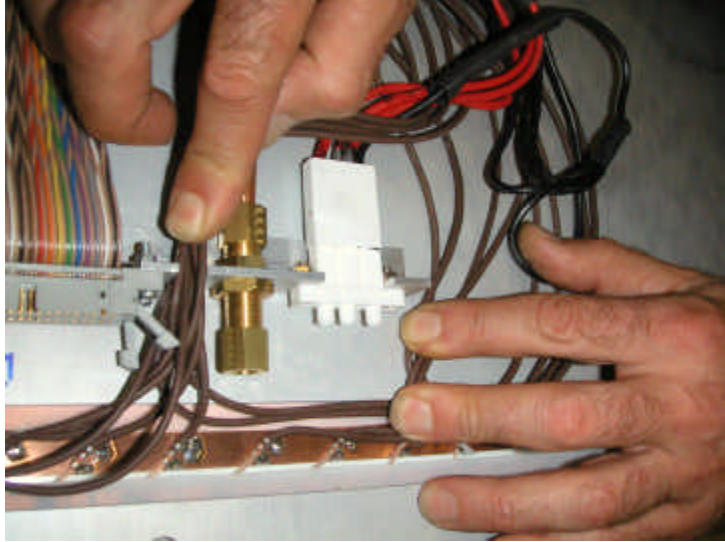
However at the outer 'R' end the situation is more complex. Here the obstruction/hindrane of connectors appears to be a problem. The solution may be to redirect more coaxial cables through the slot already milled next to the cooling union., as shown.

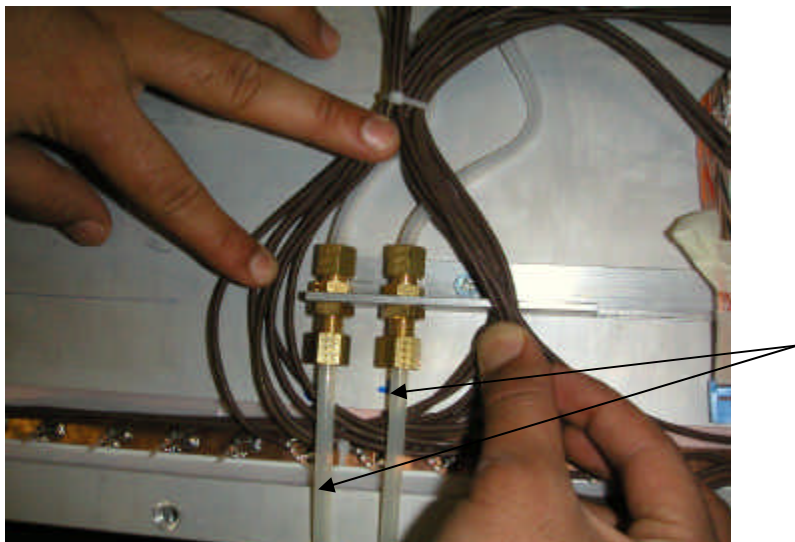
A similar argument can apply to the other side. Note the external gas pipes.

All unions and their respective lock nuts must be tight, otherwise twisted gas pipes and leaks can result.

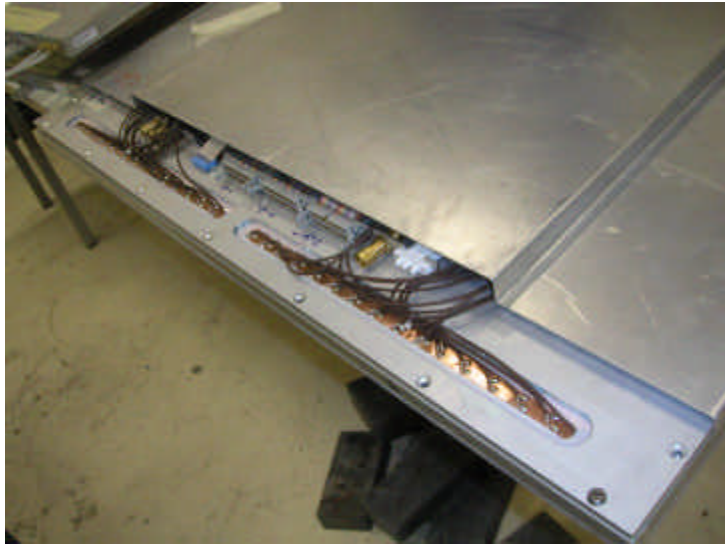
Clearly at this high 'R' side we must face the patch panel termination on RE2/3.

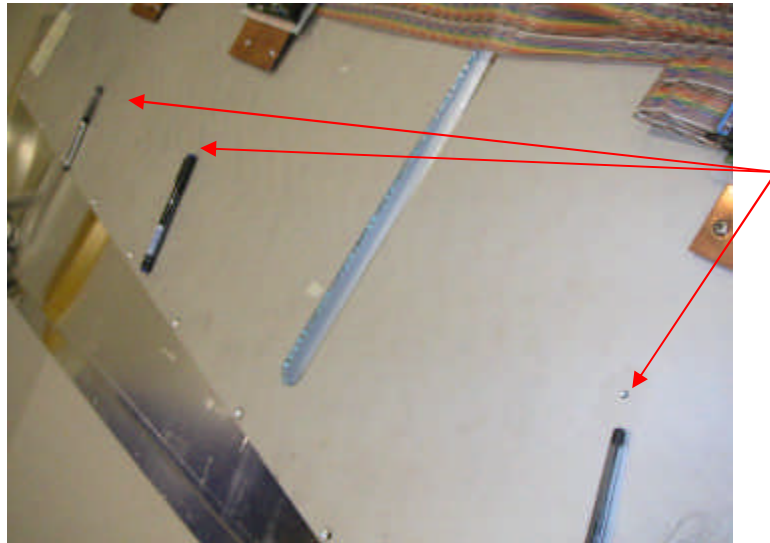
The shield cover had been intended to be mounted on the 6 x M5 threaded inserts indicated in the photo below. The use of a full span shield cover has some advantages , such as immediate full access, but will inevitably increase the occupation in 'Z' due o the flexibility of itself. Primarily ,however, the access to the electronics/chamber of the on yoke chambers requires the 2 adjacent chambers to be removed beforehand. This mistake has been made by the CSCs , we should not limit our access, especially since the decision to have the CSCs on one yoke and the RPCs on the opposite was made in part for this reason

Note the 3 pens indicating the positions of the mounting inserts.

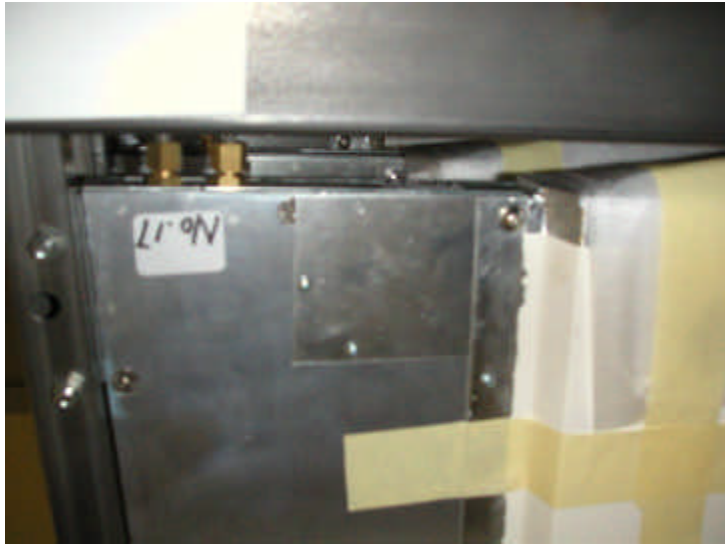
In the case of RE1 the areas of coaxial cabling outside the shield box have been covered with 0.5mm alu sheet. Secured by self tapping screws 2.9 x 4.5

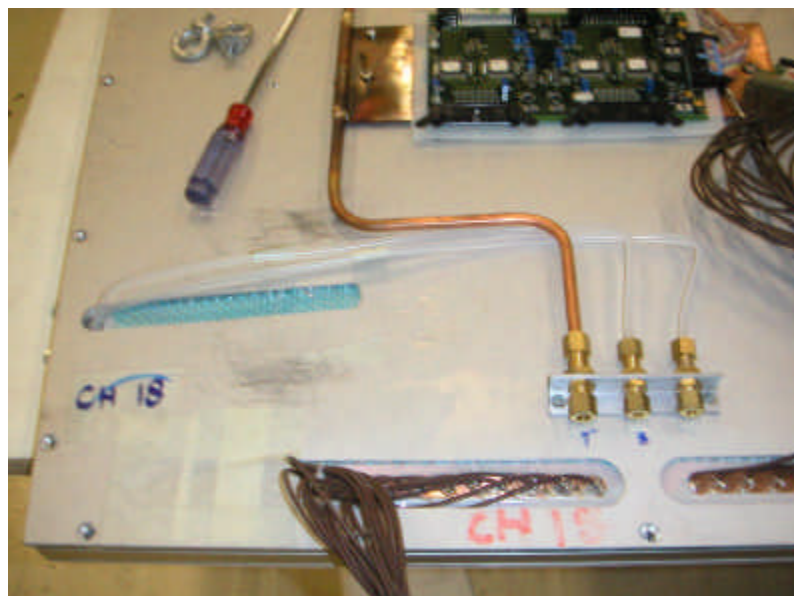
Crossing of services introduces unnecessary increase in, the thickness. Here the gas pipes are crossed and both cross with the cooling pipe.

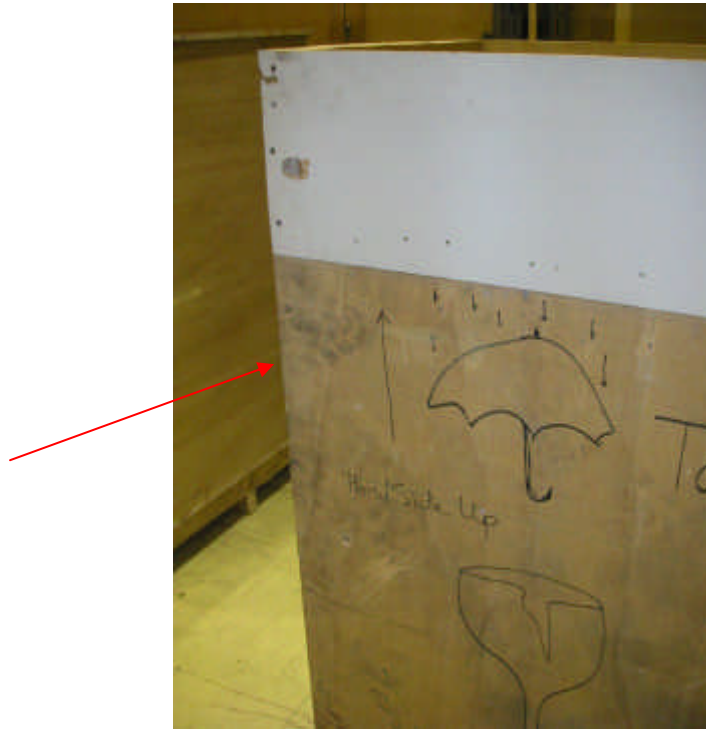
The ever present problem of damage that may occur during transport has occurred yet again. Note the 'heavy' foot prints on only one side of the now upright box, indicating that the box, and its contents, spent at least some time horizontal. With packing for more chambers this will be less likely to occur as the base of the box will increase in width so imparting greater stability and thus a lesser likelihood of tilting over. The box naturally ended up in its most stable condition that is with its largest surface on the ground!

'This side up' could be interpreted as meaning the side it is written on not where the arrow points.
