# **Some Comments on Assembly and Performance of pre-series RE2/2 chambers**

With input and comments from colleagues in the ISR lab and PH-CMM

The 3 Chambers were received at CERN on the 2nd June 2005.

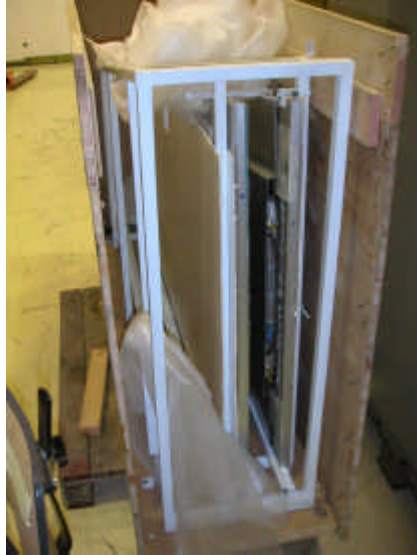
The steel frame is a good feature which provides rugged support for the chambers and in particular the space left around the structure gives some protection against fork lift perforation. This space could well be increased to  $>10\text{cm}$ .
