Report of Jan 23

ME+1/1/13

Chamber extraction

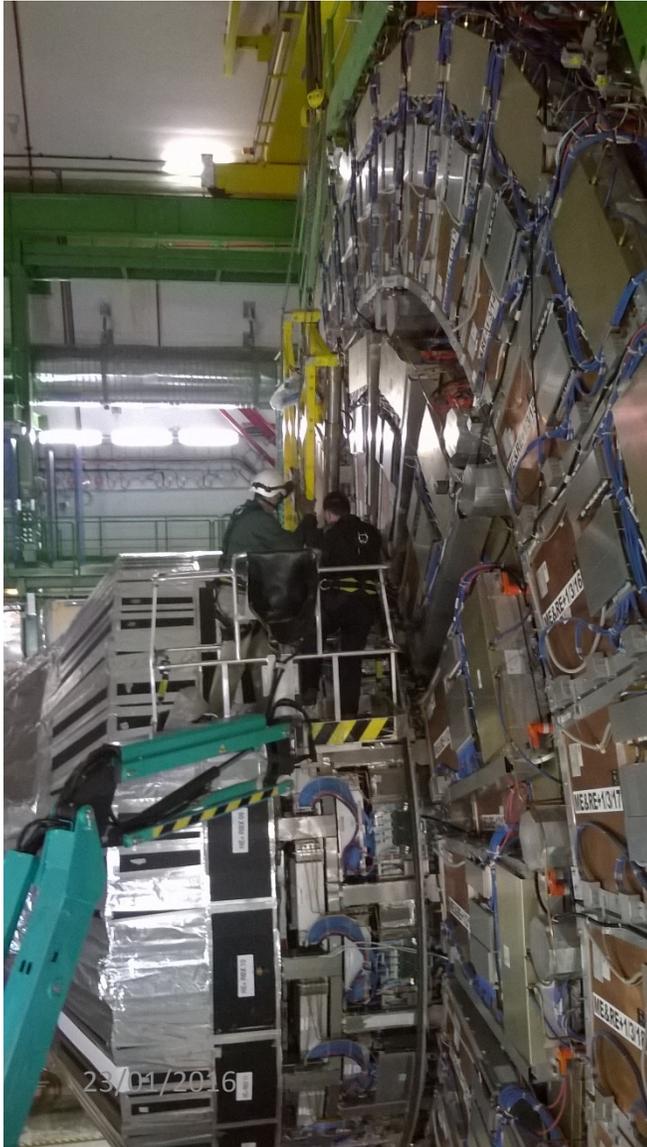
8AM CSC crew and crane operator extract ME+1/1/13 chamber from YE+1 nose

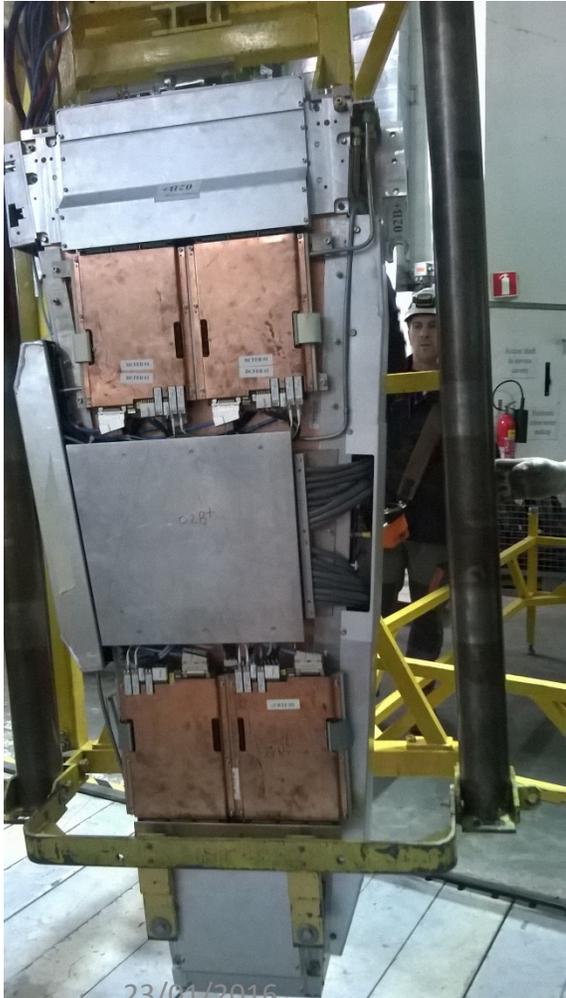
Chamber on the floor of UXC55

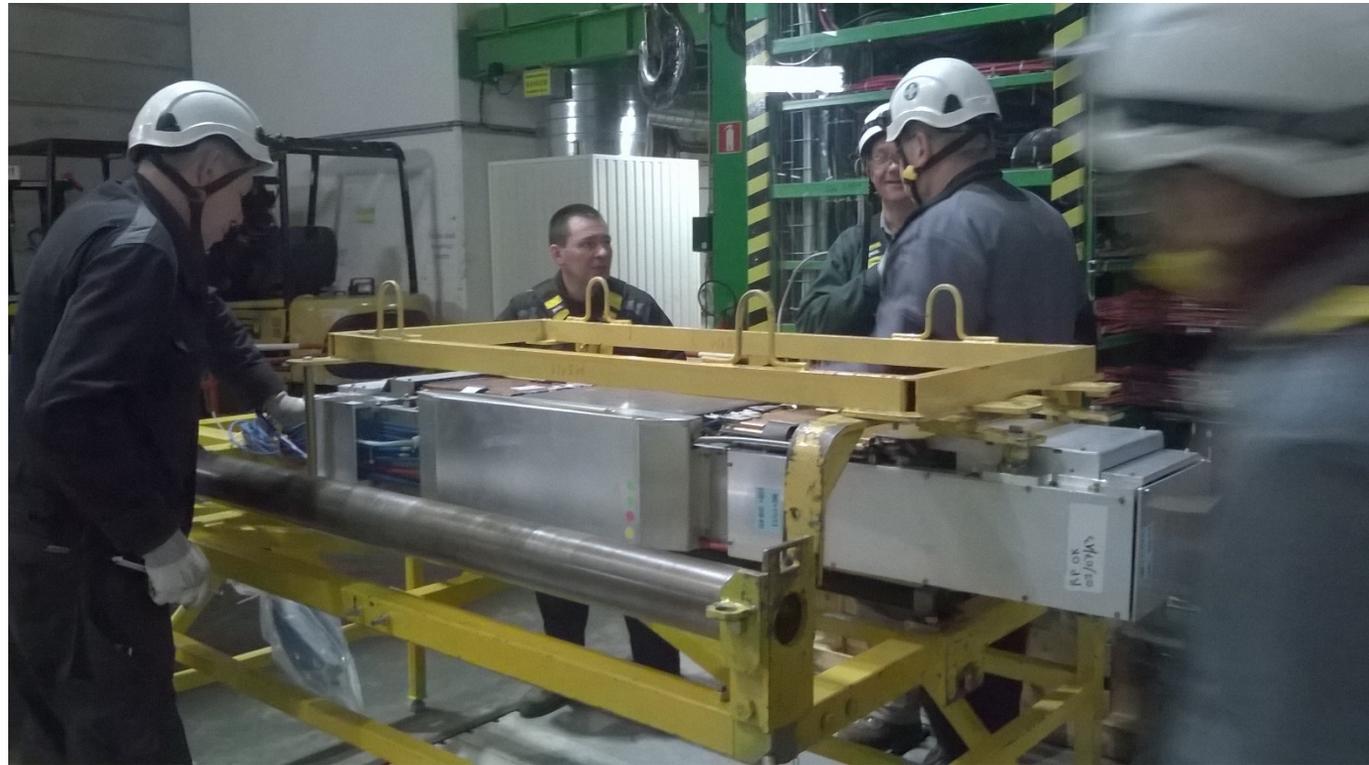
9:30AM Chamber on the floor of UXC55. First visual inspection while waiting for RP clearing

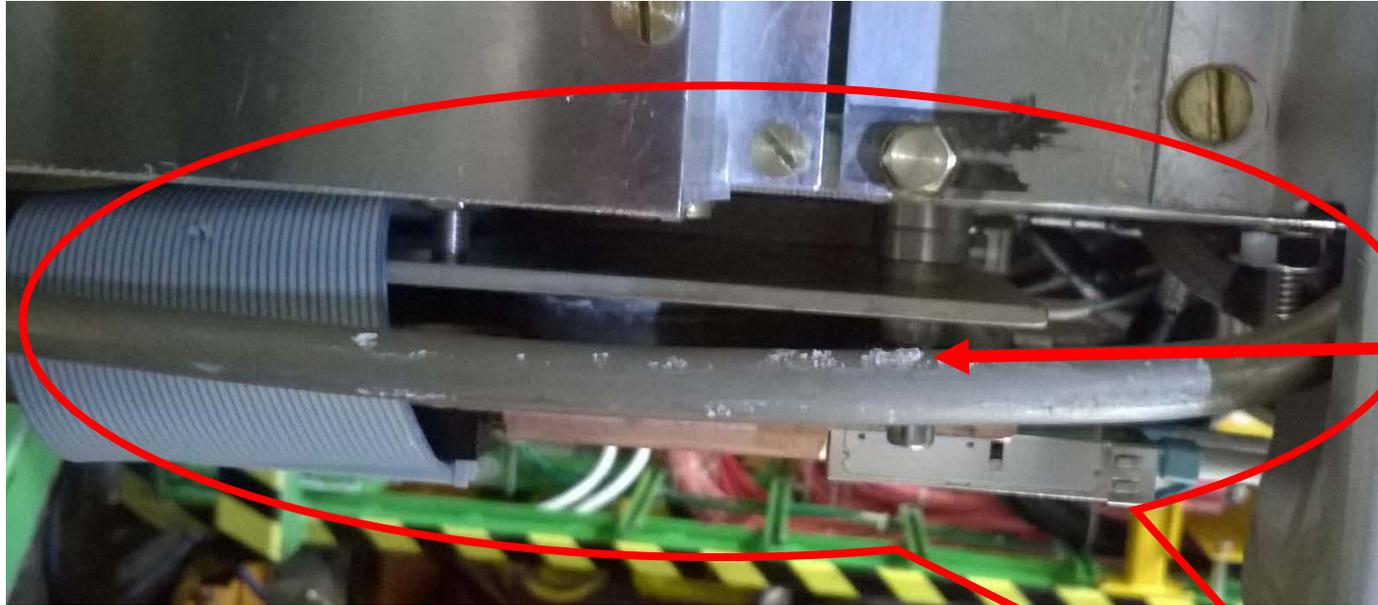
9:30AM Chamber looks ok. No signs of damage or water deposits on any sensitive parts.

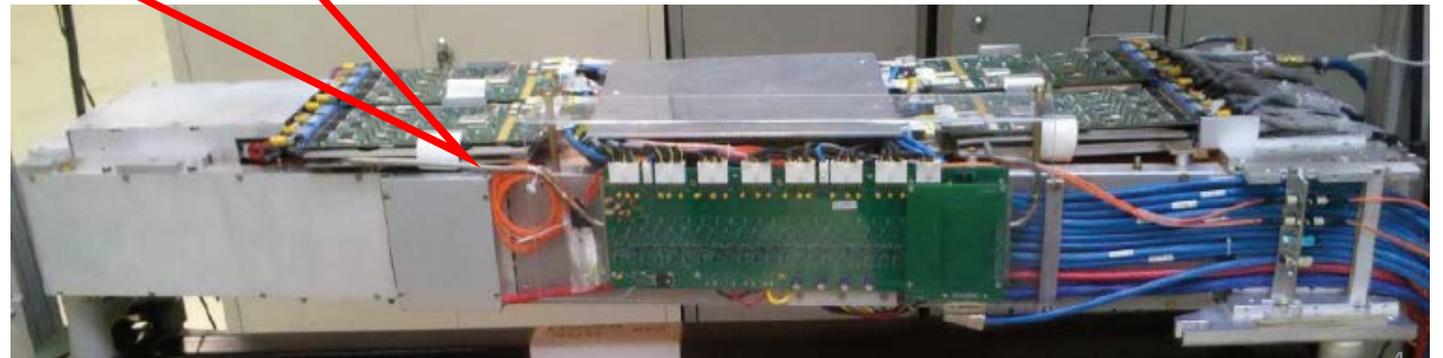
A closer inspection of one of Cu cooling pipes running along the chamber side and close to the narrow end of the chamber shows some powder-like white deposit, similar to what is seen at the lowest point of the YE1 nose when the wrap has been removed

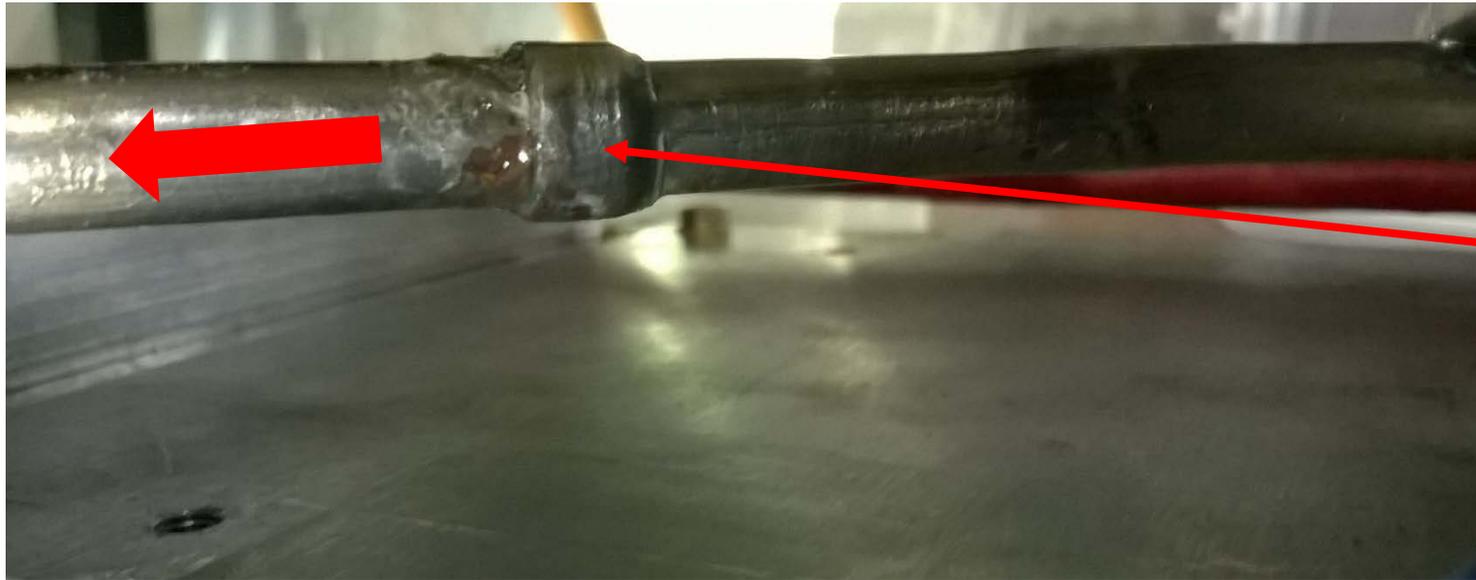
11:30AM Side protection covers removed. Visual inspection of pipe soldering point (1 of 4 along the cooling circuit) shows signs of water stain only on one side of the joint indicating water leak path.

- Monday and following days
 - Cut a few cm of the pipe around the leaky joint. Send sample to metallurgy for post-mortem analysis
 - Send samples of collected white deposits and water removed from circuit to chemical lab for analysis
 - Prepare a new cooling circuit (from one of spare chambers) for replacement
 - Reassemble cooling parts and test
 - Reassemble electronics and test
 - Ready for re-installation
 - Estimated time ~1 week

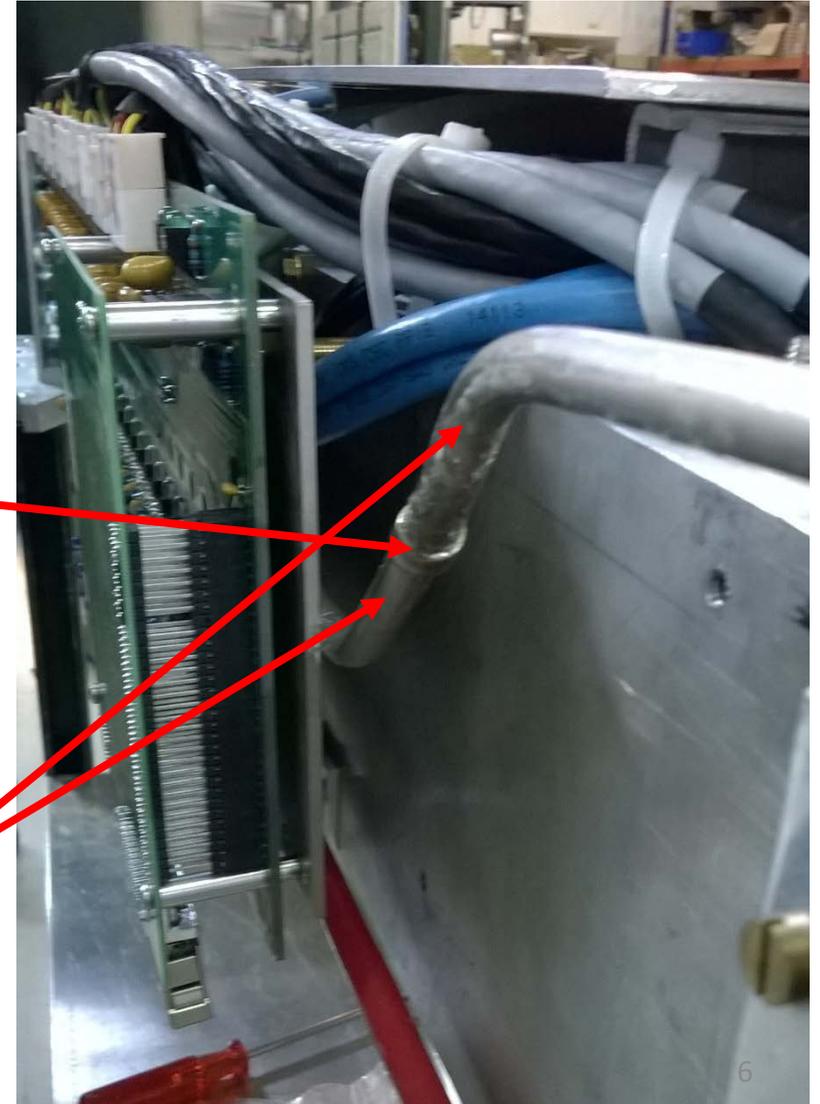
Pipes on both sides of joint look slightly misaligned, but that is just speculation

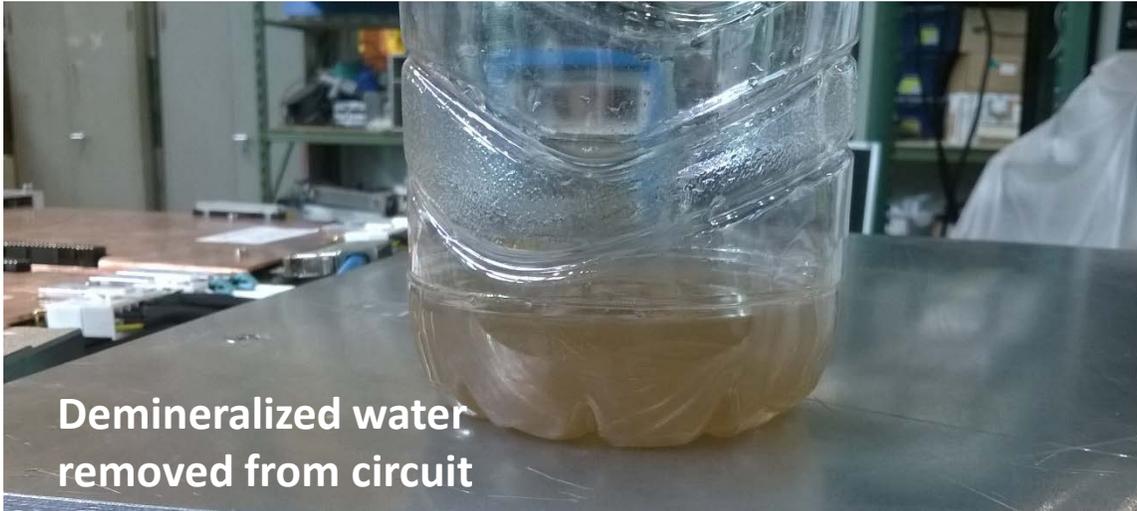
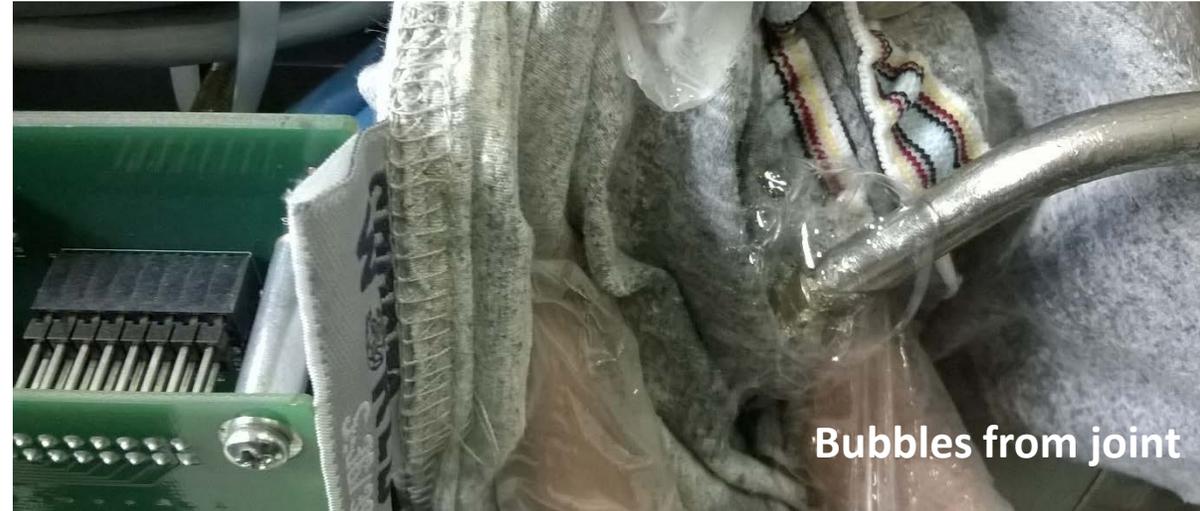
Empty cooling circuit and test with gas

- Collect white dust for chemical analysis
- Empty cooling circuit. Water appears rather brownish!
- Pressurize cooling circuit with N₂ gas at 4bar. Leak check 4 joints along cooling circuit using 1000 bubble
 - Use gas and not water to avoid circulating water from different supply thus washing out useful analysis clues
- The suspected leaky joint shows clear sign of leak (bubbling). All other joints are tested fine
- Dismount chamber electronics and cabling. Expose cooling circuit
