# EXPERIENCE WITH LONG TERM OPERATION WITH DEMINERALIZED WATER SYSTEMS AT DAANE

L. Pellegrino, LNF – INFN, Frascati (Roma) - Italia

During eight years operation of the DAANE water cooling system some critical situations have been successfully managed by upgrading the demineralized water system. The collected data and the experience gained in the field of copper corrosion and related water treatment are critically revised.

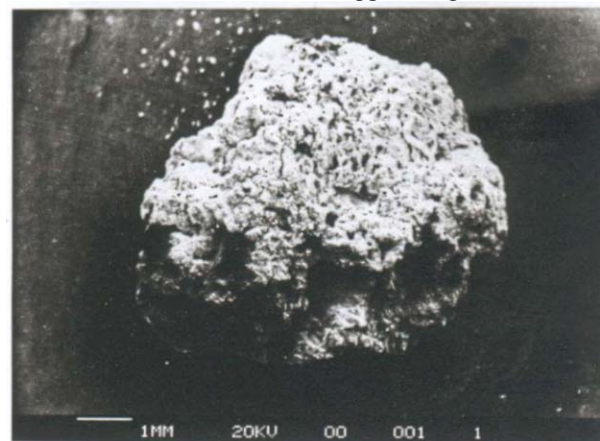
The rubber hose between the manifold spigot and the coil end forms a flow section enlargement, with internal diameter going from 4 to 6 and again to 4 mm, as a little "chamber". Solid pebbles ( $D > 5$  mm) formed in some of these "chambers" inside the hoses and, there, moved back and forth, obstructing sometime the flow in one or more coils. Therefore the coils, no more cooled, heated until safety thermal device switched down the whole chain of four wiggler magnets.

Figure 3: copper oxide pebbles.

The material of obstruction was analysed by the CSM of Pomezia, Italy, (SEM microscopy with EDS spectrometer), showing copper and copper oxides as

the only component, as well as the water at inlet and outlet of the polishing system, as in table 2. In figure 3 is the micrographic picture of a pebble.

The conclusion was that the relatively high conductivity, the relevant dissolved oxygen contents of cooling water and the high electric potential of some coils with respect to the grounded piping yield the production of copper oxides and their migration according to the potential difference. Probably, sulphide-reducing bacteria catalysed the agglomeration process of the oxide, starting on the lips of the inlet copper spigots, in a slower flow region.

The deposits grew until detached and continued growing, probably without leaving the "chamber".

We modified the polishing circuit and its location in the plant, to assure a continuous treatment of the whole water mass with the proper flow in the mixed bed bottles, and added new instruments and a data logger; the N<sub>2</sub> cushion system was reviewed and frequently checked; the whole plant pressurization scheme was reviewed, to ensure a positive pressure everywhere, avoiding unwanted air intakes.

As soon as a stable operating condition was reached, the failure did not present anymore.
