CERN  
CH1211 Geneva 23  
Switzerland

EDMS NO.  
**2720844**

Date: 26/03/2022

# Microscopy inspection of white residue found on different samples from CMS RPC gas system

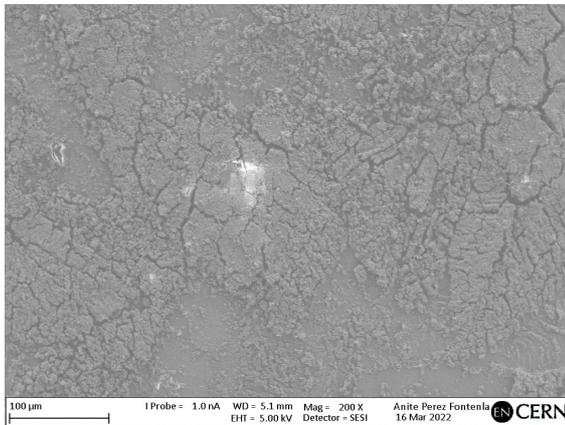
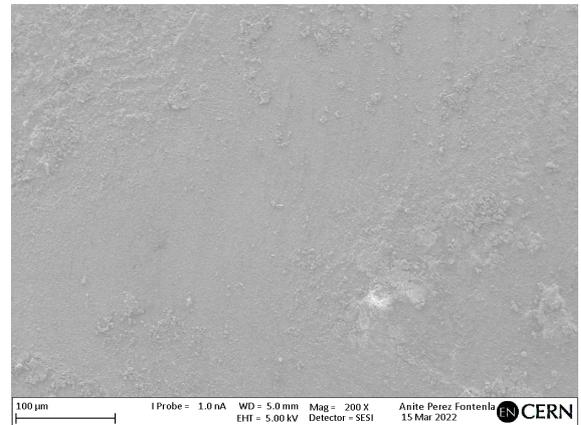
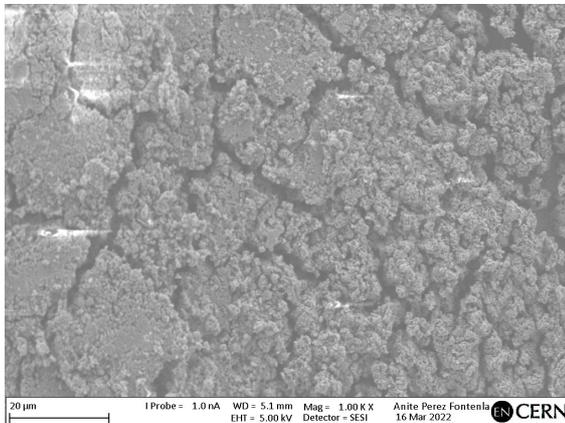
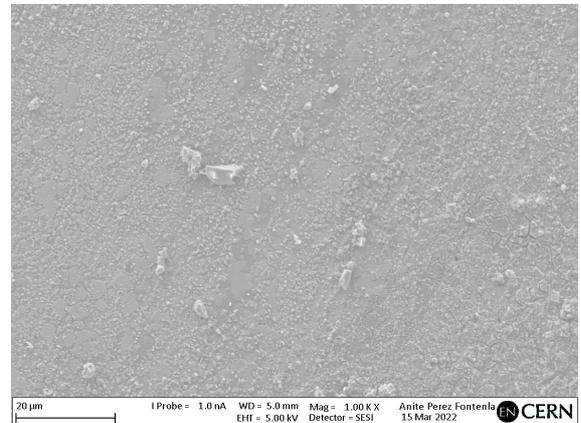
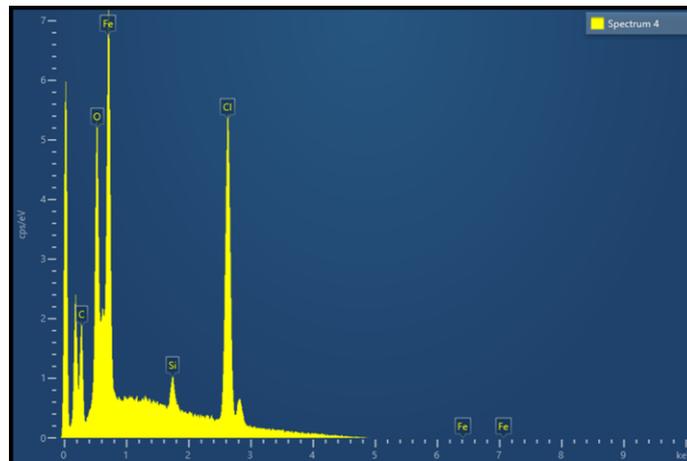
Figure 3 – Comparison of ball's surface aspect (200x and 1 kx) and EDS (at 5keV) on the residue present in ball #1

Both ball's surfaces were inspected by SEM. The observed residue was chemically analysed by EDS at 5 keV and 10 keV with different EDS detectors. In all the studied sites of both samples, the presence of chlorine (Cl), iron (Fe) and oxide (O) and, in lower amount, other elements like chromium (Cr) and silicon (Si) was confirmed. The semi-quantitative results of the residue analysis in ball #1 and ball #2 are included in Table 1.

The residue was thicker in ball #1. Comparative of SEM images on the ball's surface and representative EDS spectrum on Ball #1 are included in Figure 3.

Element	Float balls	
	Ball #1	Ball #2
<b>C</b>	5.3	6.1
<b>O</b>	4.6	7.9
<b>F</b>	0.0	0.0
<b>Na</b>	0.0	0.1
<b>Al</b>	0.0	0.0
<b>Si</b>	0.7	1.8
<b>Cl</b>	53.0	28.1
<b>Cr</b>	0.0	8.6
<b>Fe</b>	36.5	47.2
<b>Ni</b>	0.0	0.3

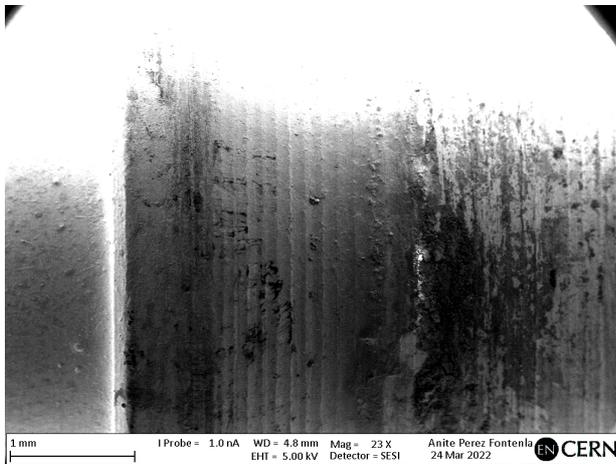
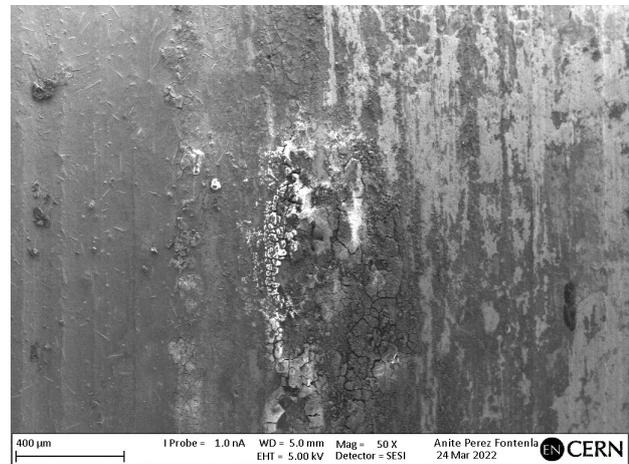
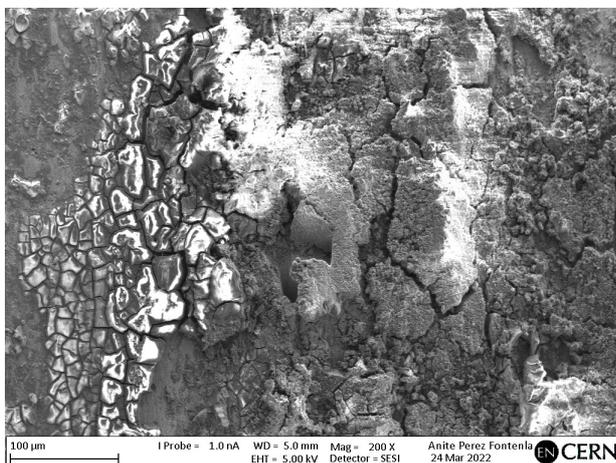
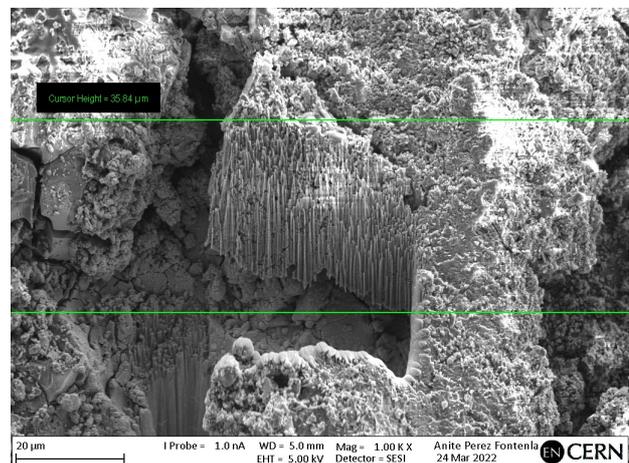
Figure 4 – Needle valve surface at the location where the residue accumulated and FIB cut to estimate the residue thickness (23x, 50x, 200x and 1kx)

The needle valve, presents a region where a whitish residue accumulated and is even visible by eye. Representative SEM images of the residue area are included in Figure 4. FIB-SEM cross section was performed in order to evaluate the residue thickness and it was estimated in  $\sim 35 \mu\text{m}$ .

In the case of the needle valve (brass component with Cu~ 66 wt. %), the residue visible by eye presented an important amount of chlorine (Cl~ 23 wt. %), aluminum (Al~ 29 wt. %) and fluorine (F~ 8 wt. %). The thickness of the residue was estimated by FIB-SEM in 35  $\mu\text{m}$ . FIB-SEM was performed also on an area (in principle) non-affected and the presence of Cl was confirmed at the surface and features rich in Cl were identified at a depth of ~5  $\mu\text{m}$ . The obtained results indicate a general damage of the needle valve due to the interaction with the Cl (and most probably an electrolyte presence).

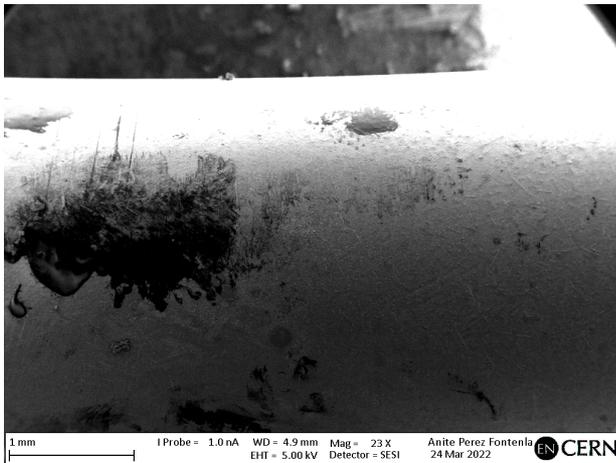
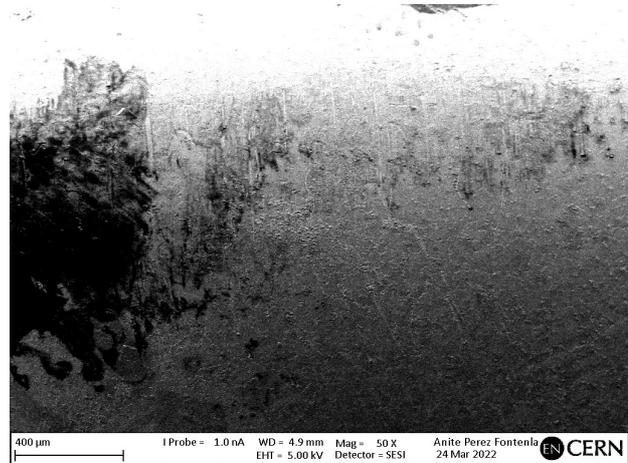
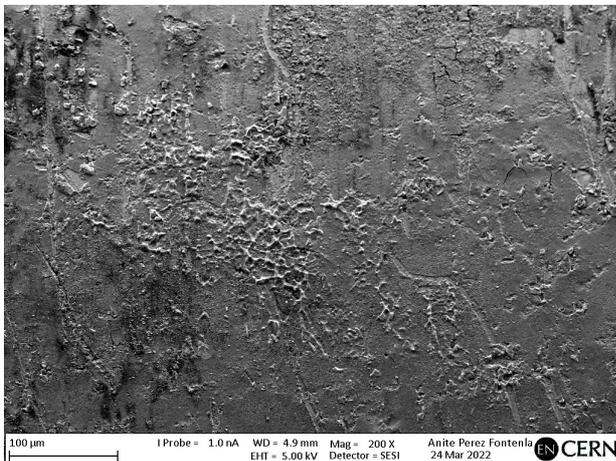
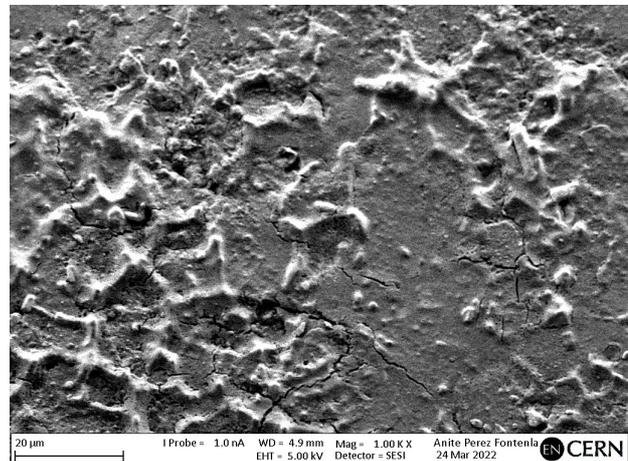
Figure 5 – Needle valve surface A (23x, 50x, 200x and 1kx)

Neighbouring areas, in principle non-affected, were also imaged and analysed. Surface A (Figure 5) and surface B (Figure 6) exhibited damaged surface. FIB cutting was performed in Surface B in order to evaluate the affected layer and features were visible even at an estimated depth of  $\sim 5 \mu\text{m}$ .

Chemical composition results from top view in the various locations of the needle valve (residue, surface A and surface B) as well as the analyses performed in the FIB cross section comparing the base material (spectrum #28) and the visible features (spectrum #29) are included in Table 5. EDS analysis confirmed a significant Cl wt. % in all the analysed surfaces and that the features observed in cross section are also areas affected by interaction with the Cl.
