# Intervention on 31 March and 1 April 2017 gas leaks

Ian Crotty 3 April 2017

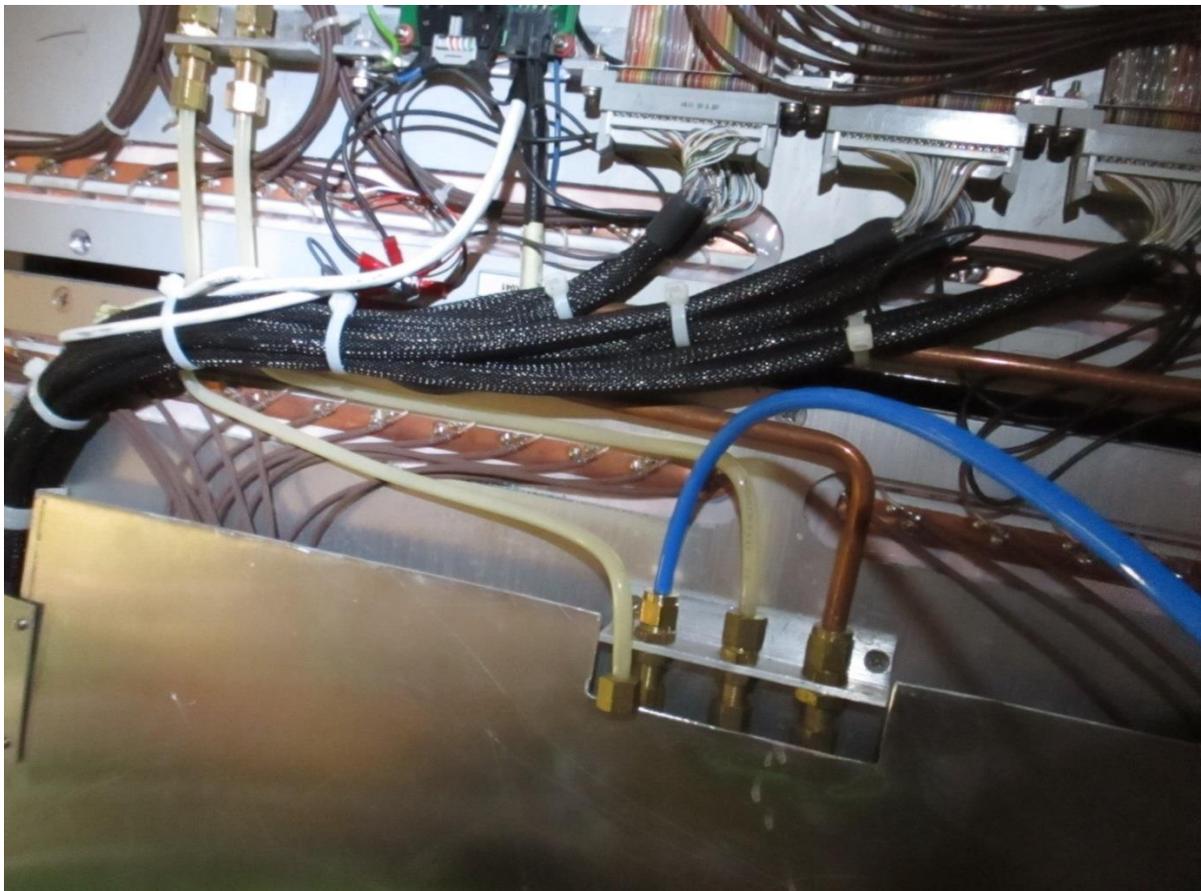
The pipe used in the RE+3/31 between the type 2 & 3 was NOT LDPE. It had gone hard and dirty yellow. See photos. Identification in progress.

Link between type 2 and 3 showing “yellowing” of polymer pipe.

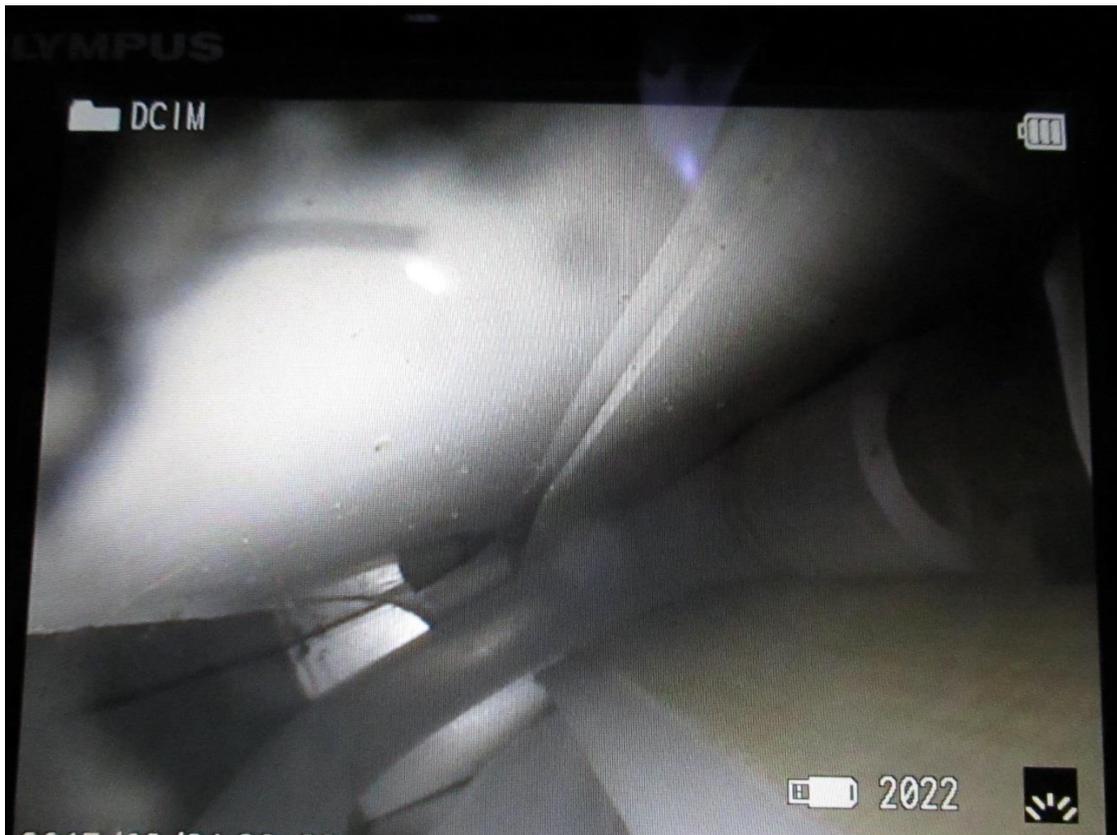
Piping inside RE+3/3/31 appears to be in excellent condition, no discolouring, except perhaps for very slight crazing at the point of diameter increase where the pipe is forced onto the barbed gap fitting (gas gap inlet).

Inside chamber, gap entry at end of chamber.

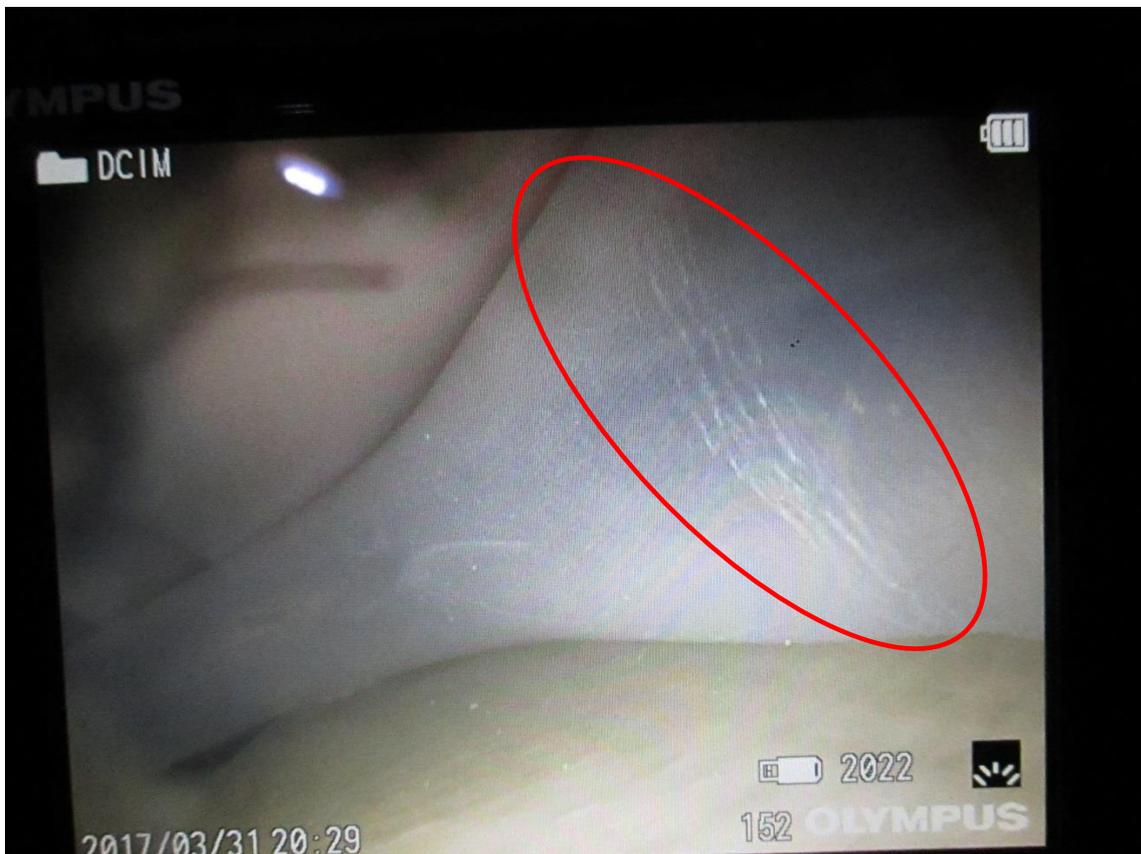
Close up of pipe on barbed gap inlet showing very slight crazing just before diameter increase.

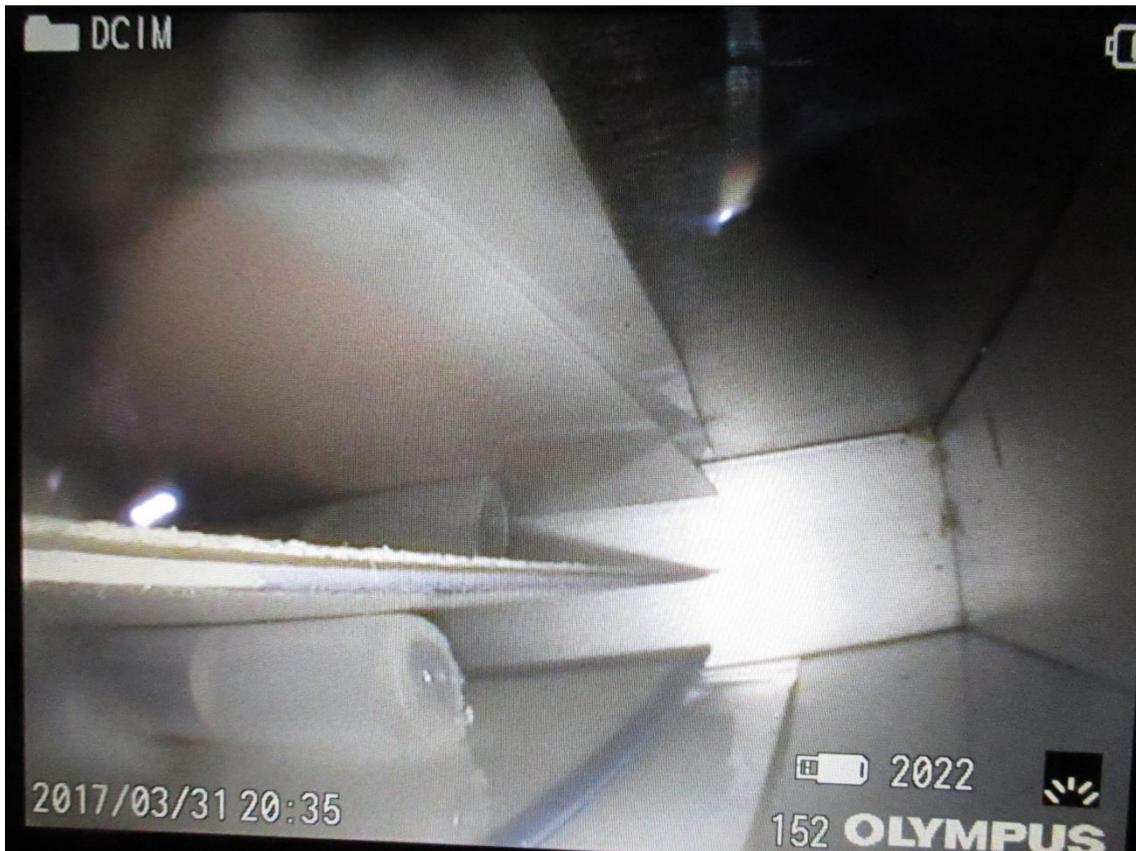
Plugged up corners on top and bottom gaps.

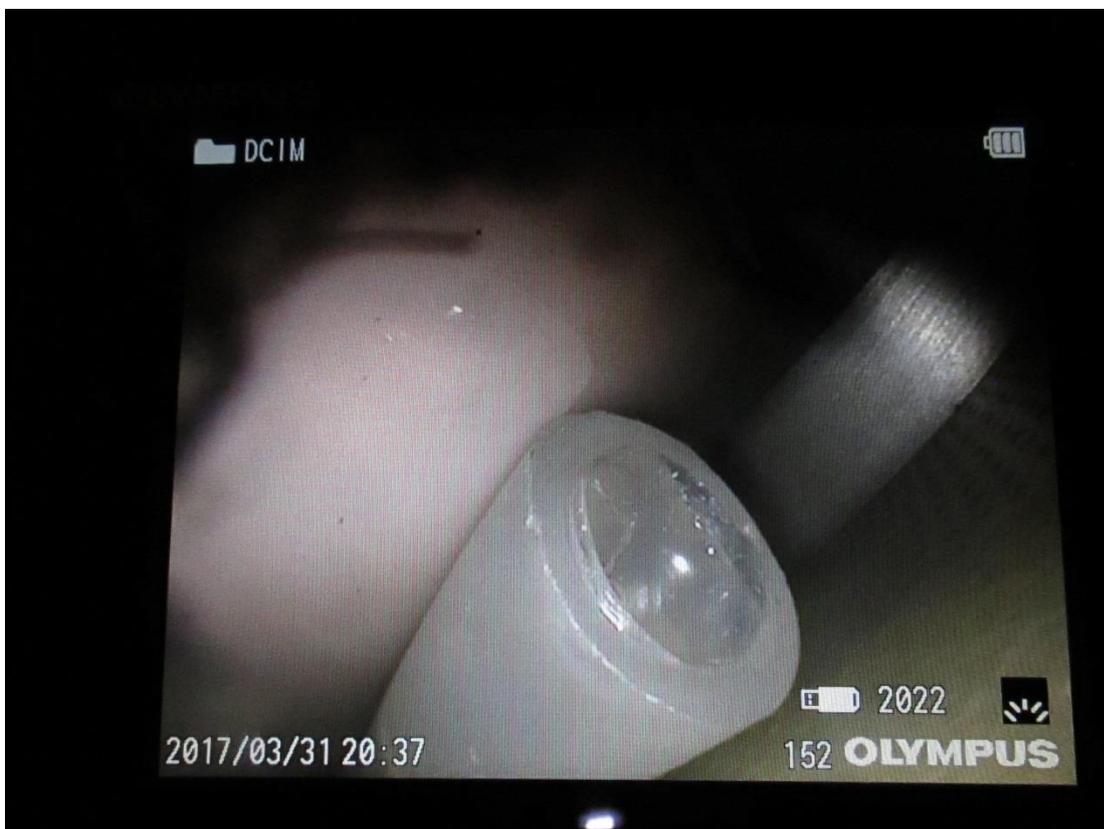
Shrinkage of hot melt in plugged up ends ? or 0.25mm slippage of plug ?

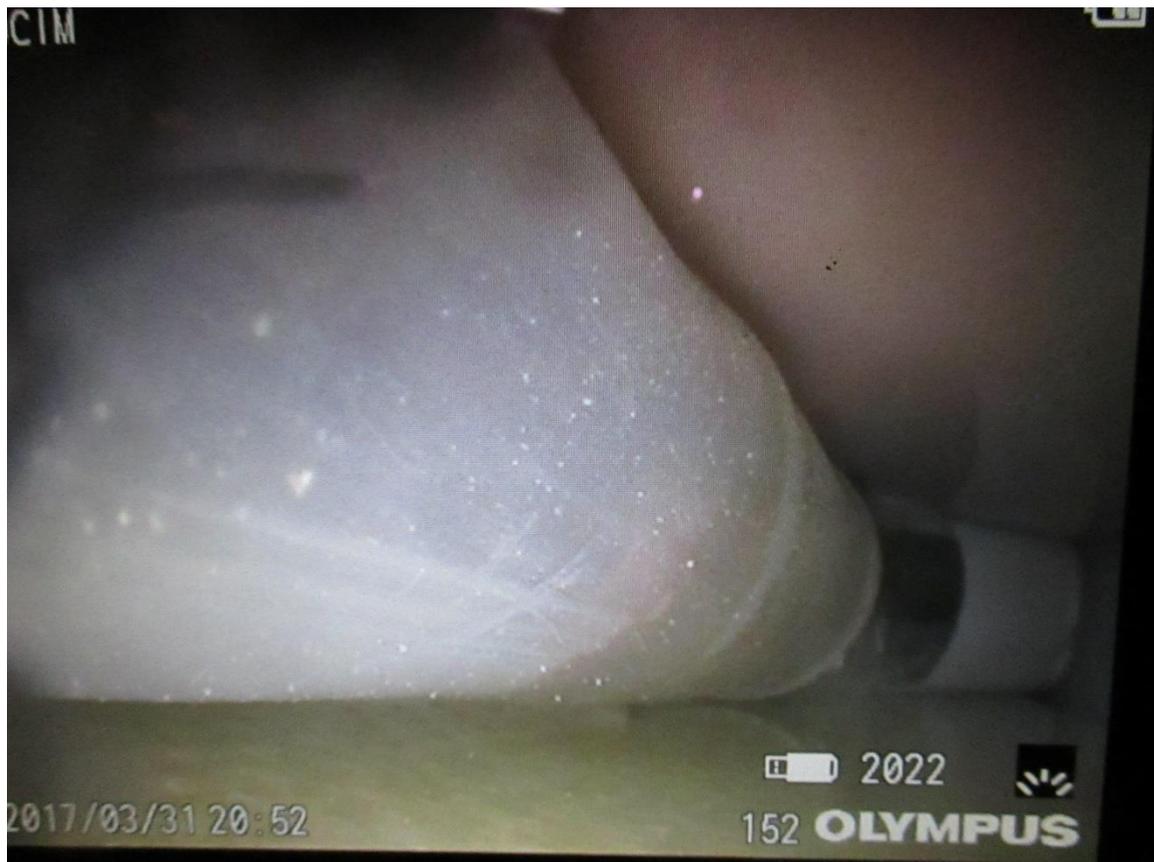
Superficial scratching and dust

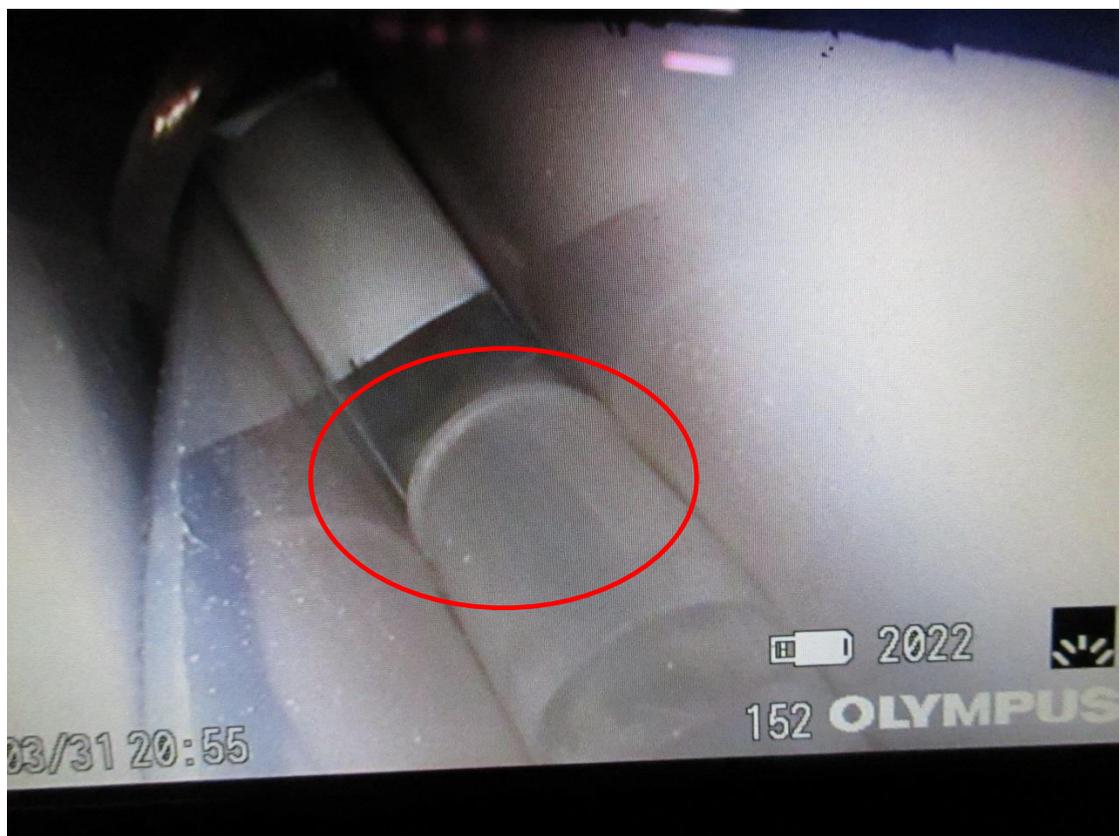
Increase in end diameter due to excessive heating
