Chemical analyses of deposits in the RPC chambers

Dayron Ramos Lopez
Polytechnic and INFN of Bari

Layout of RPC prototype-1 for CMS Upgrade project (iRPC)

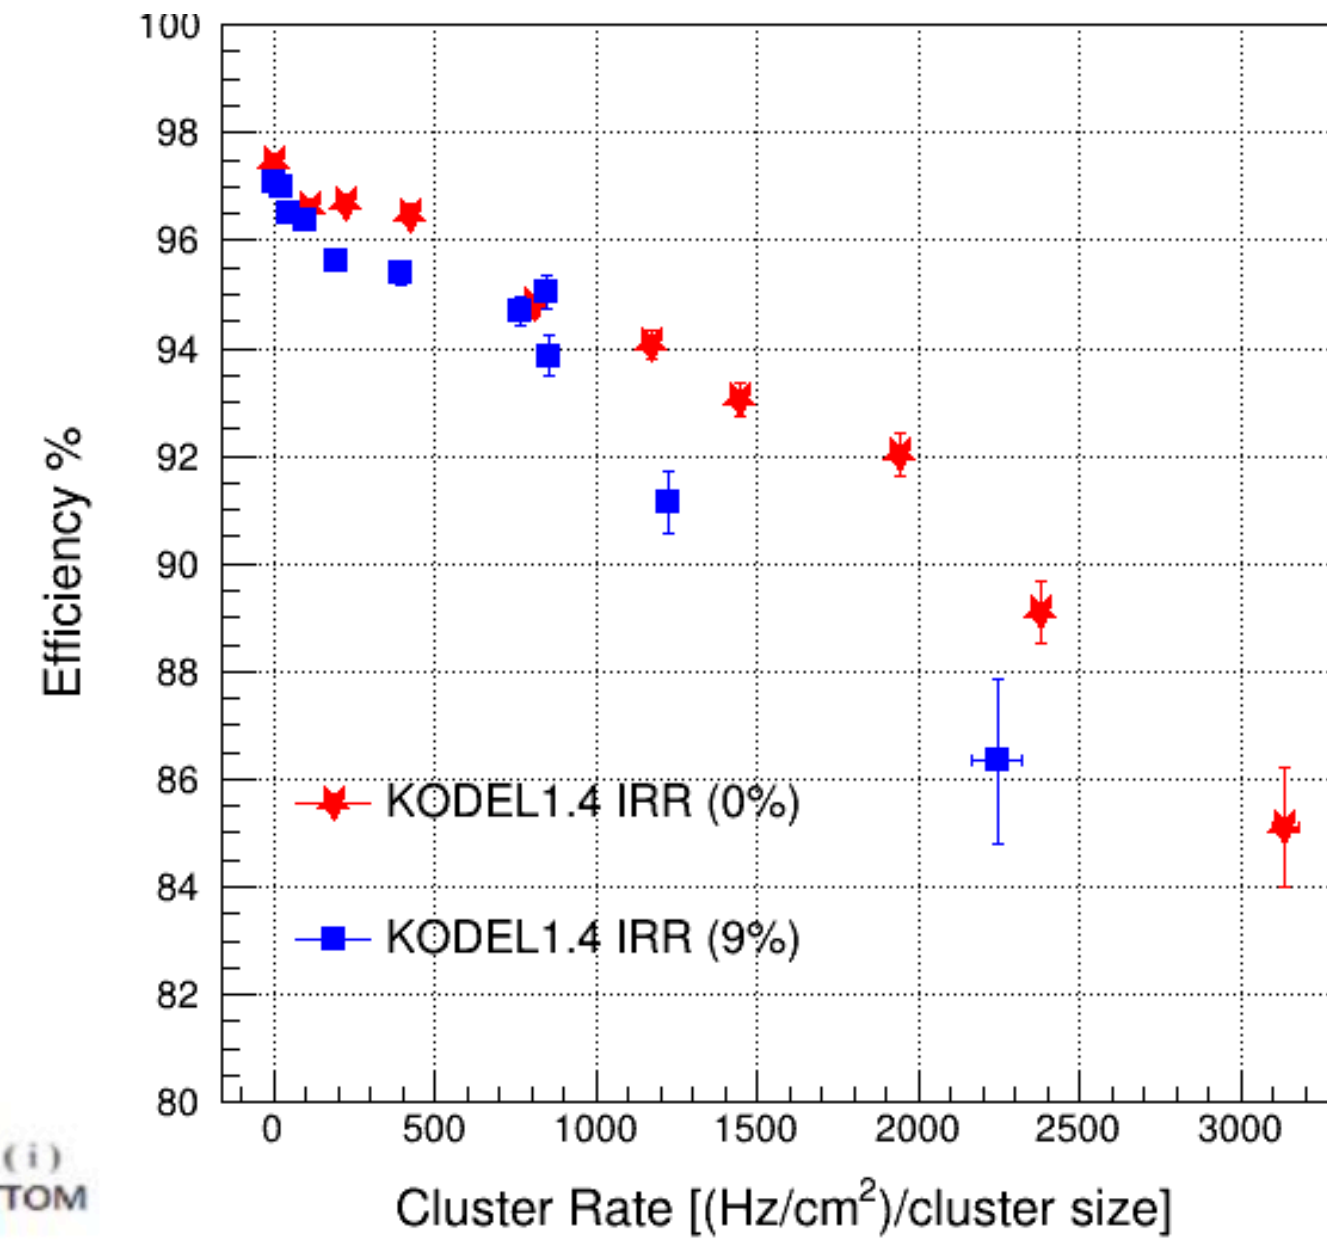
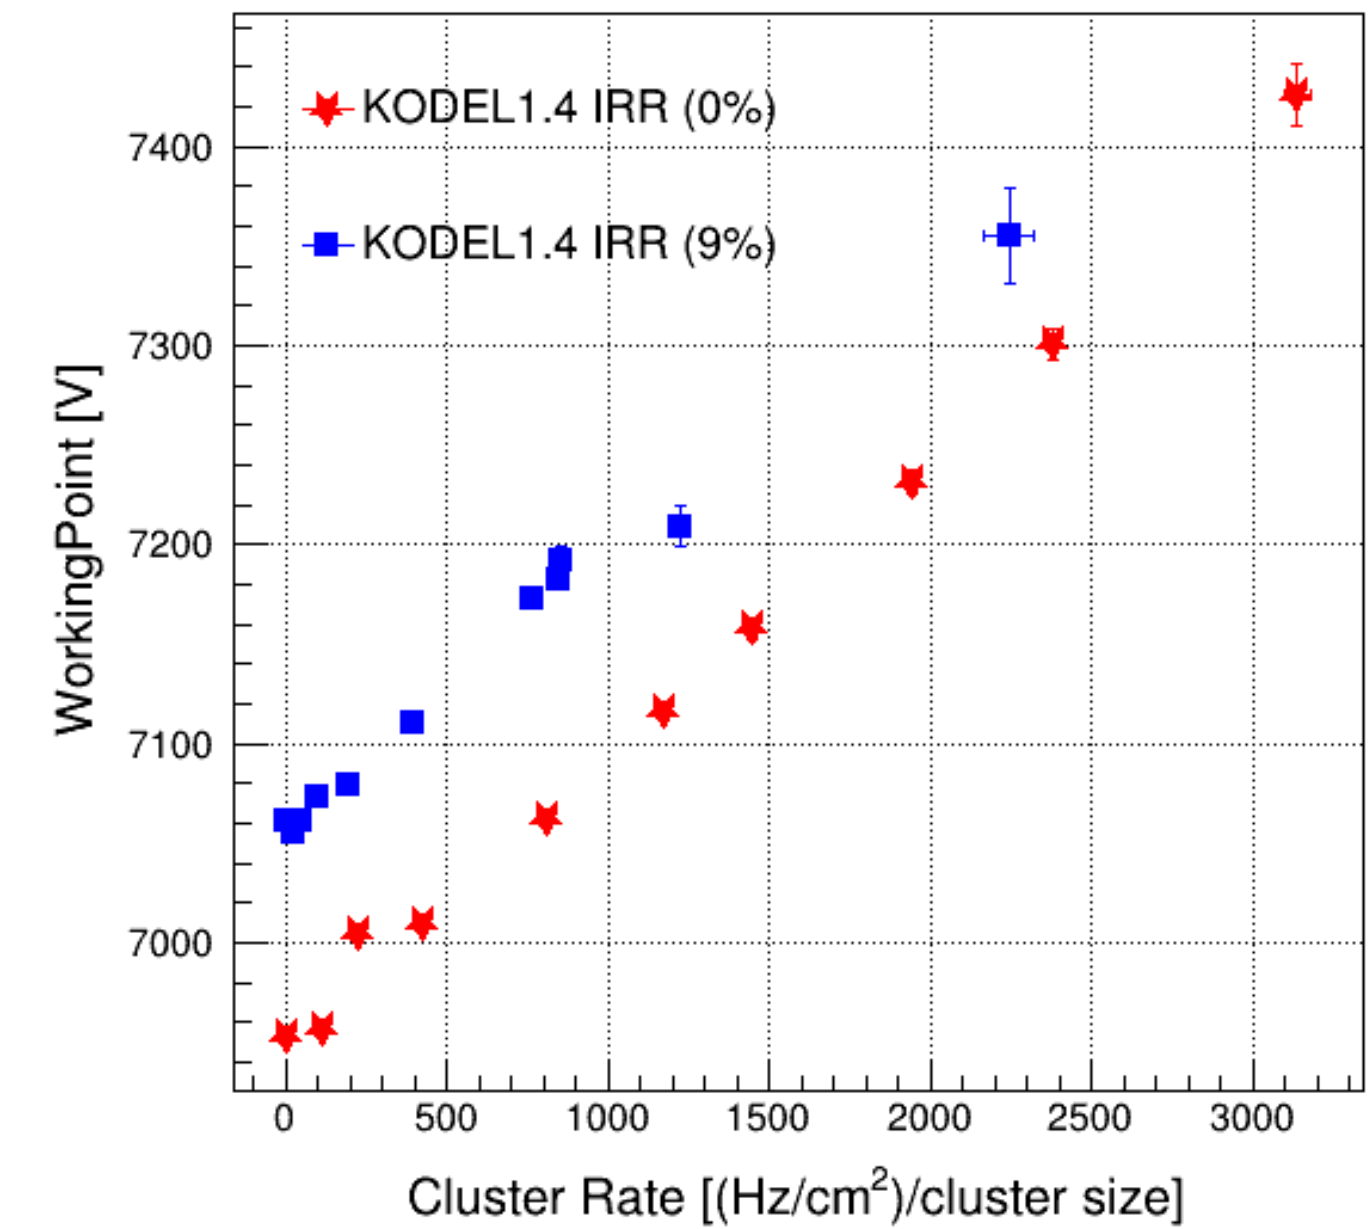
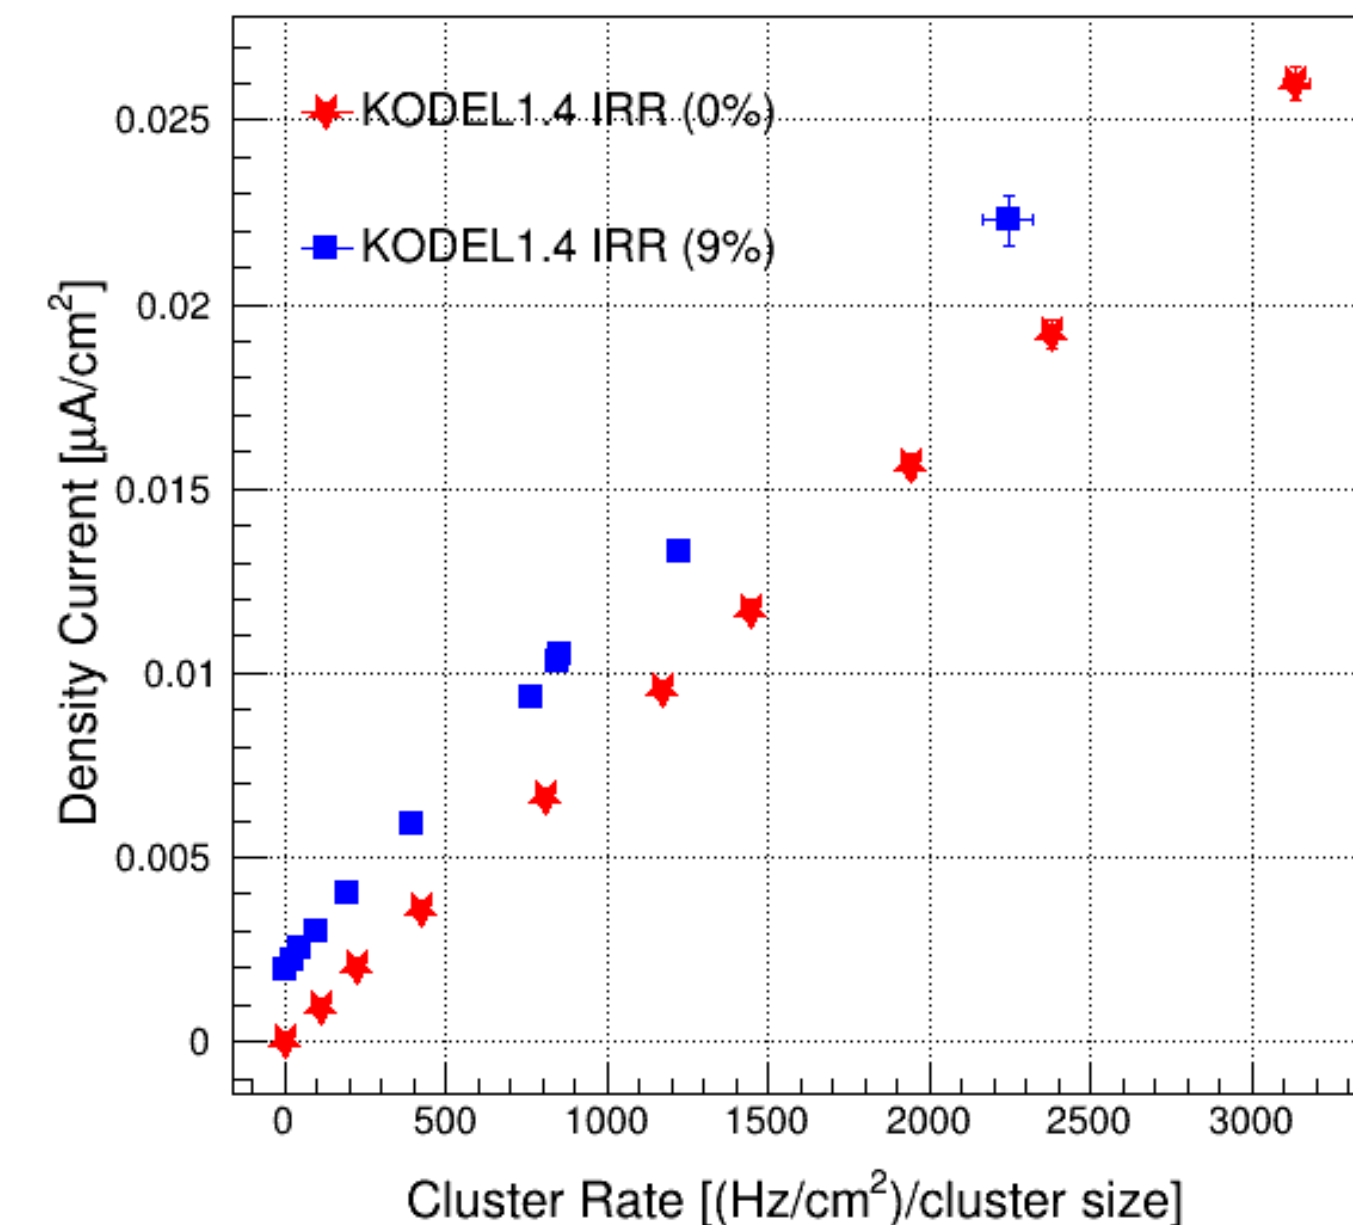
- Performance degradation after 90 mC/cm² (August 2018 TB)
- 100V WP shift
- Operational current increase

Irradiation campaign @GIF++
Before irradiation (May 2017)
After 9% irradiation target (August 2018)

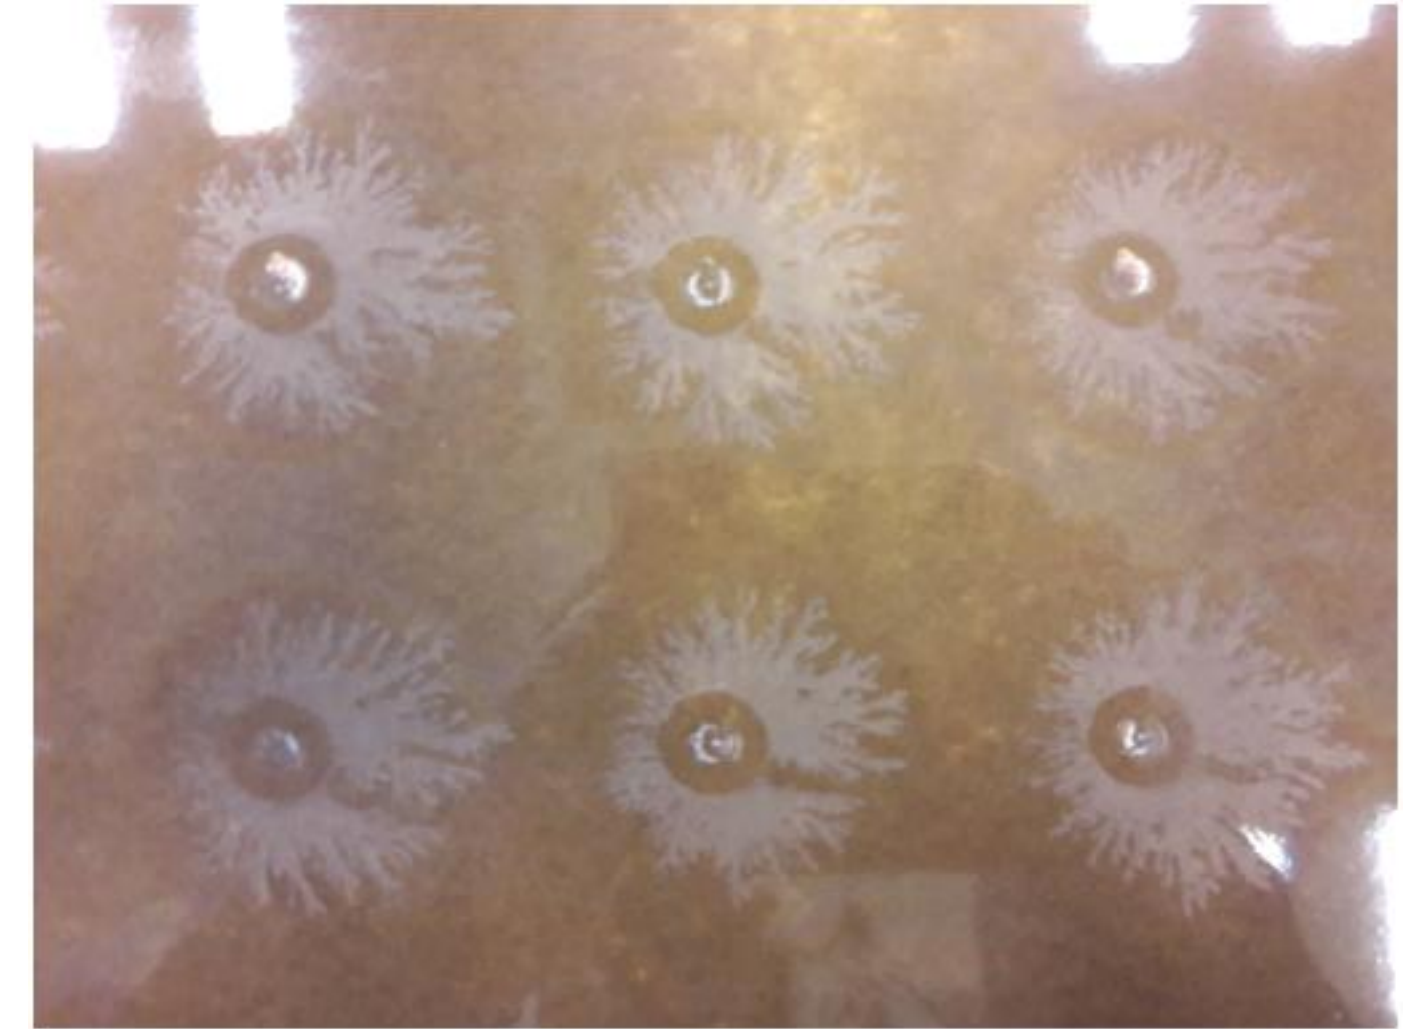
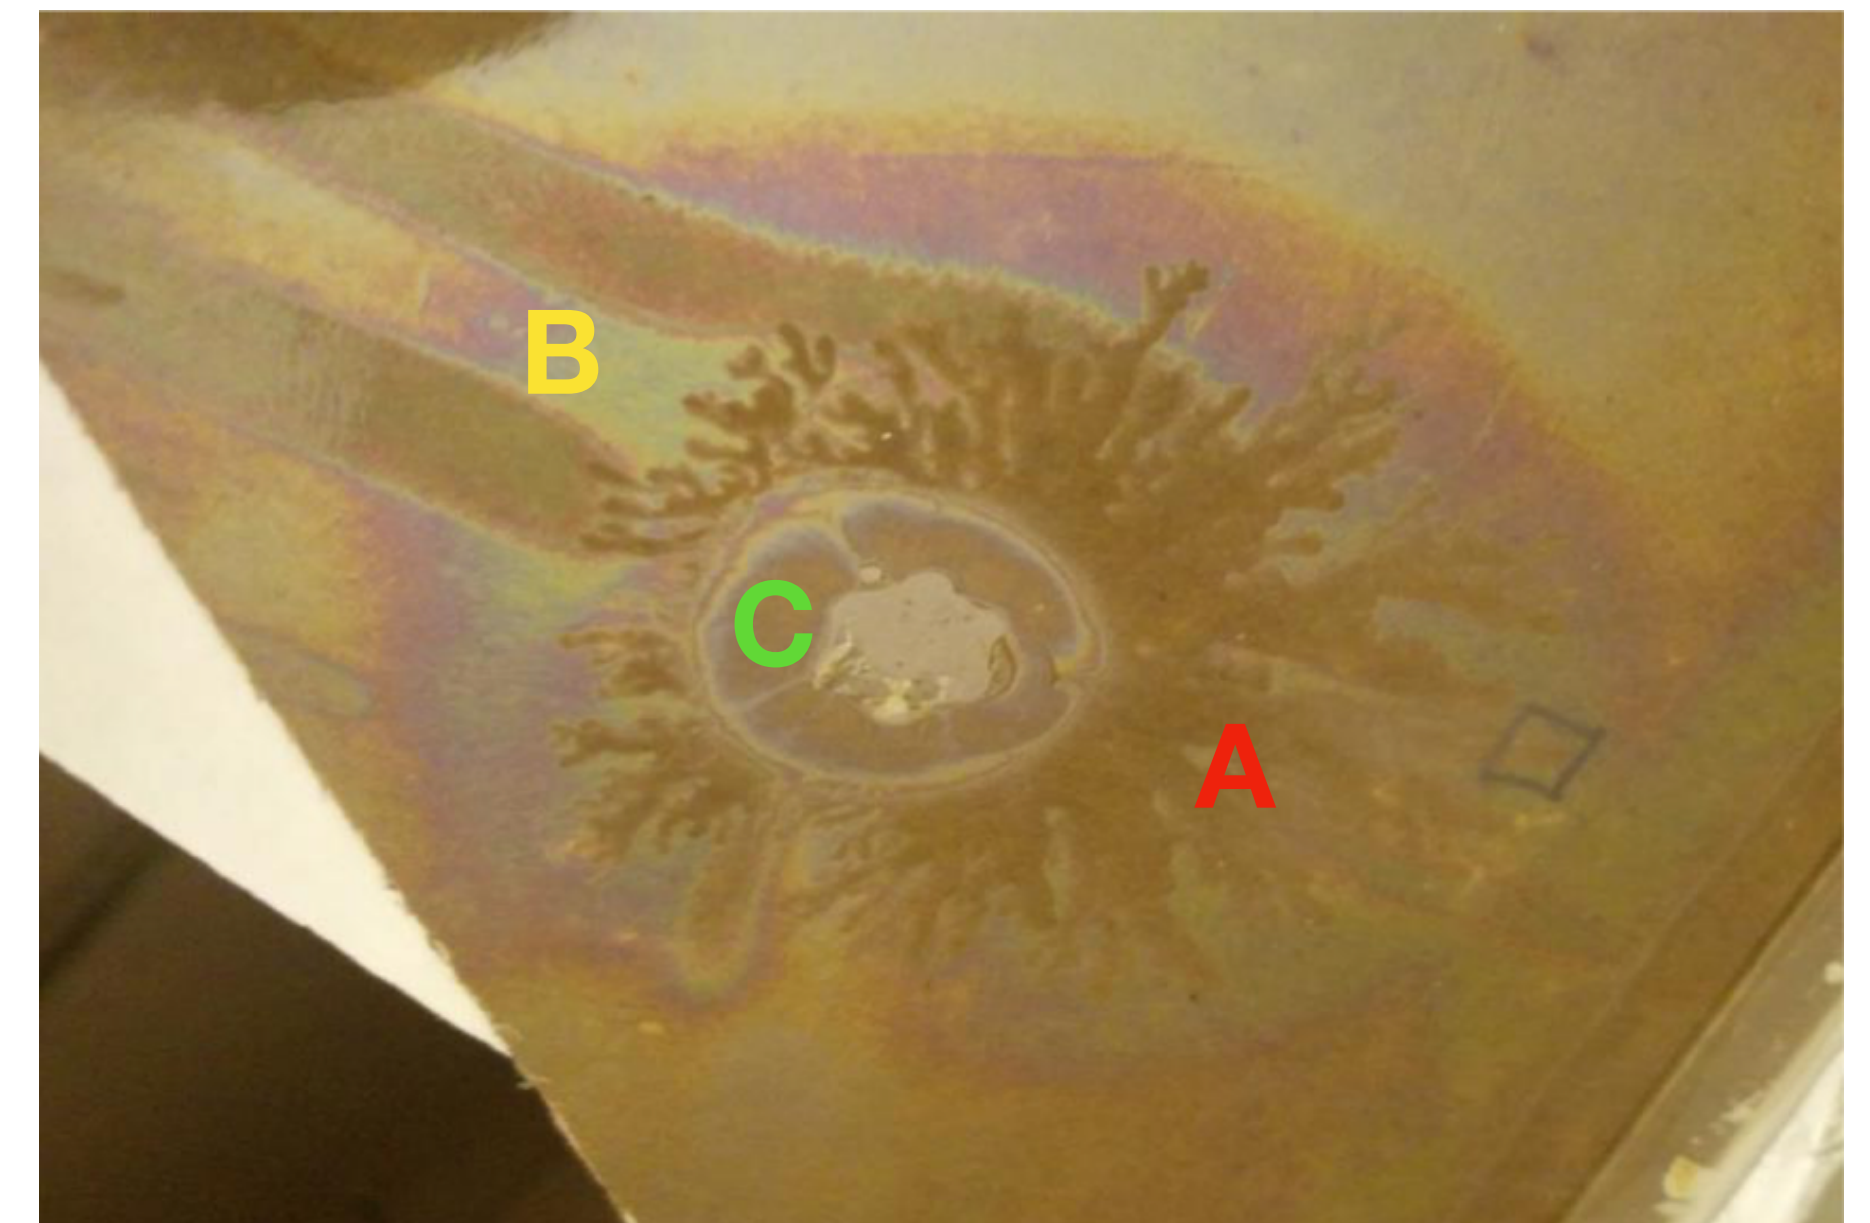
iRPC visual inspection

- A.** White matt spot around spacers and oil inlet/outlet
 - B.** Halo near the spacers
 - C.** Ring around spacers and edges look similar to the halo and the below spacers area
- SIMILAR EFFECT OBSERVED IN RE4 IRRADIATED @ GIF++

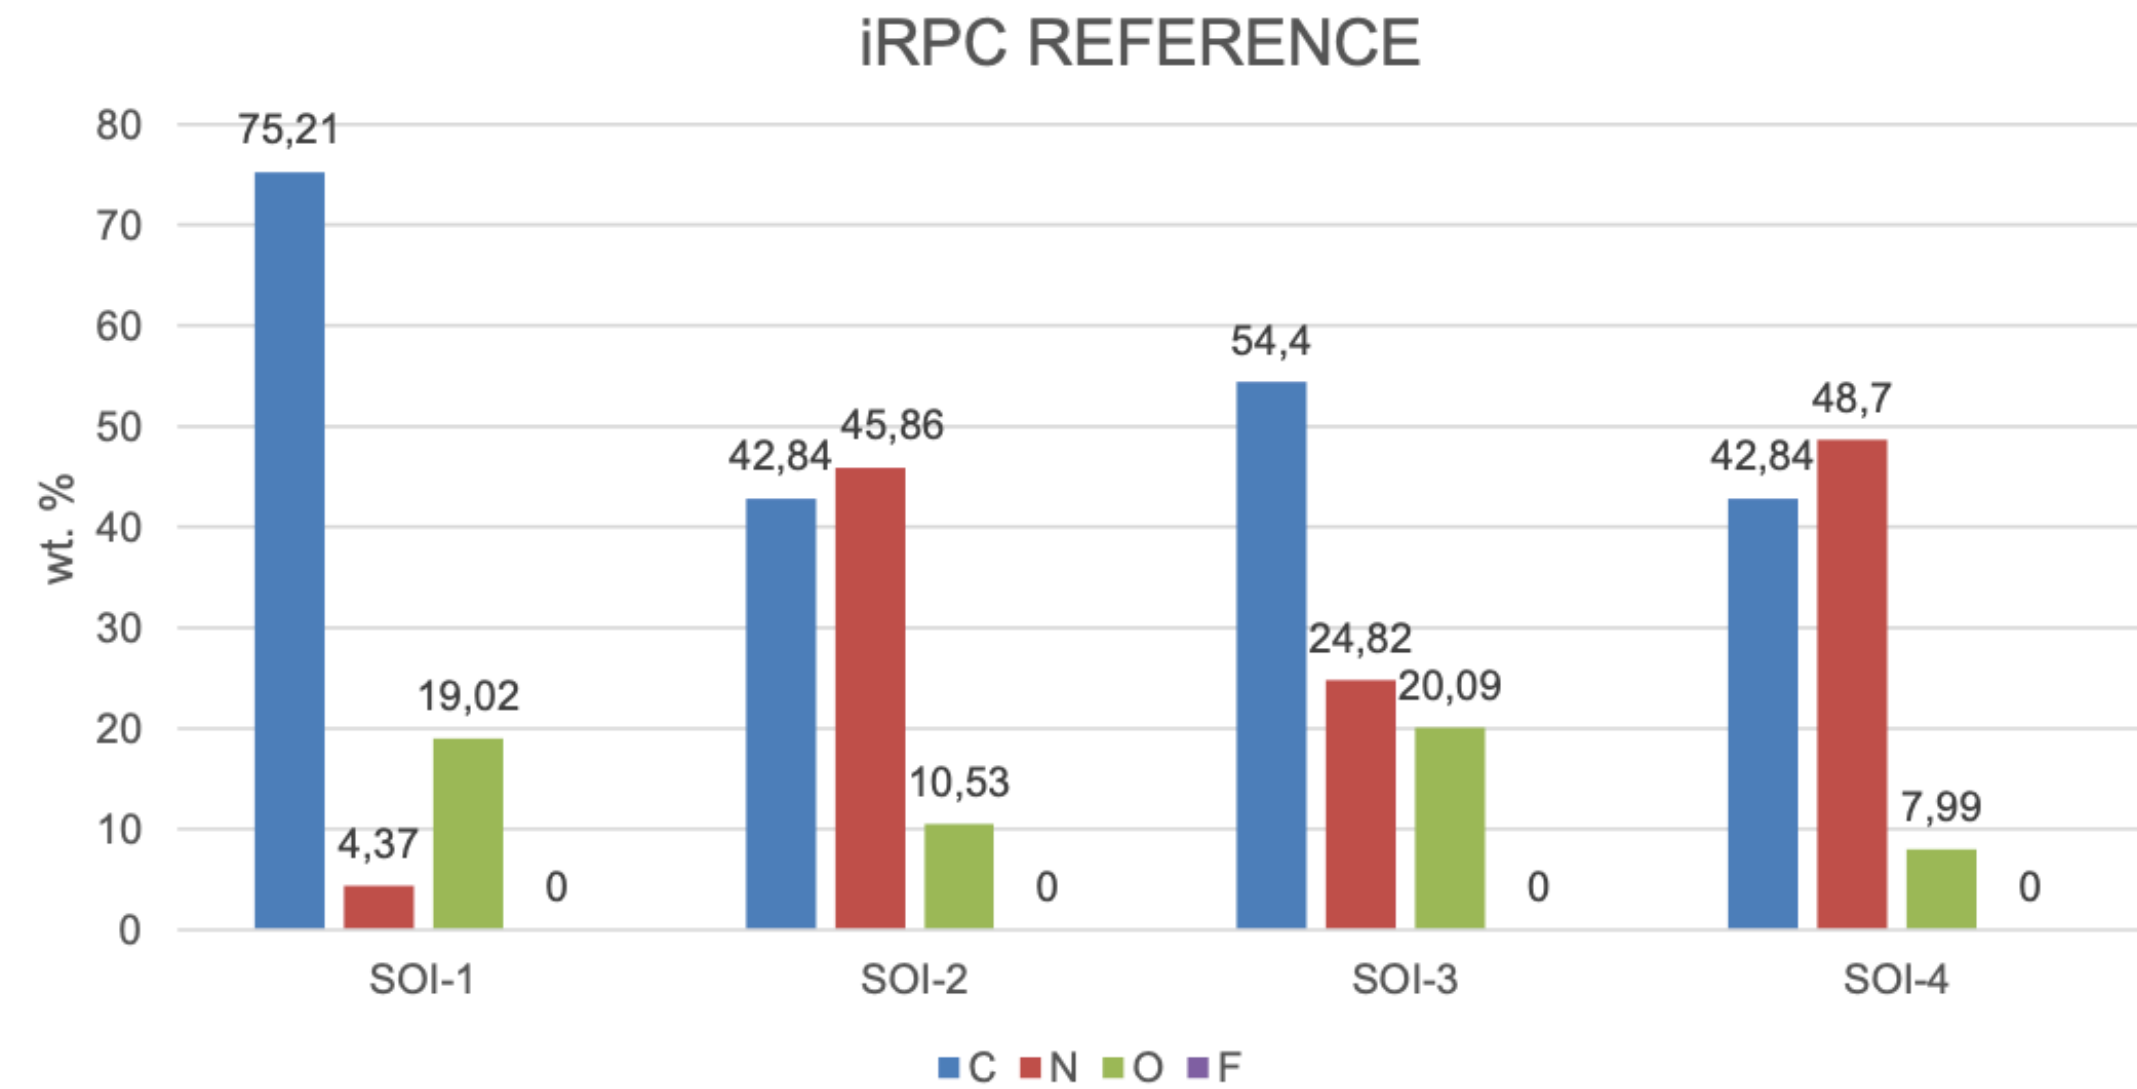
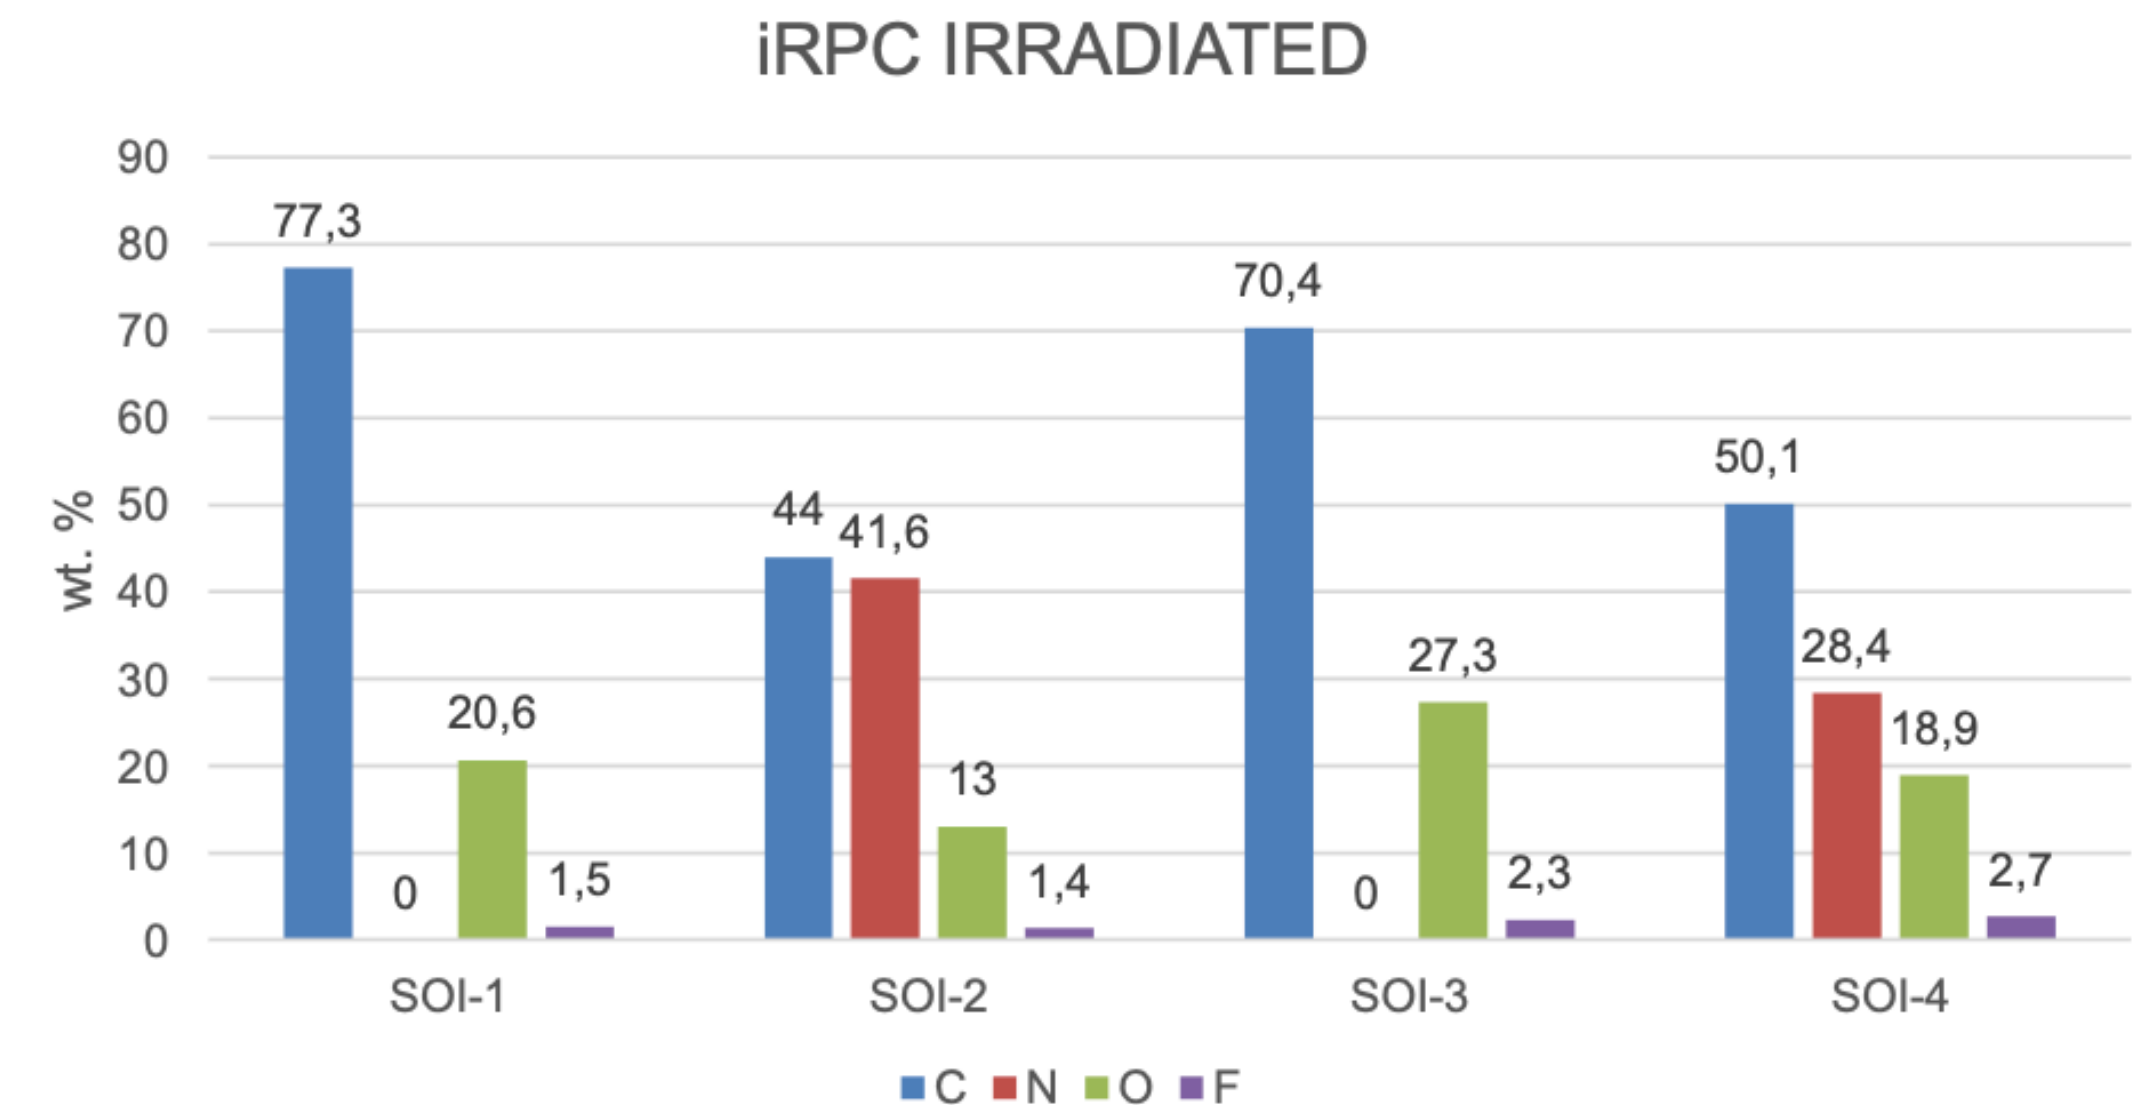
- Fluorine presence in IRR SOI
- Less N in SOI-3 and 4 IRR
- Similar composition SOI-4 IRR and SOI-3 REF

*SOI = site of interest

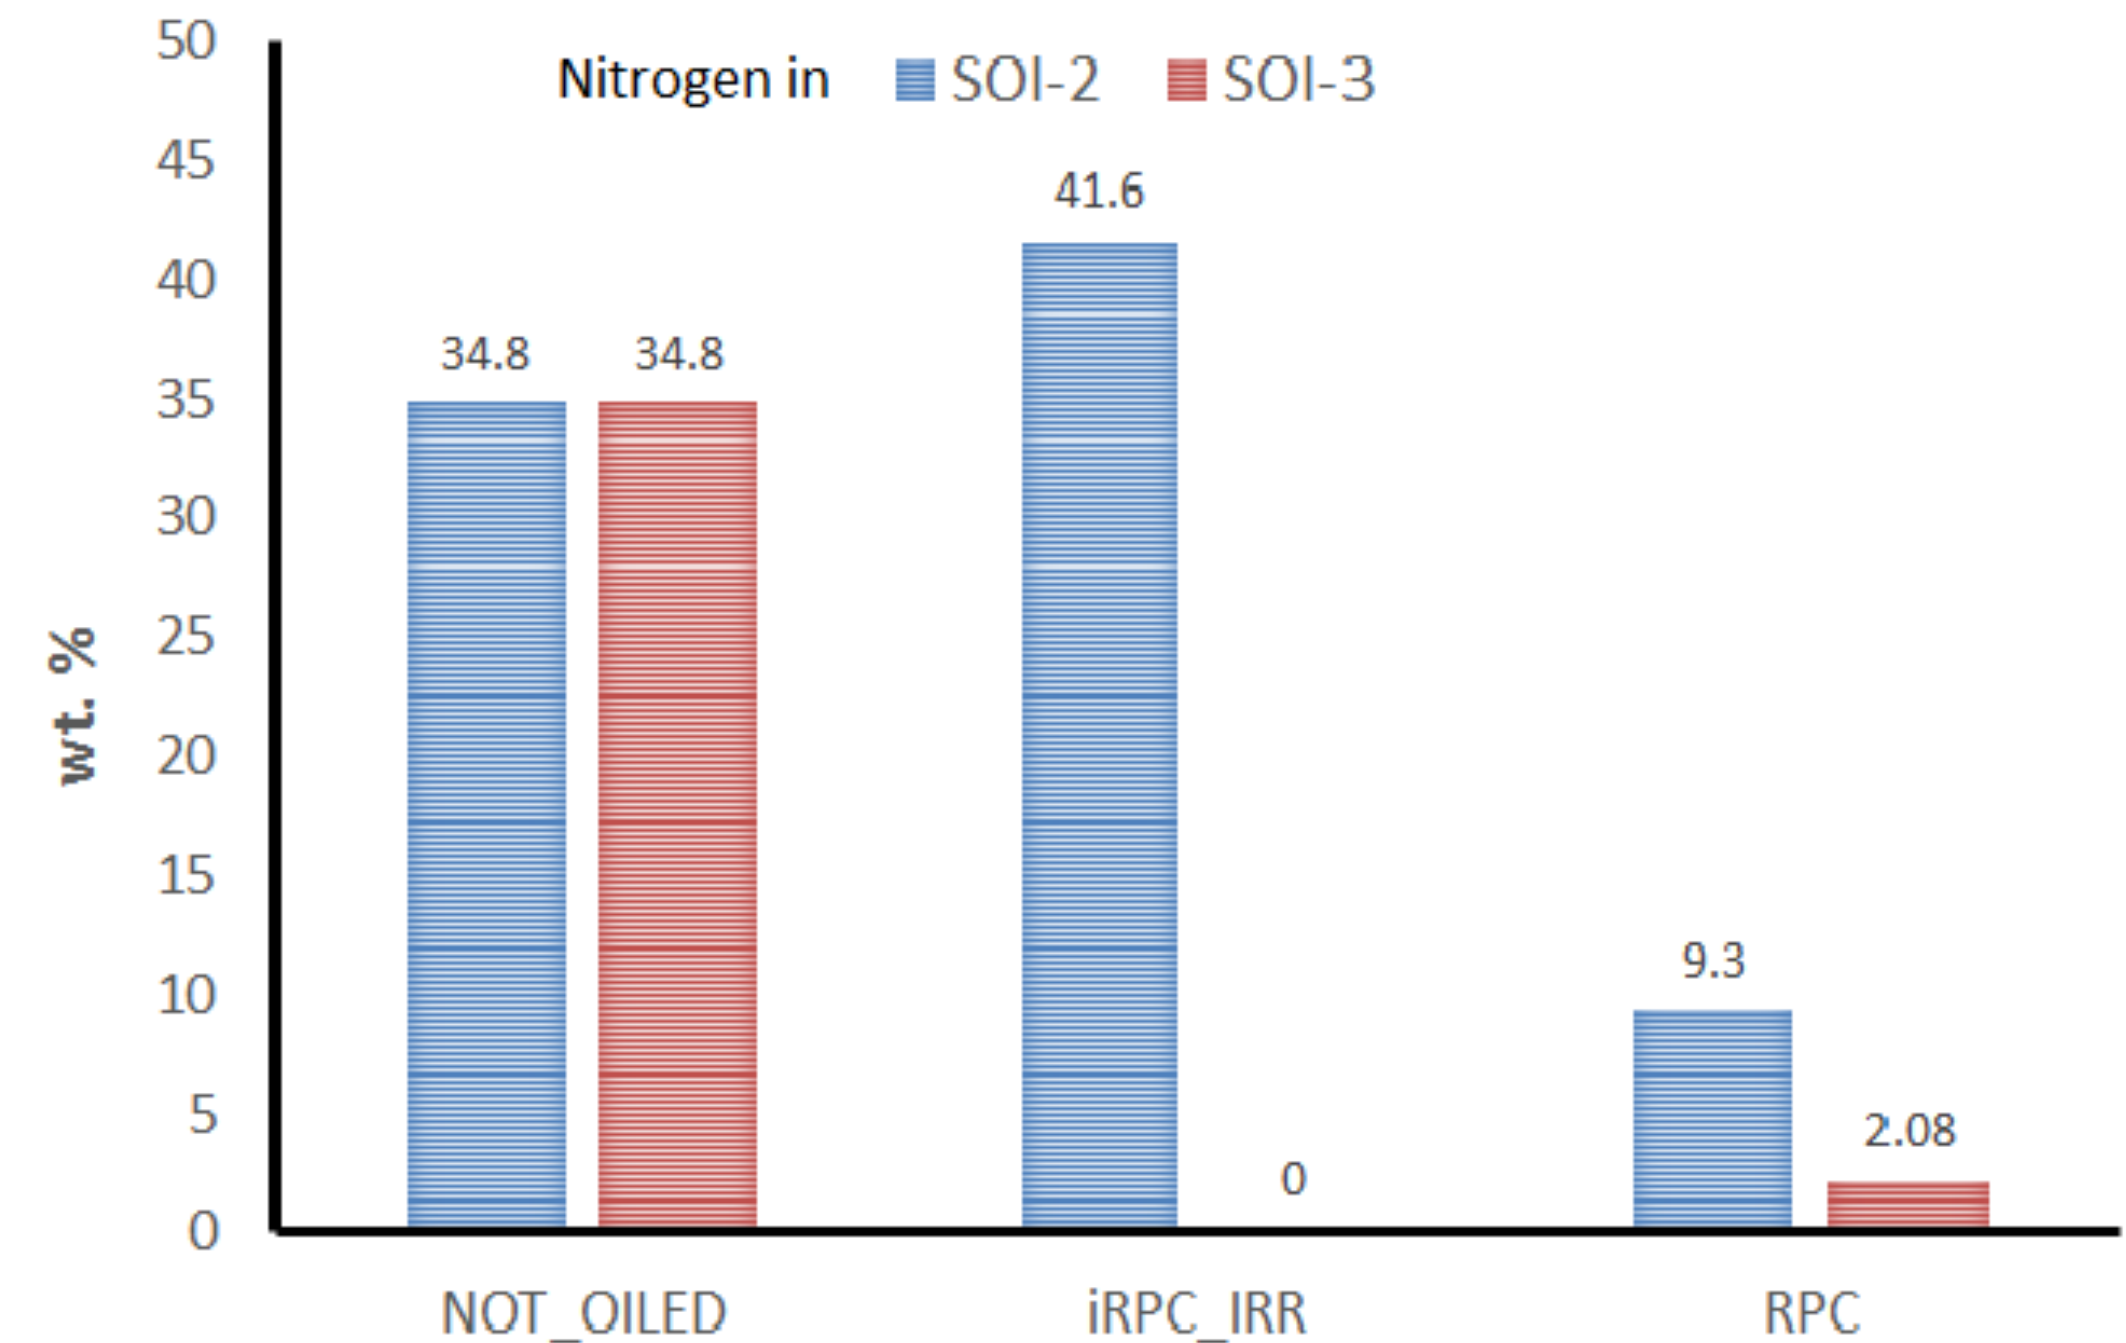
- N associated the external HPL layer made of melamine resin
- N presence in SOI-2, comparable with the not-oiled sample, indicating a lack of oil
- Thicker oil layer in RPC reference with respect to iRPC_IRR

**SOI-2: Ring around the spacer,
SOI-3: White matt stain**

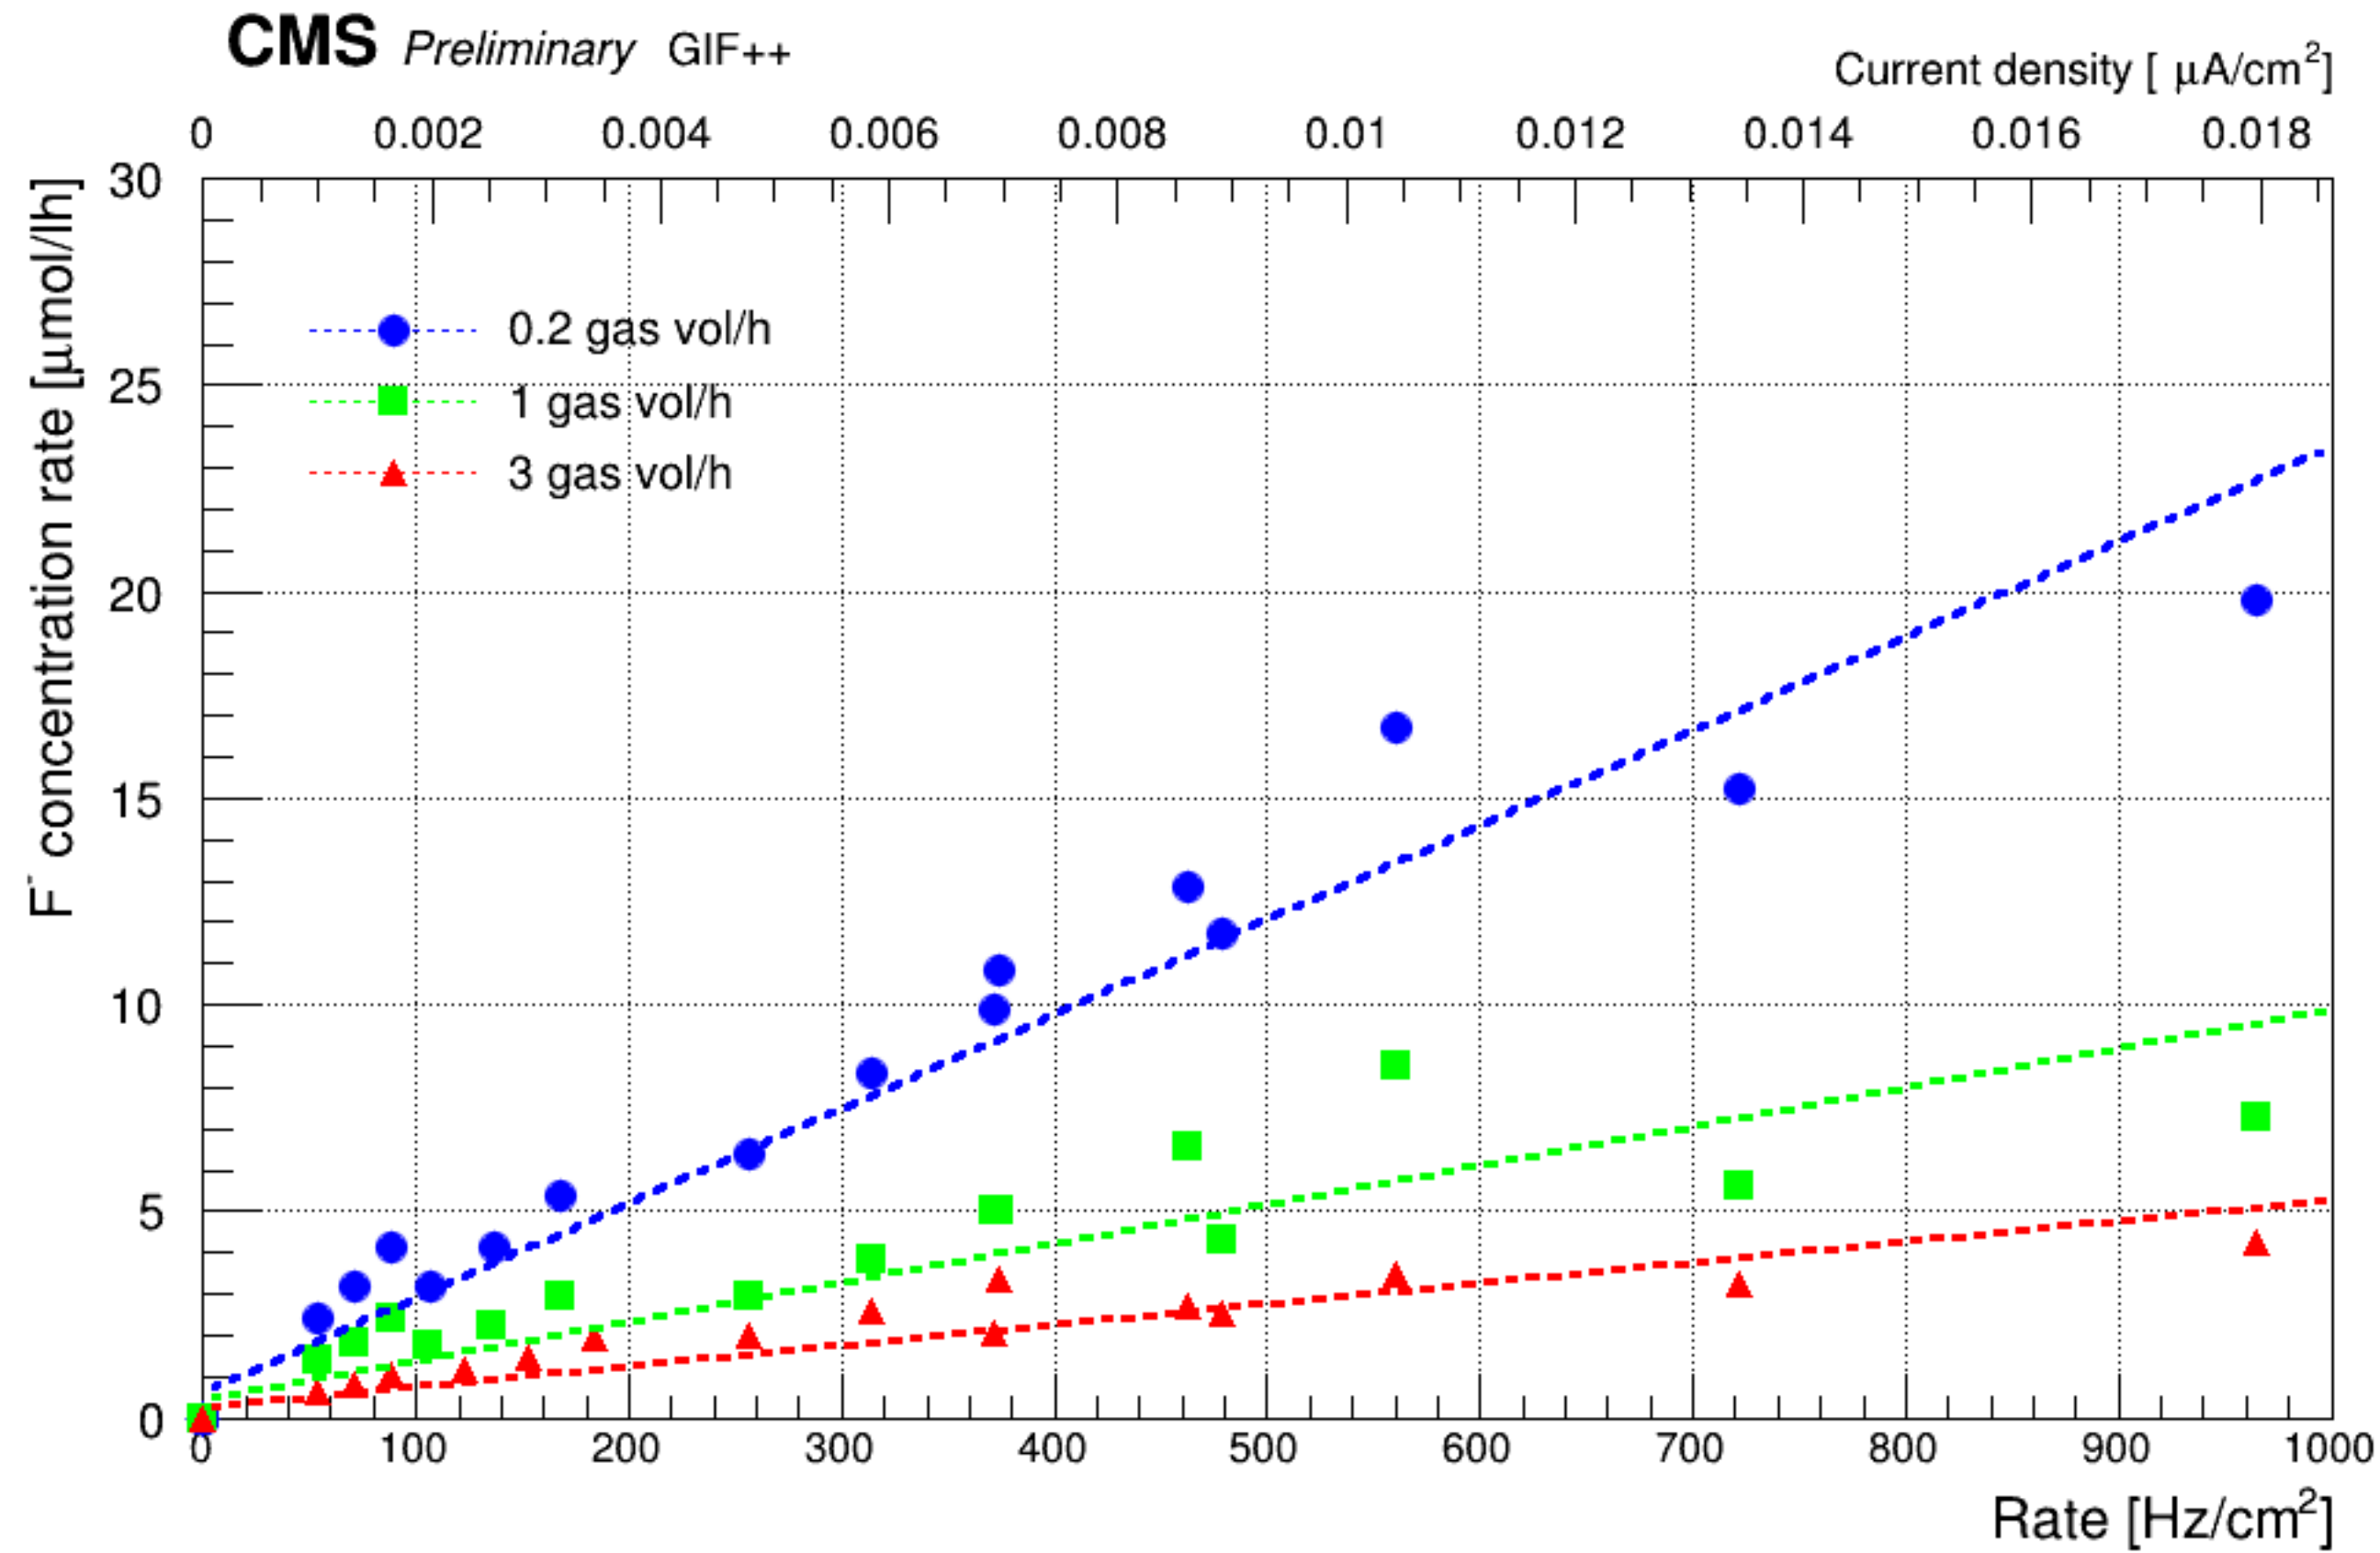
HF production @ different background conditions

- Linear dependence with the rate (current)
- At higher flow, less HF concentration (different slope for each gas flow applied)
