Chemical analyses of deposits in the RPC chambers

Dayron Ramos Lopez
Polytechnic and INFN of Bari

Layout of RPC prototype-1 for CMS Upgrade project (iRPC)

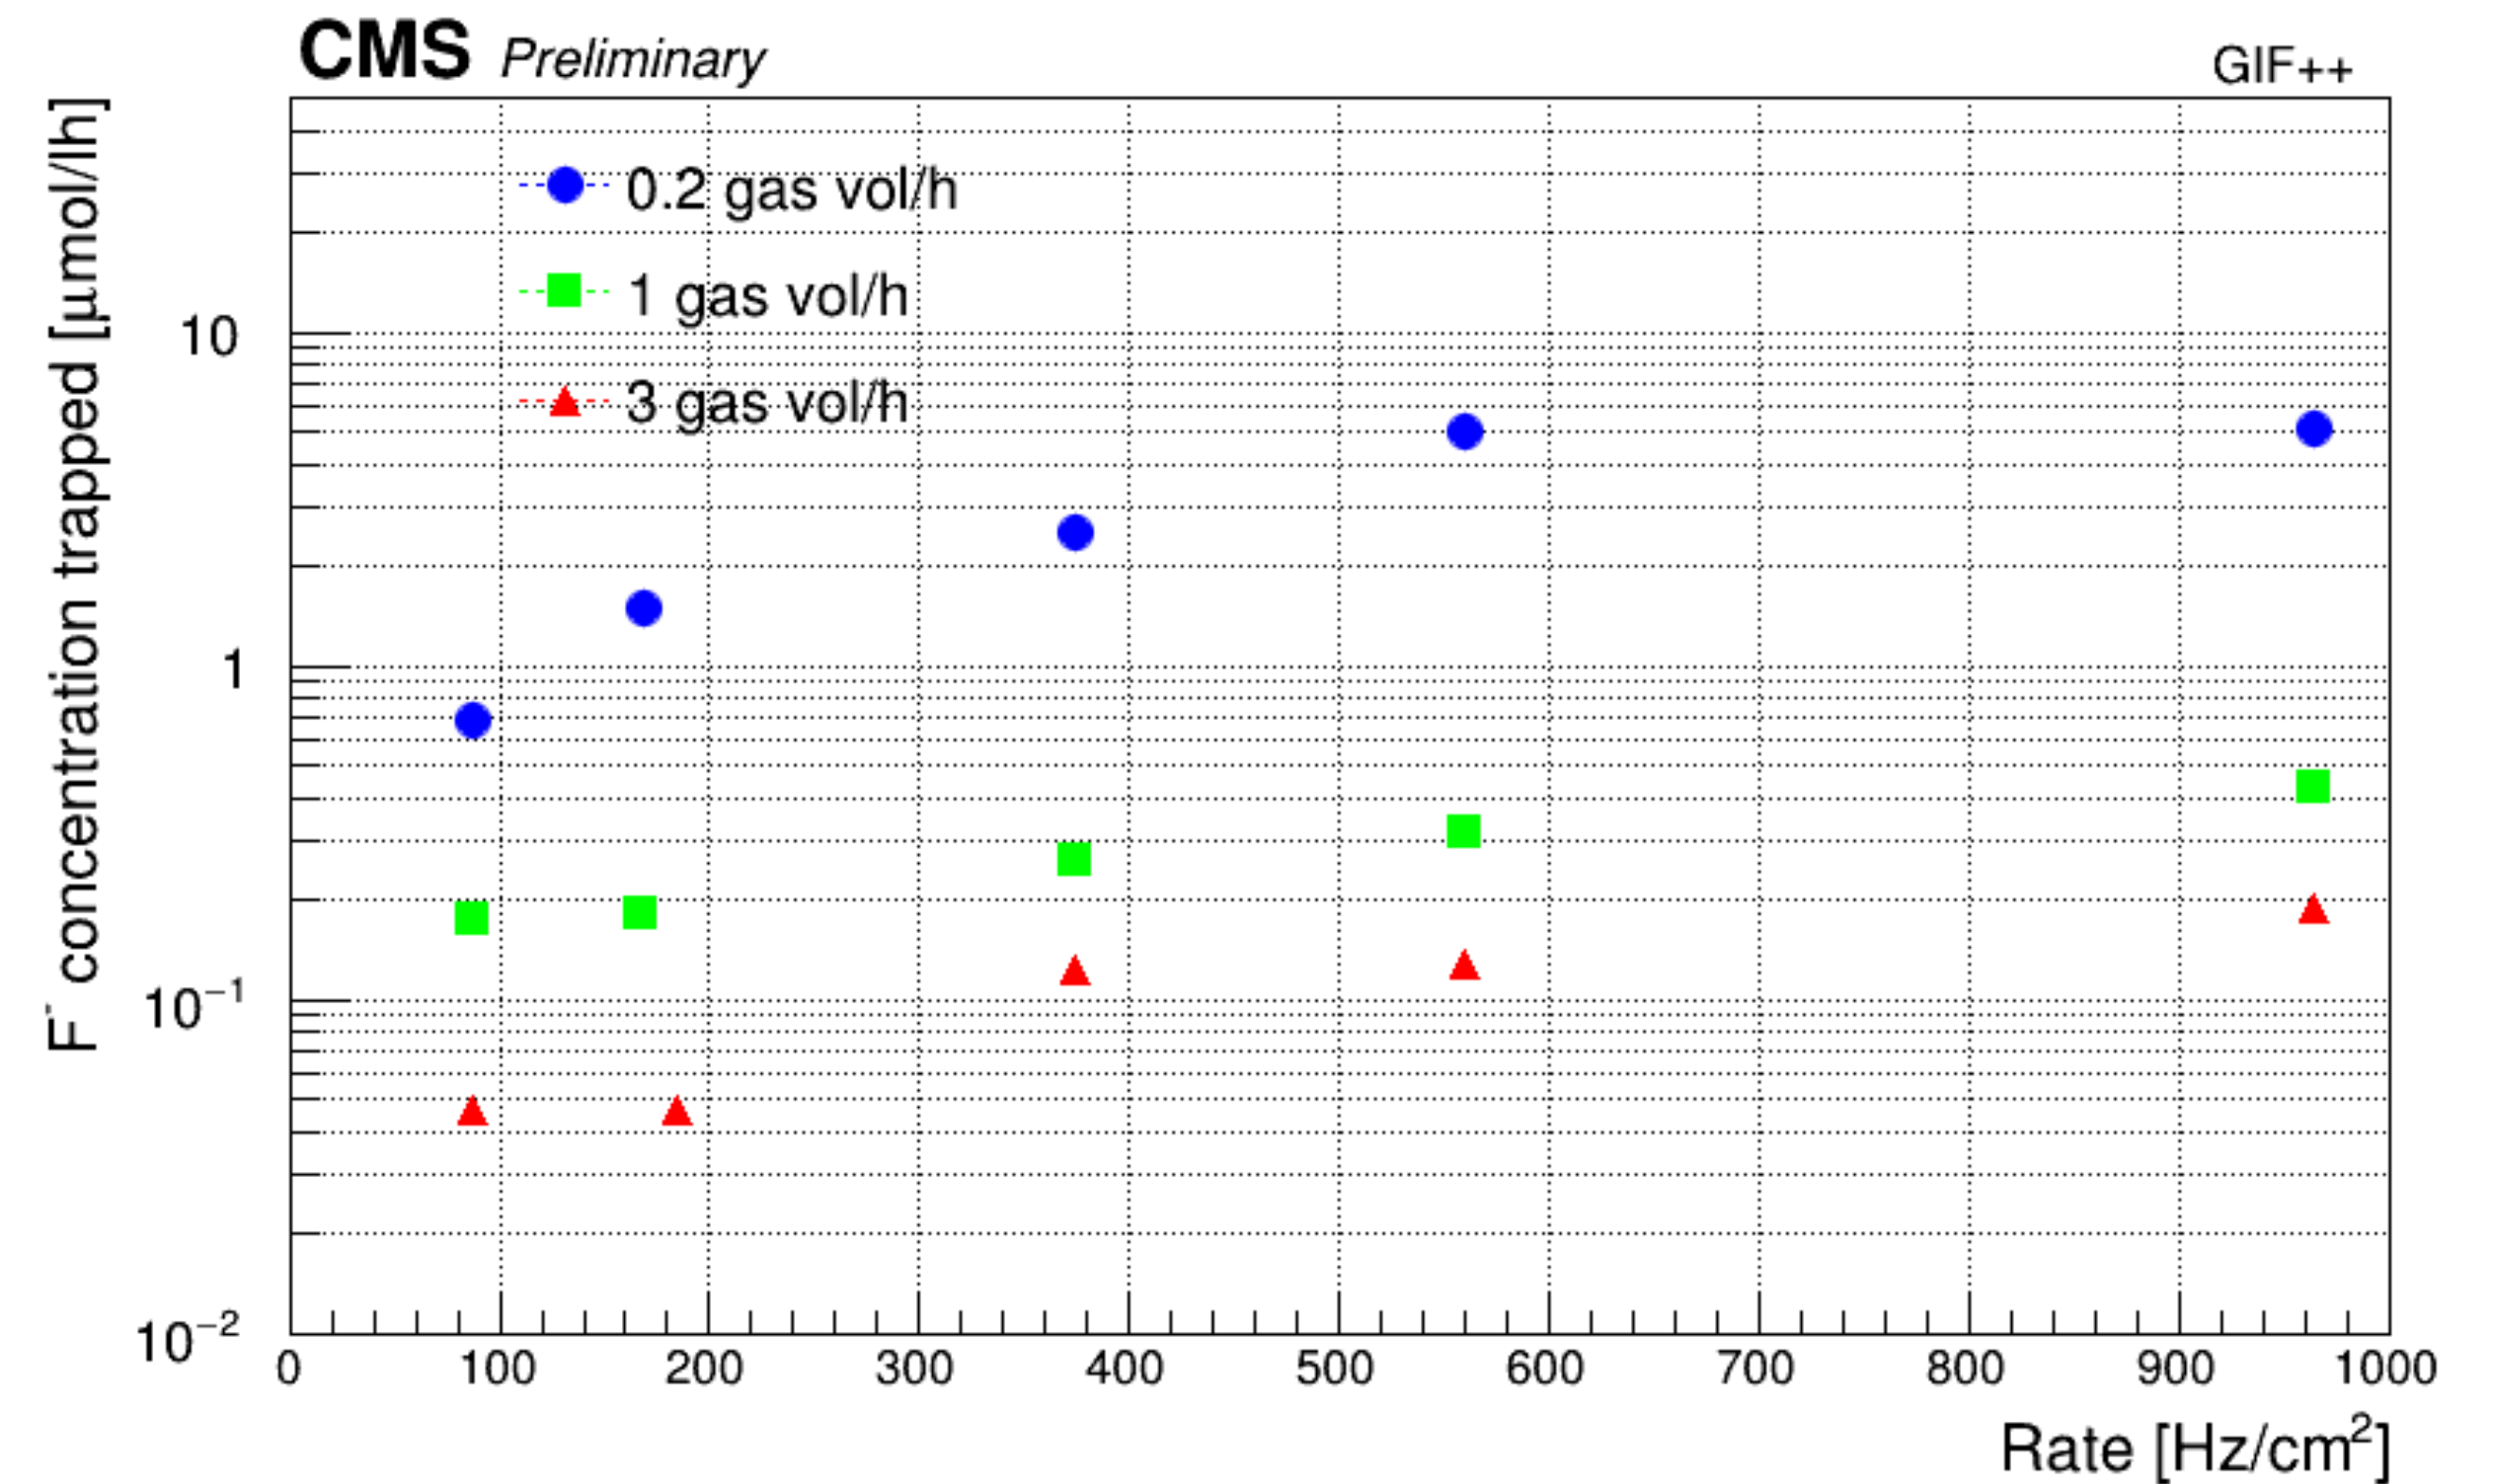
Fluoride concentration rate HFO-based mix

- HF concentration using the ecogas mixture is around 2.5 times greater than the standard
- HFO breaks five times more easily than C₂H₂F₄

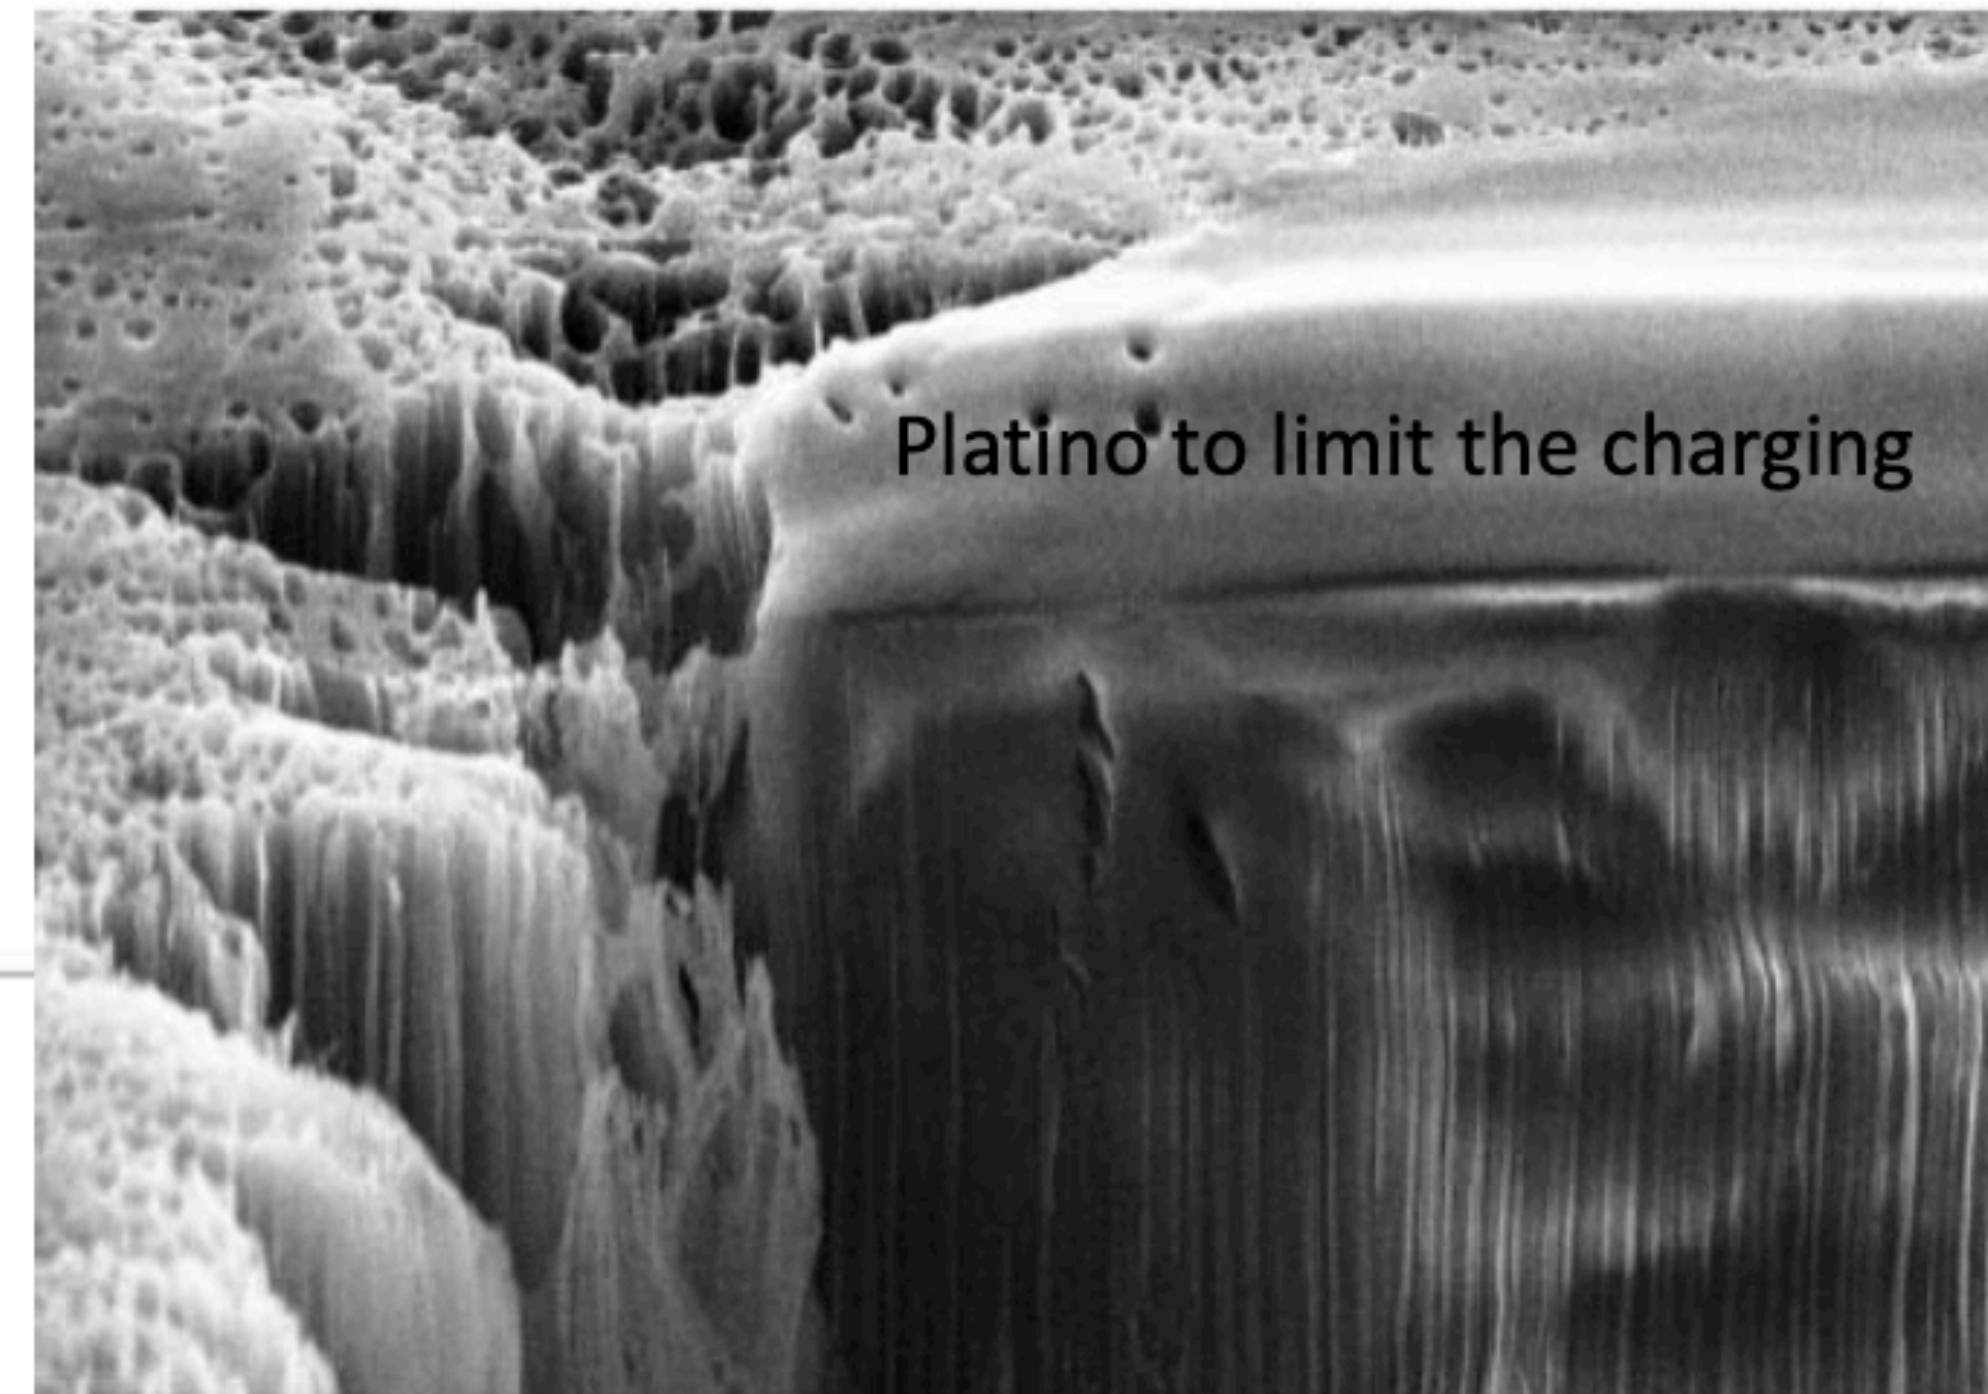
FIB+ SEM

Due to the charging problem, the FIB was not stable and the hole not precise. Moreover SEM has been affected.

No evidence of any layer presence

FIB+EDS @ 10um below the surface (SOI-2 &SOI-3): same chemical composition as for the surface.
