EN Engineering Department

Date: 06/02/2019

Microscope inspection of oiled High Pressure Laminated (HPL) Bakelite

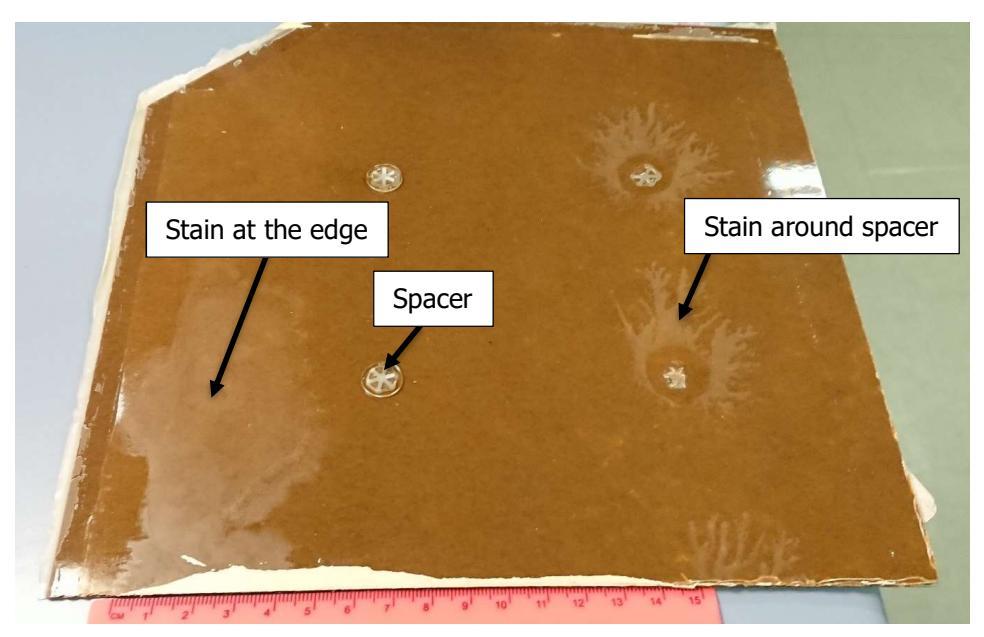
When the gaps have been opened some matt spots around the spacers were visible, and in addition, in the two problematic gaps there are big matt spots on the edge (Figure 1).

Figure 1 – Visual inspection of sample with matt spots around the spacers and at the edge area

A non-irradiated gap has been opened to use as a reference. No any matt spots have been observed, even if it is possible to notice a halo around the spacers.

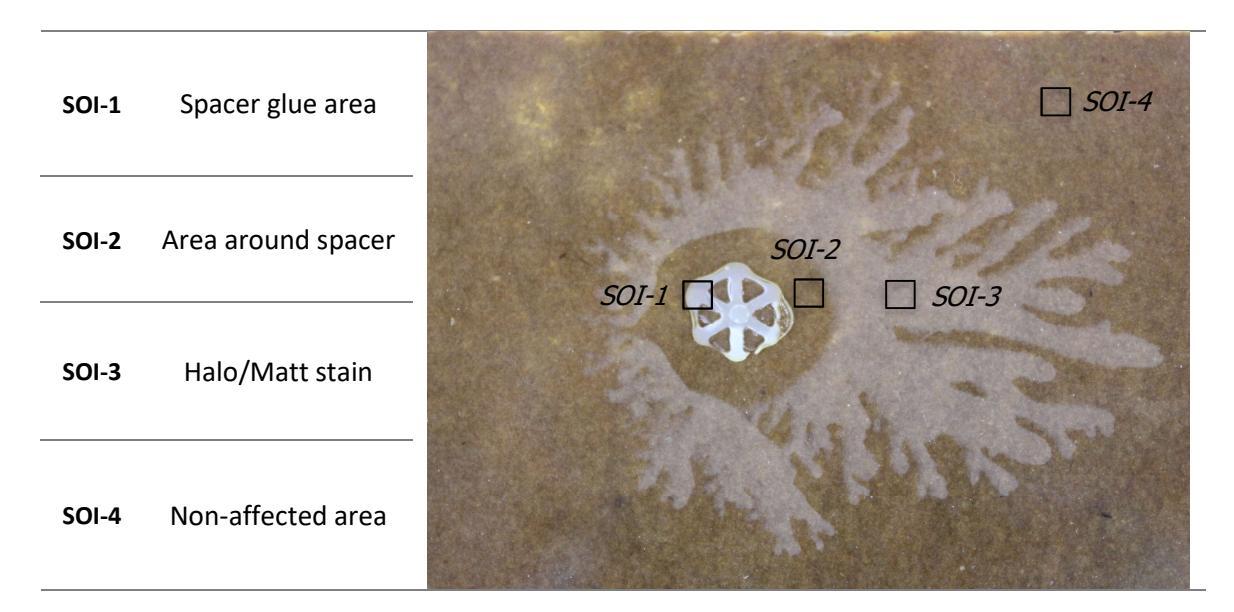
A maximum of four sites of interest (SOI) were defined in each sample. Representative example is shown in Figure 2 (but not all samples presented the four SOI described).

Figure 2 — Example of the SOI locations around

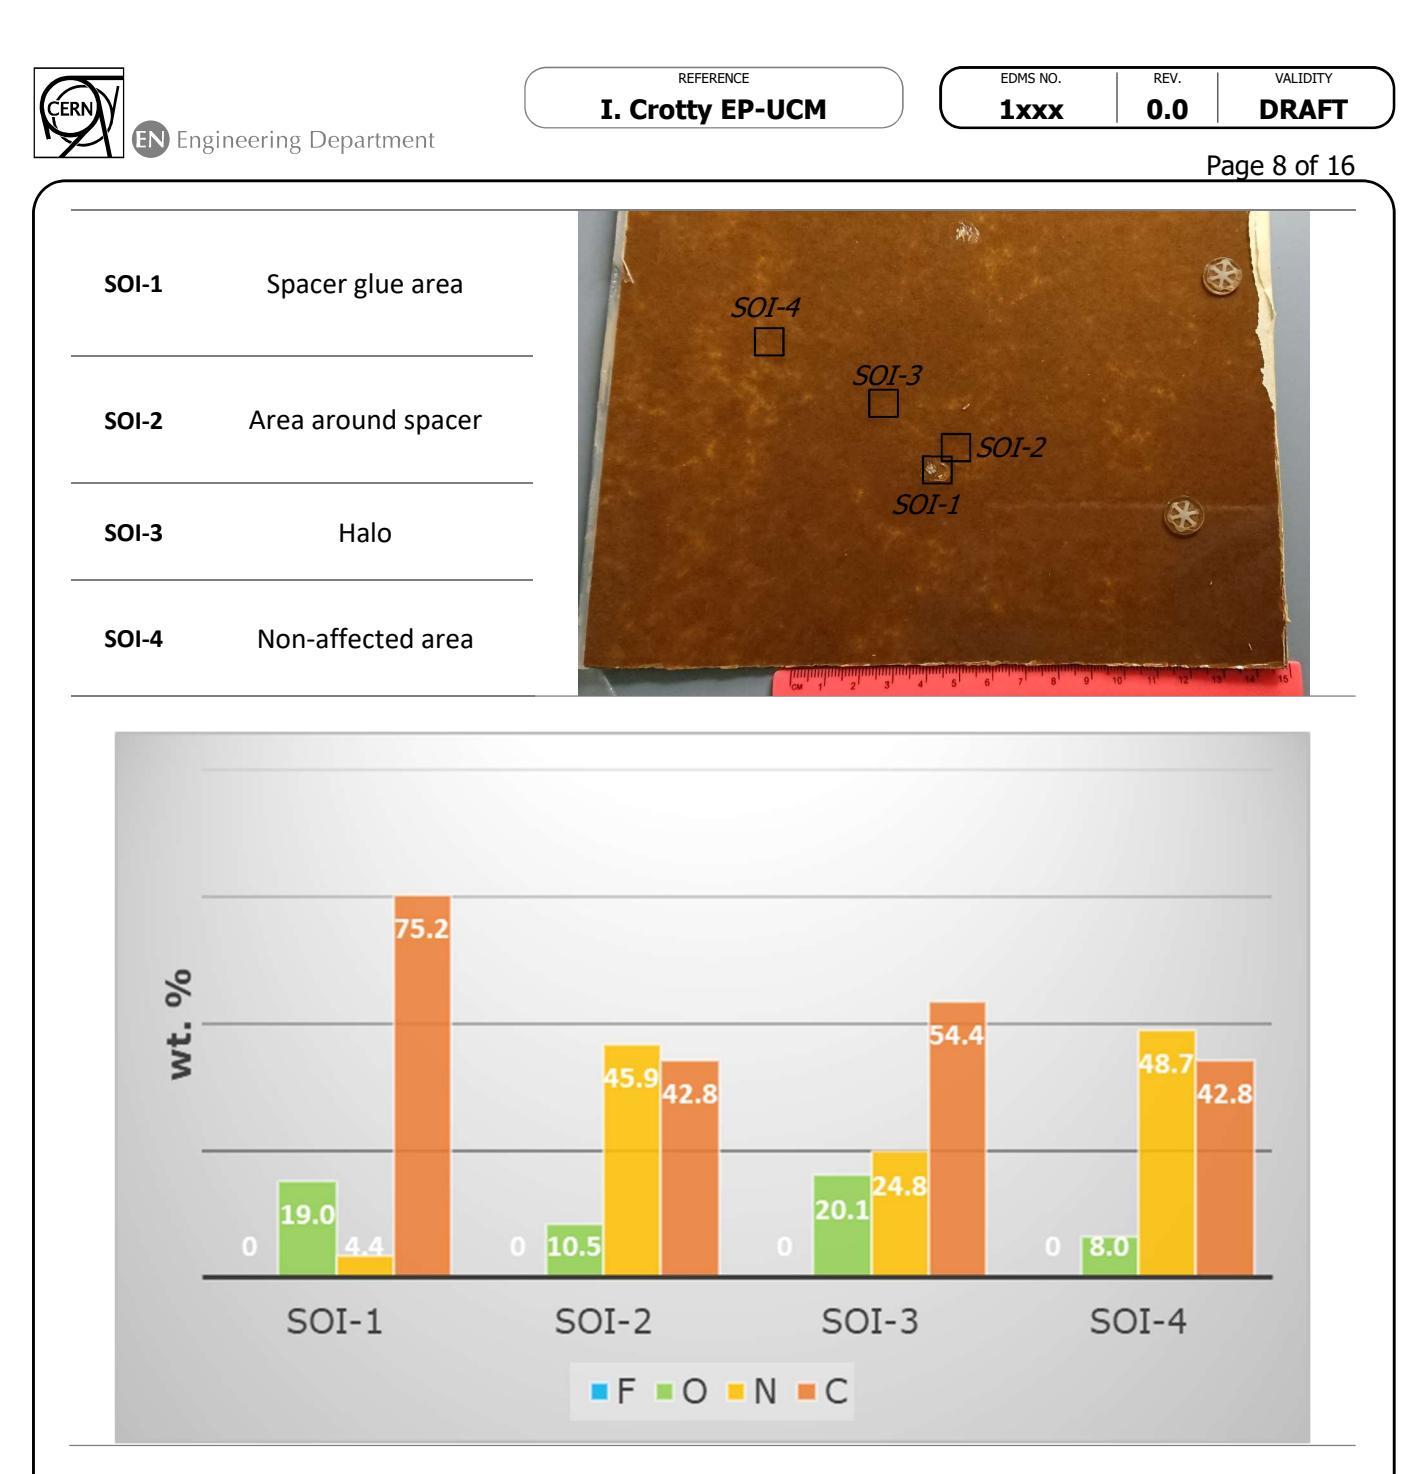
- F was only detected on the irradiated samples (Sample #2 and Sample #3), not at the reference (Sample #1);
- The glue composition was determined in SOI-1 in Sample #2 as the remaining volume is thick enough avoiding any influence of the layers below on the EDS spectrum. It is mainly rich in C and O;
- The halo in Sample #1, not irradiated, presents C, N and O while same area after irradiation in Sample #2 presents only C and O;
- Irradiated and non-irradiated present the same composition around the spacer (SOI-2) and the non-affected area (SOI-4).
- The big stain close to the edge in Sample #3 (SOI-2) presents N, C and O.

Figure 3 —SOI locations in Sample #1 and EDS results in wt. %

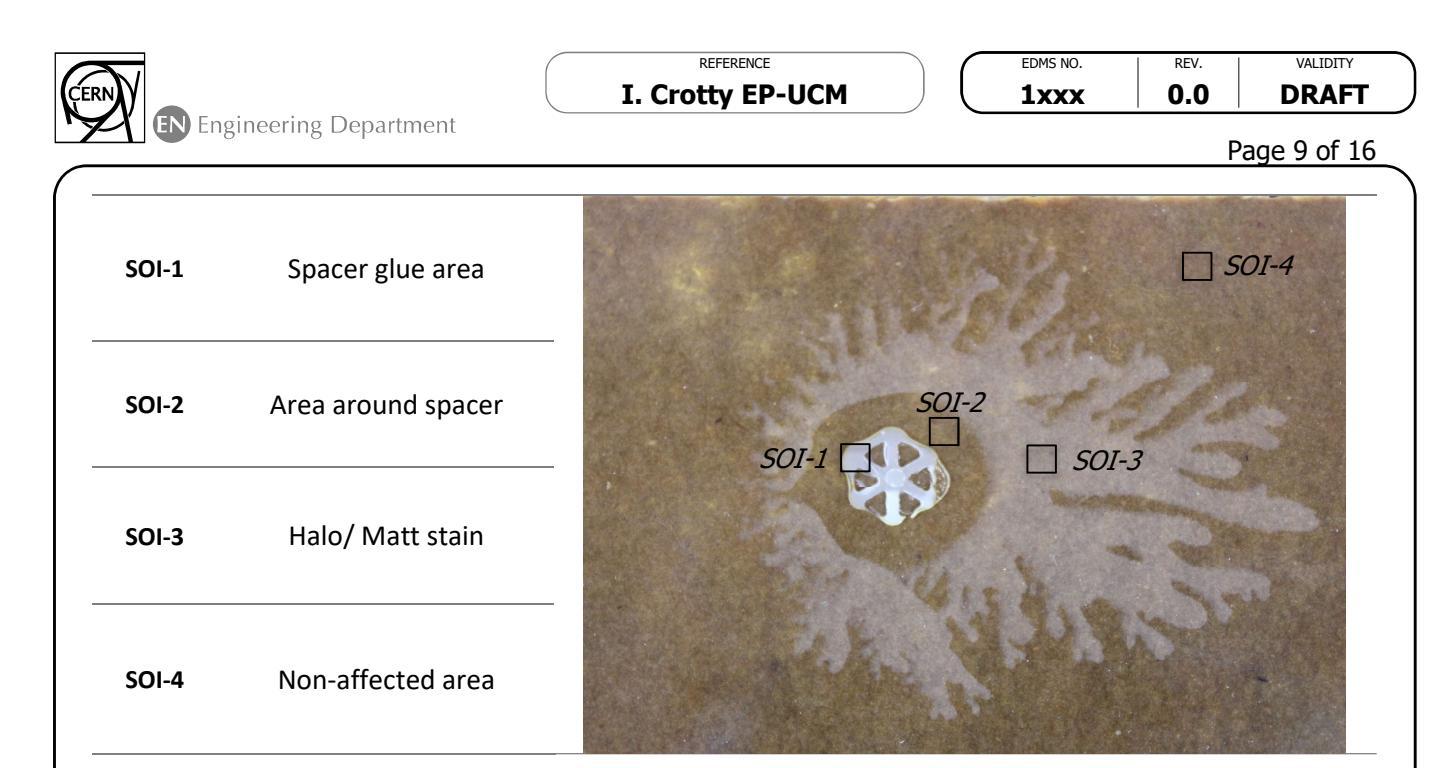
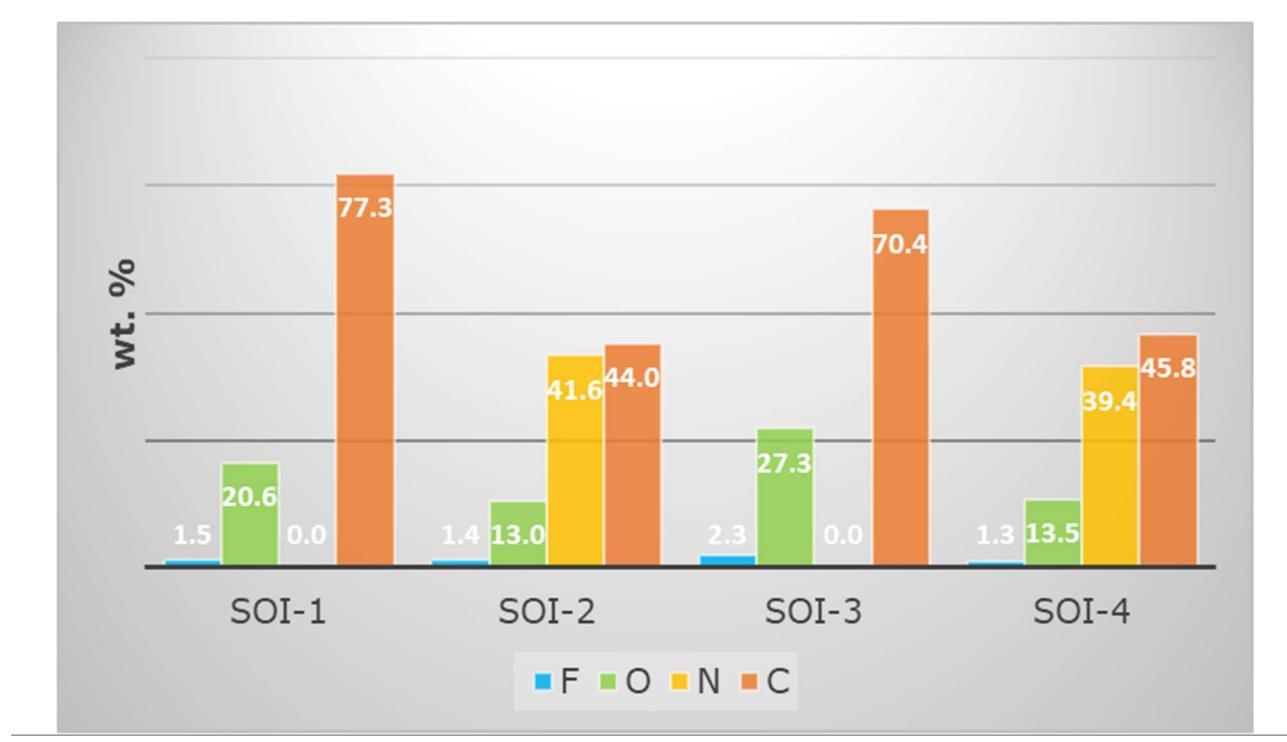
Figure 4 —SOI locations in Sample #2 and EDS results in wt. %

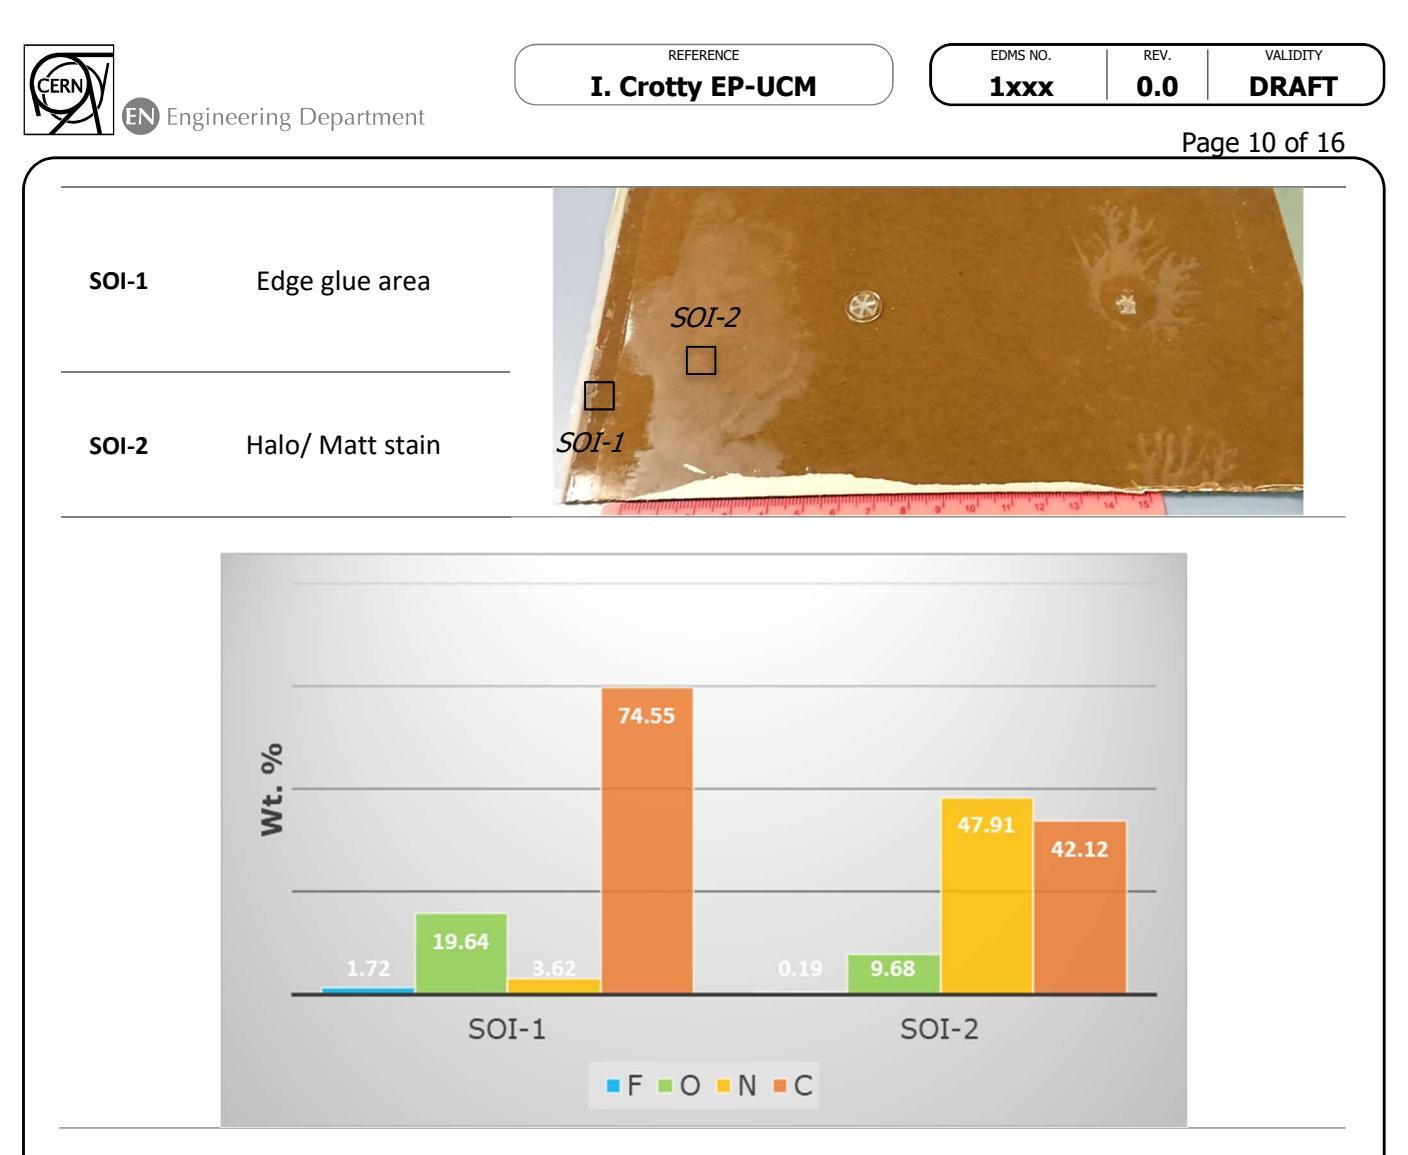
Figure 5 —SOI locations in Sample #3 and EDS results in wt. %

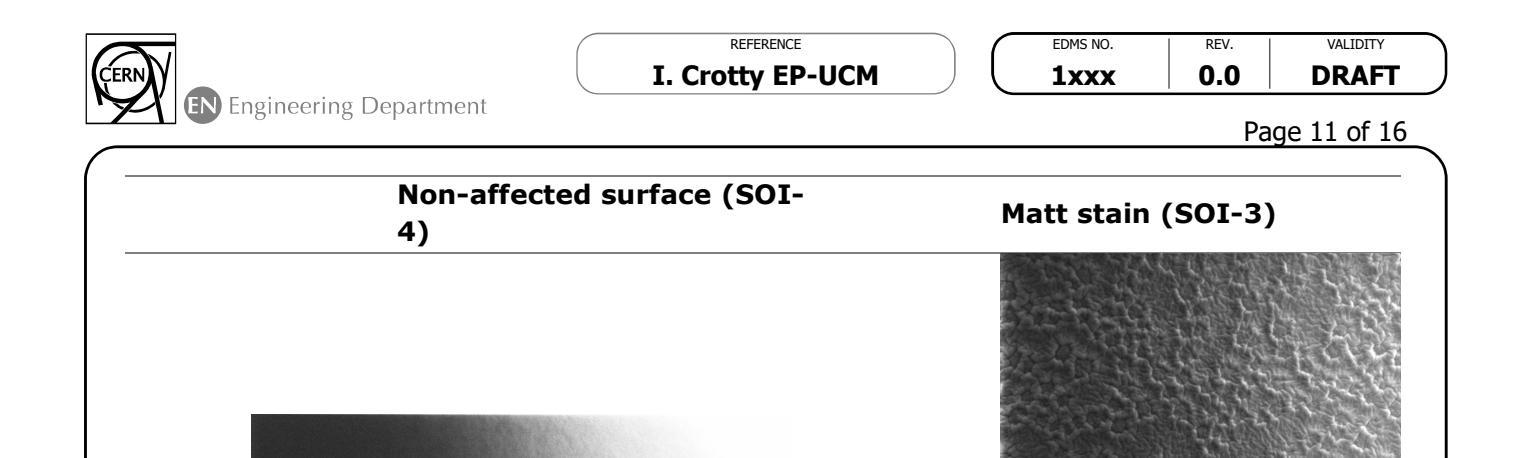
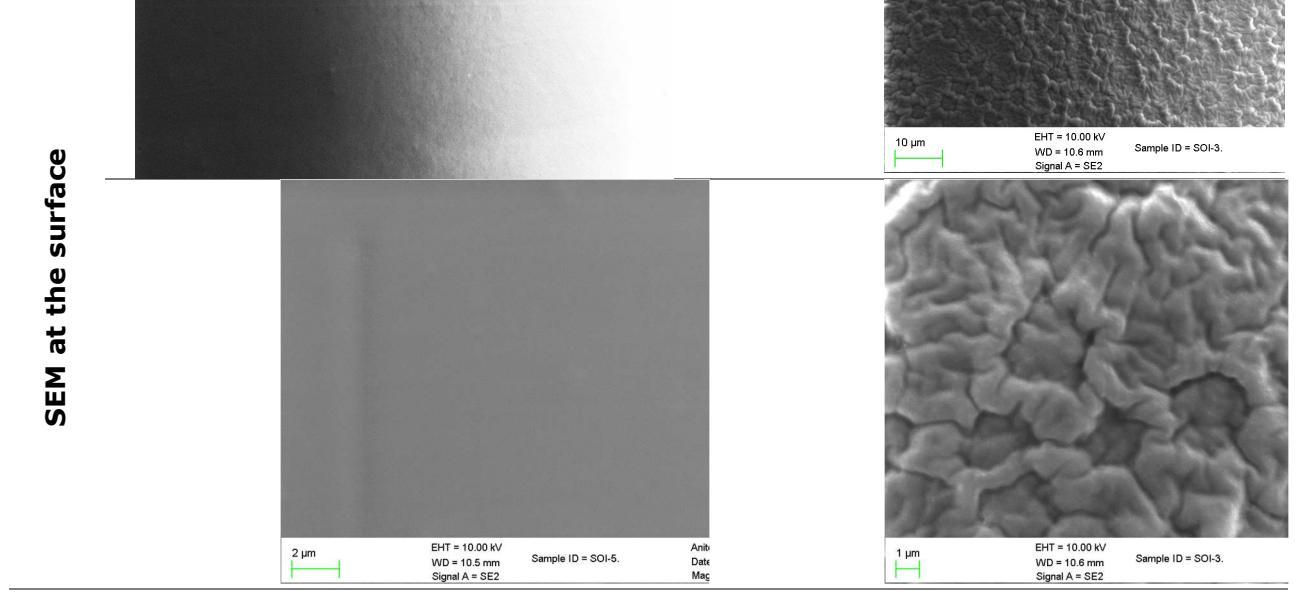
Additionally, the surface characteristics at the non-affected area and at a randomly selected stain was compared by SEM imaging on Sample #2 presenting the first one a smooth aspect while the second one shows a rough topography. Representative images are displayed in **Error! Reference source not found.**

Figure 6 – SEM SE2 images representative of the surface aspect at the nonaffected area and matt stain area and FIB cross sectional view and location of the EDS analyses (close to the surface and at two microns depth approximately)

• In addition, the microscopy inspection pointed out that matt stains present a certain roughness in opposition to non-affected areas and non-irradiated samples that present a relatively smooth surface;

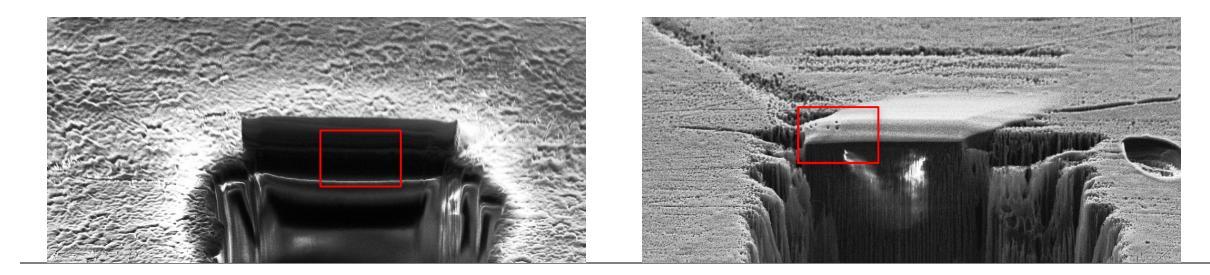
In an attempt to better understand the origin of the observed stains, cross section was prepared on two locations (SOI-2 and SOI-3) by FIB cross sectional milling initially depositing a carbon protection barrier at a milling current of 300 pA and accelerating voltage of 30 keV. Coarse milling was then performed at a milling current of 15 nA and accelerating voltage of 30 keV. Polishing of the revealed surface was then performed at a current of 3 nA and accelerating voltage of 30 keV. (See Figure 7).

Figure 7 – FIB milling cross section overview in SOI-2 and SOI-3 and location of the images displayed in Figure 8 and Figure 9. The charging effect during the milling caused beam distorsion and alignment issues as it can be observed in the irregular shape of the holes

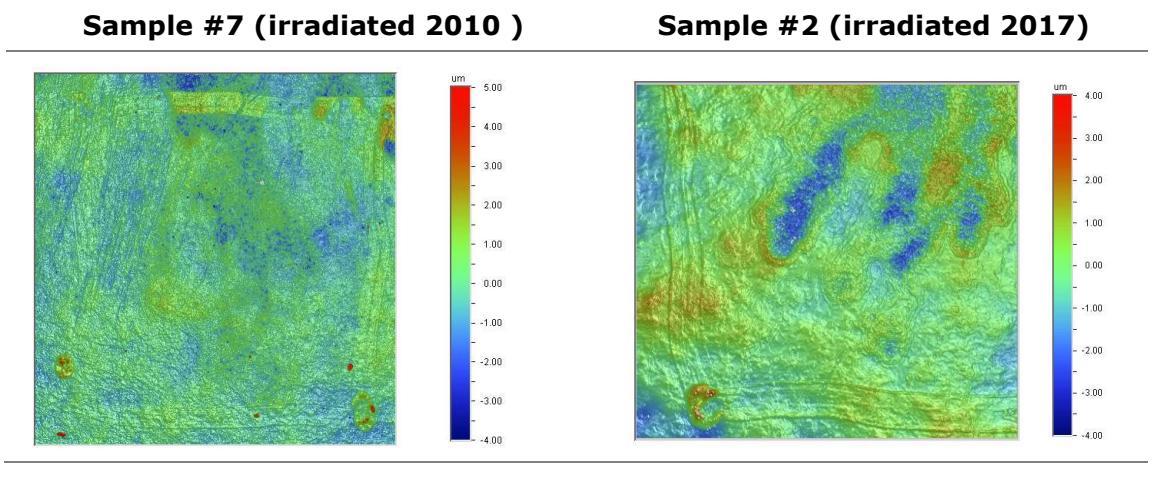
- F was detected only on irradiated samples;
- The EDS analysis in Sample #4 (used as reference surface free of linseed oil) showed that the composition is rich in C, N and O. The presence of C and N is well aligned with the composition melamine and C and O are also present on the phenolic resin.
- The EDS analysis in Sample #1 (used as reference surface with linseed oil) showed that the composition at the halo is similar to the composition of the Bakelite without oil (Sample #4).
- Moreover, if we compare the surface aspect by laser interferometry of the samples irradiated in the past that performed well (i. e. Sample #7) with the Sample #2 tested in 2017, thickness inhomogeneity's are visible (study performed by Didier Glaude - EN-MME/MM – EDMS: <u>2065851</u>).

Hypothesis: The oil layer is thinner in the halo region leading, after irradiation, to a heavily affected surface.

Figure 10 – Laser interferometry results from EDMS 2065851 in Sample #2
