BaBar RPC
story, from my
perspective

J. Va'vra

Content

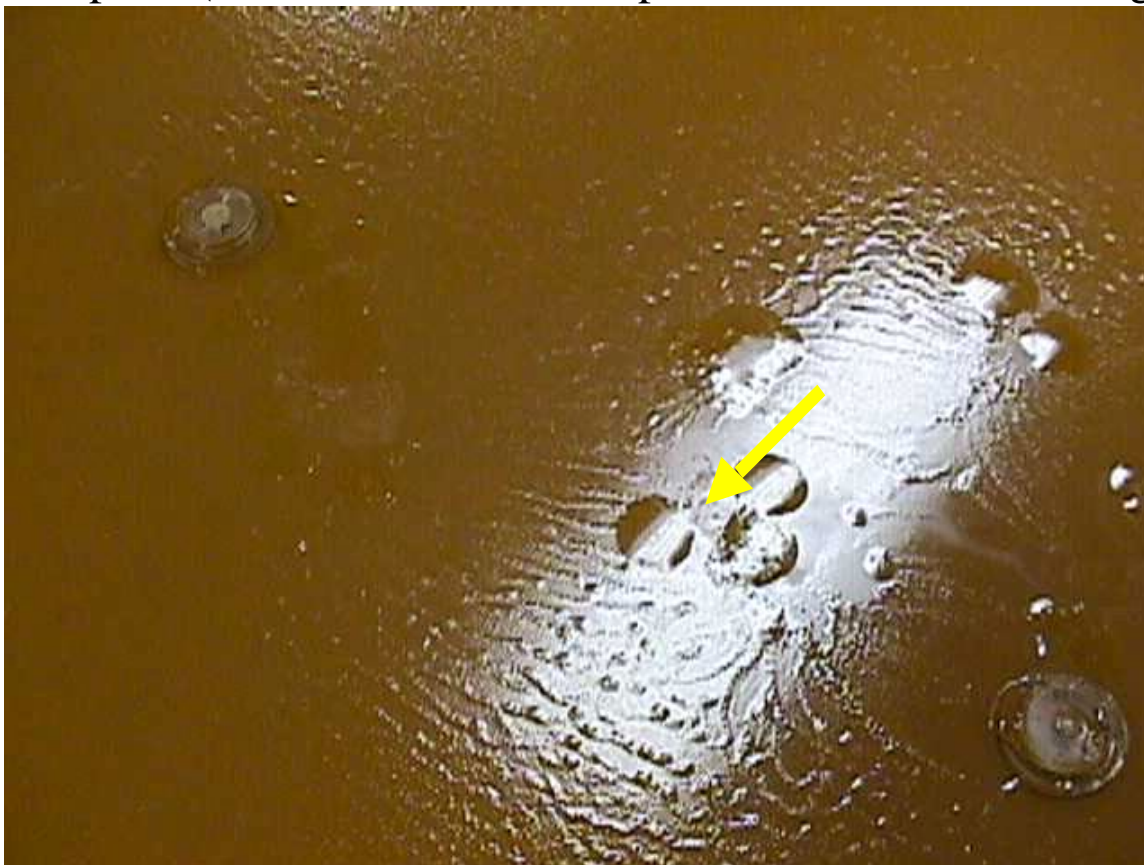
Sample 2 (“bad” chamber - a drop which did not cross the gap):

Note: A large amount of the linseed oil. Some indication of the oxidation of the linseed oil and the formation of an organic acid

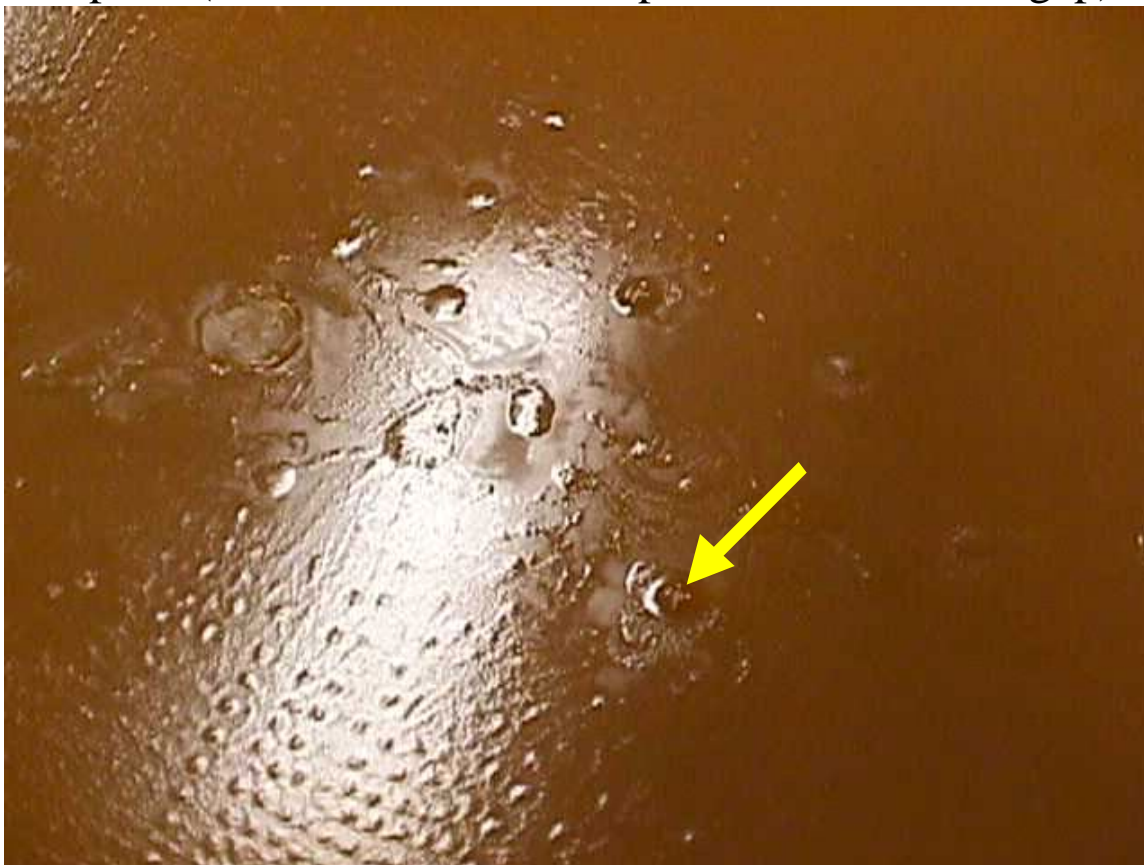
Sample 3 (“bad” chamber - a drop which crossed the gap):

Note: A large amount of the Linseed oil. Some indication of the oxidation of the Linseed oil and the formation of an organic acid.

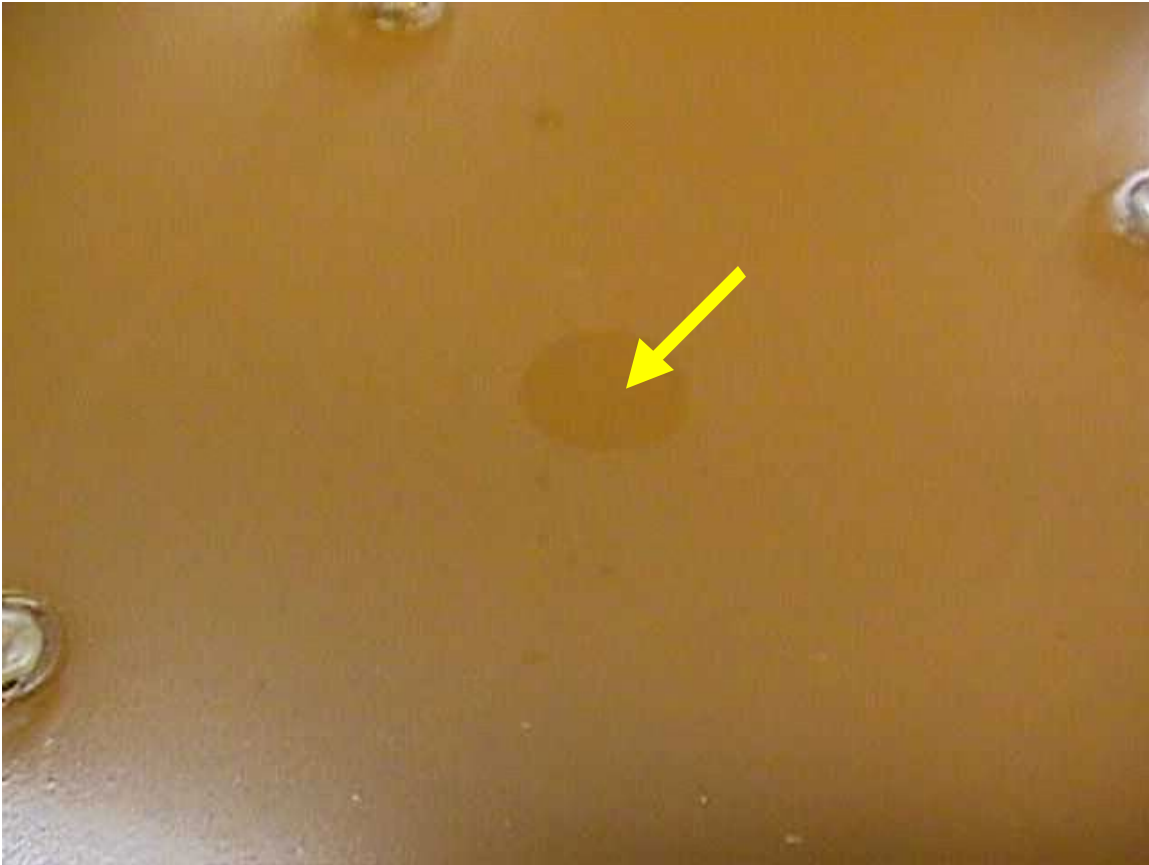
Sample 5 (“good” chamber – far from the buttons):

Note: Away from the button, there is a smaller proportion of the Linseed oil compared to the level we have seen in the “bad” chamber.

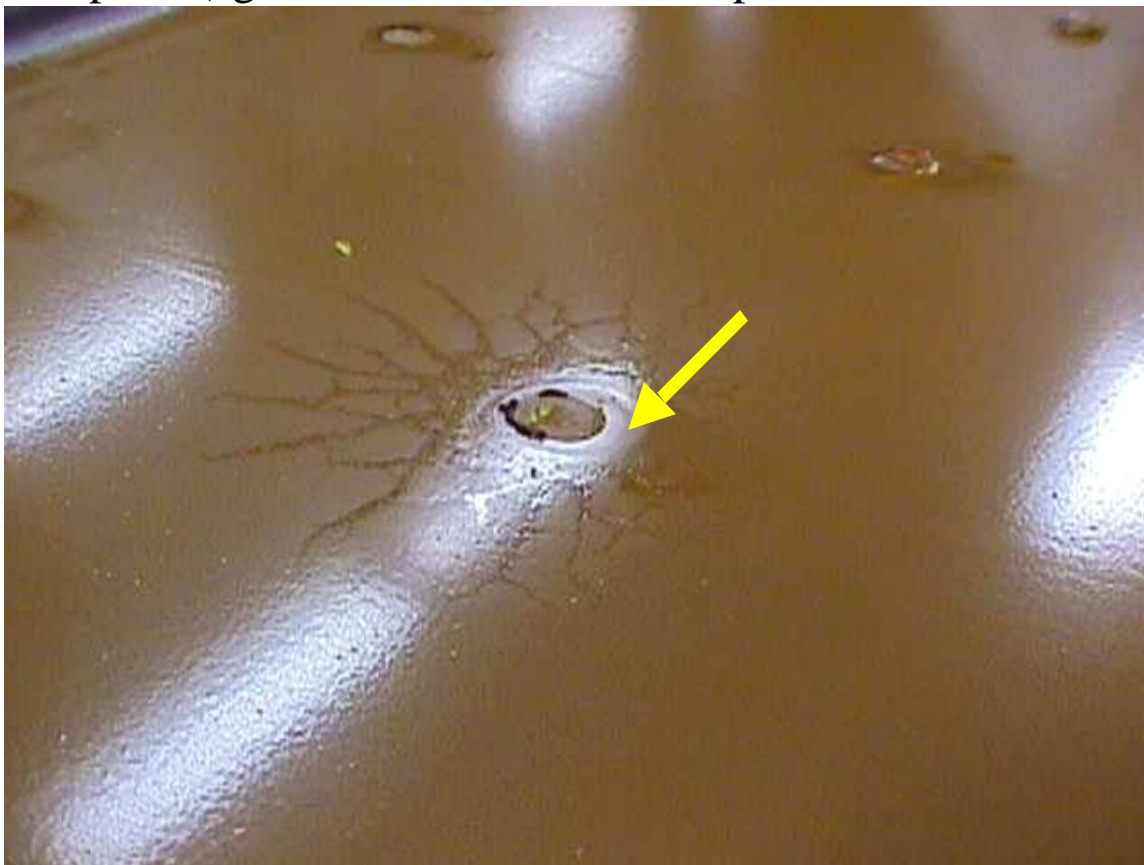
Sample 7 (“good” chamber – a “star” pattern near the button):

Note: A large amount of the Linseed oil. Some indication of the oxidation of the linseed oil and the formation of an organic acid. Near the button, we see larger proportion of Linseed oil.

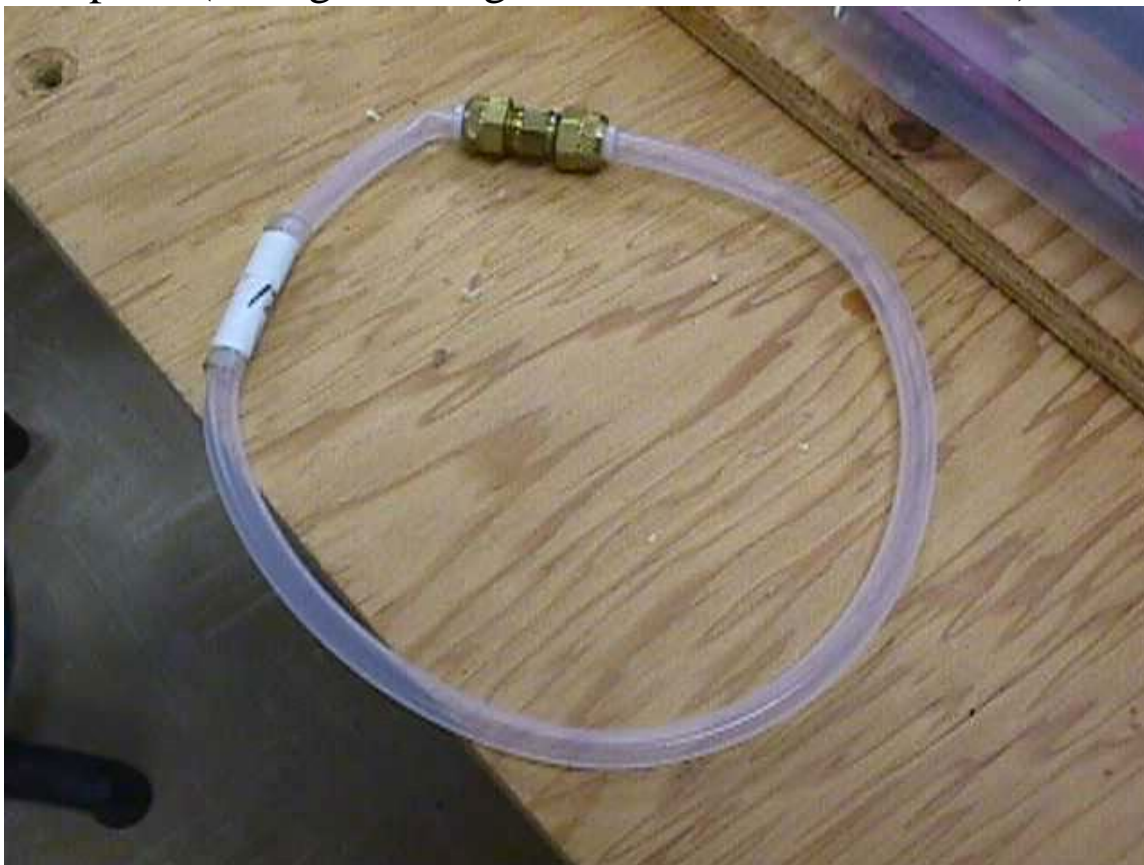
Sample 6 (inlet gas tubing from BaBar RPC detector):

Note: The tubing has traces of the hydrocarbon oil. This is how any oil signature would look like. The oil may have come from the Freon gas, possibly. There is no sign of the Linseed oil though.

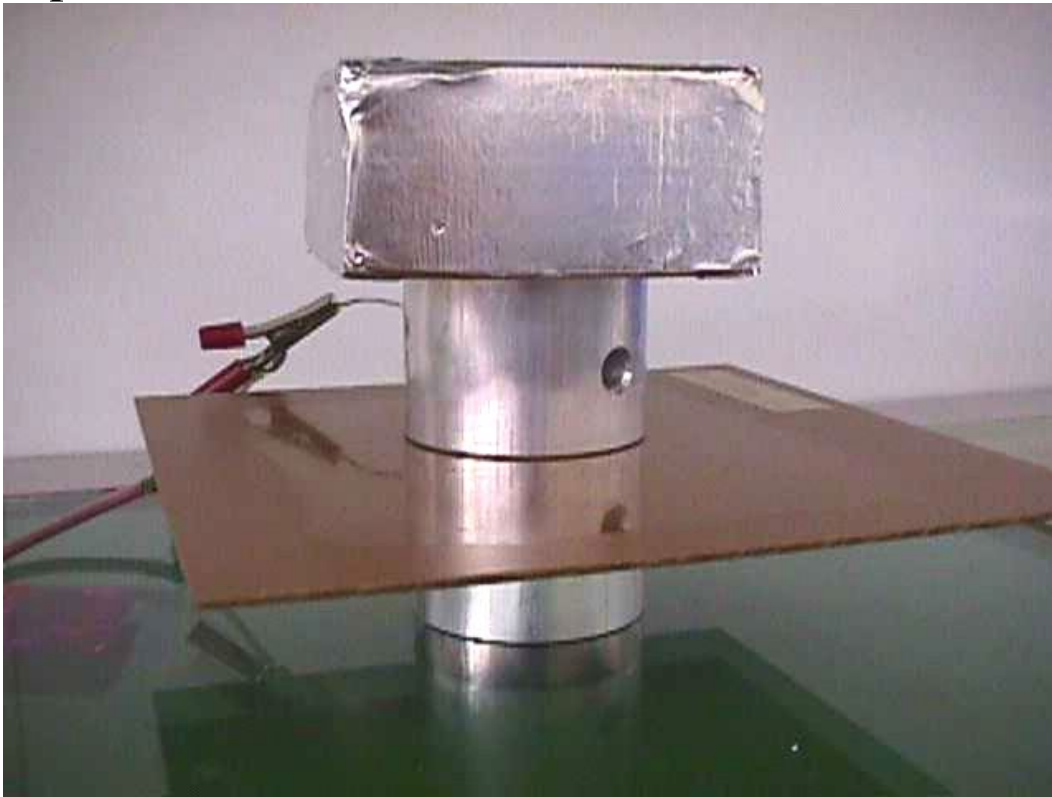
Setup to measure the Bakelite sheet volume resistivity:

- Setup is in air, which has controlled temperature.
- Linseed oil is from Orchard Hardware Store.
- Bakelite is painted with the Linseed oil.
- There is no graphite paint on the Bakelite.
- Electrodes are made from aluminum.
- All time histories were obtained under a “current on” condition.
- Voltage across the Bakelite is -1000V.
- Bakelite has NO graphite !!

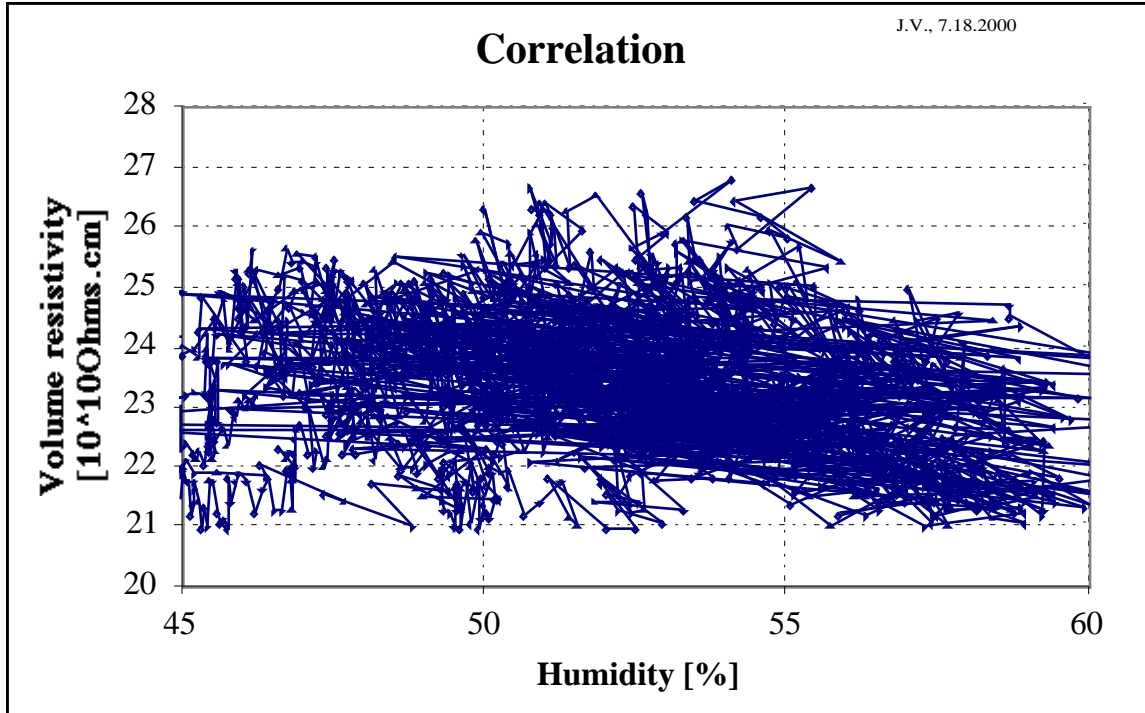
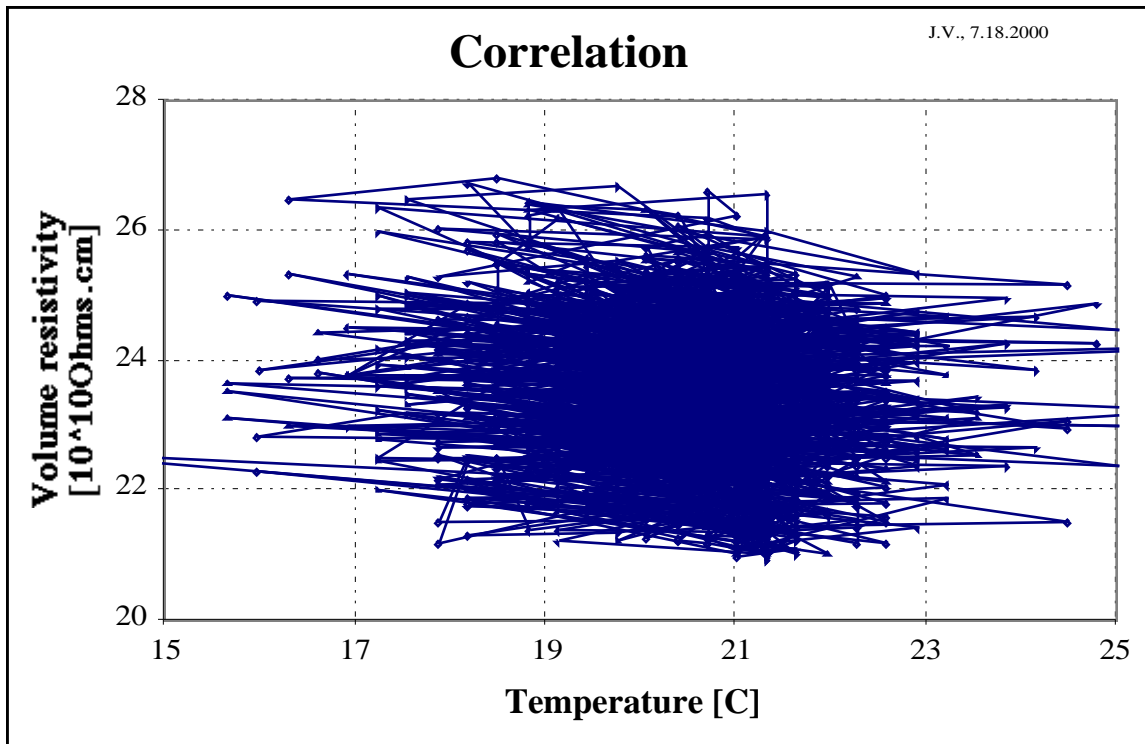
1. A long term behavior of the volume resistance of the Bakelite sheet, covered with Linseed oil, at room temperature and humidity (samples are outside oven in this particular test):

- Volume resistance of Bakelite did not change after ~ 0.3 C, while at room temperature.

- Volume resistance of Bakelite sheet, covered by Linseed oil, seems to correlate more strongly with humidity. Based on later measurements, this is due to Linseed oil.

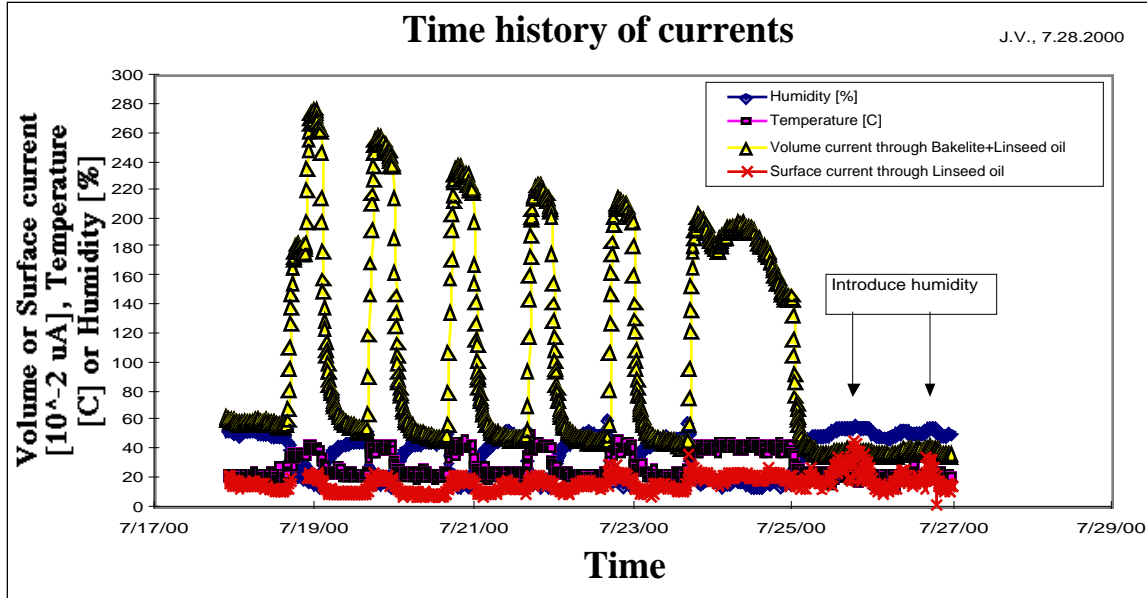
2. $\rho_{\text{Volume}}(\text{Bakelite+Linseed oil})$ & $\rho_{\text{Surface}}(\text{Linseed oil})$
= f (Time, Temperature - vary, Humidity):

- Cycle temperature in the oven between 20 and 40°C. The Bakelite volume resistance increased by a factor of ~2.

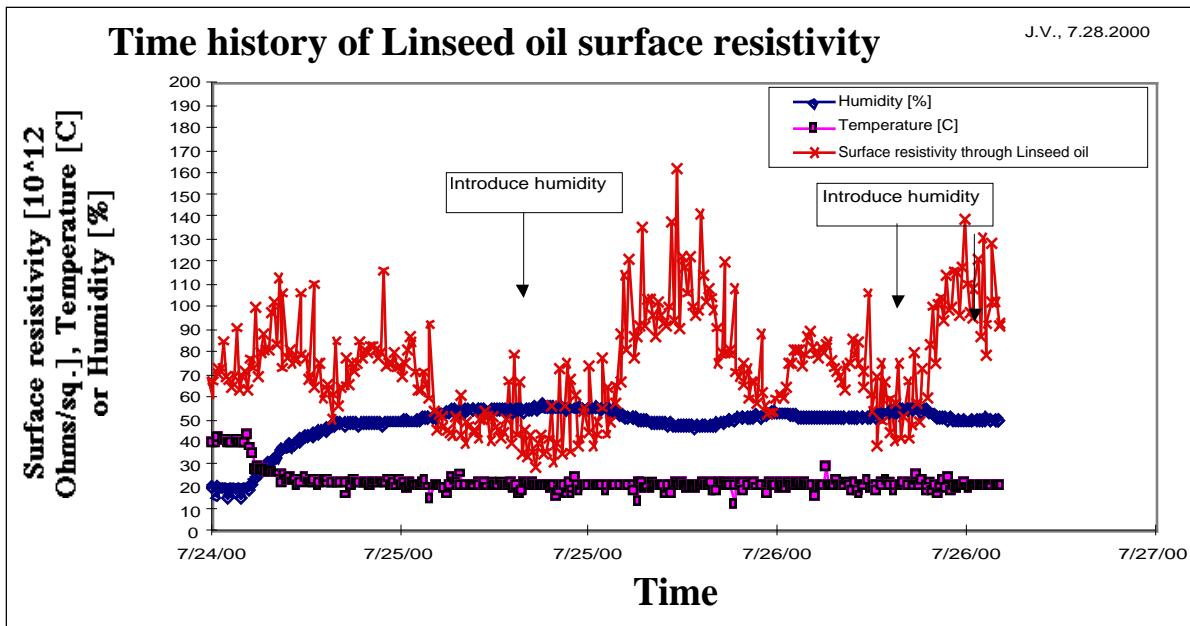
3. ρ_{Volume} (Bakelite + Linseed oil) & ρ_{Surface} (Linseed oil) = f (Time, Temperature, Humidity - vary):

- One can generate a factor of 2-3 reduction in the surface resistance by introducing a humid air (a change of ~5% rel. humidity) from outside of the Linseed oil surface. It recovers to original value after the humidity is removed.

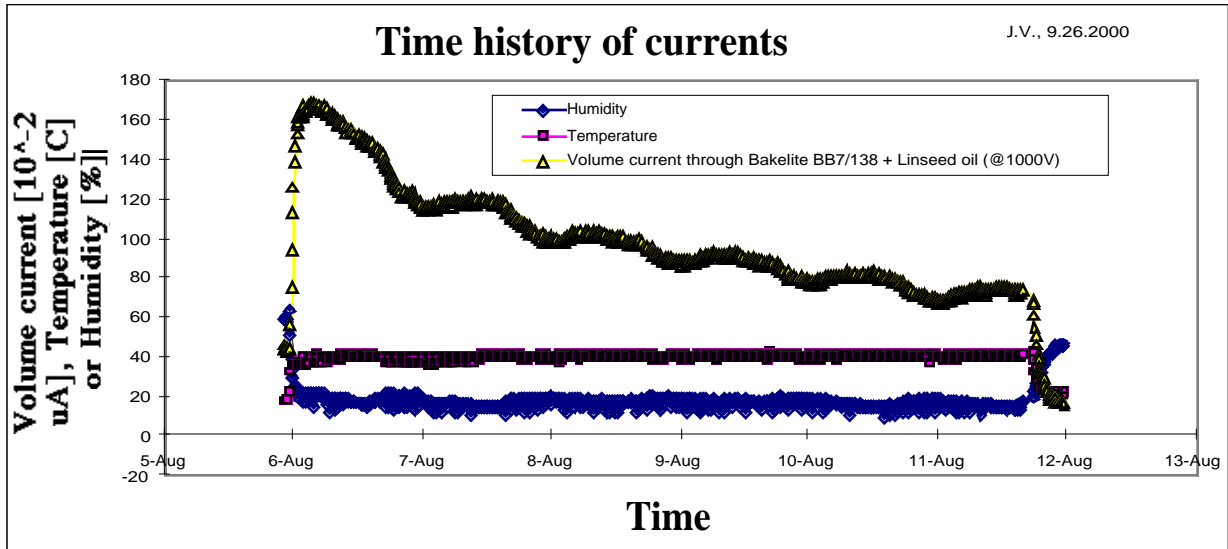
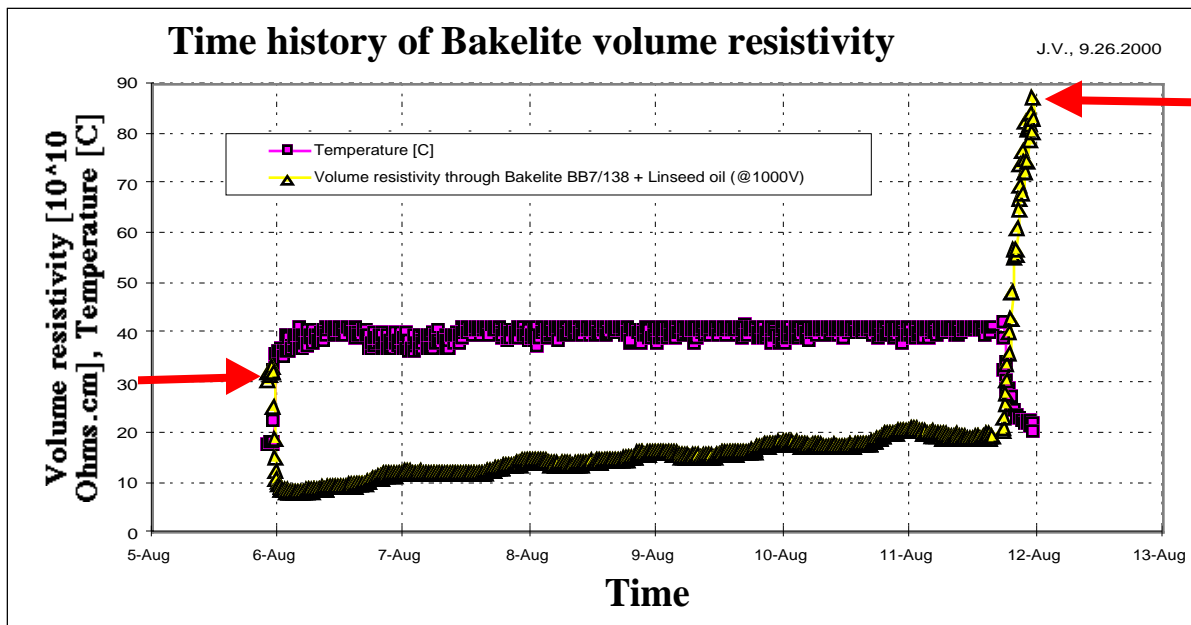
4. $\rho_{\text{Volume}}(\text{Bakelite} + \text{Linseed oil}) =$
 $= f(\text{Time, Temperature} \sim 40^\circ\text{C, Humidity}):$

- Bakelite has no graphite on the surface !!
- Volume resistance of Bakelite, covered by the Linseed oil, increased by a factor of ~3, after ~15 mC/cm² at 40°C.

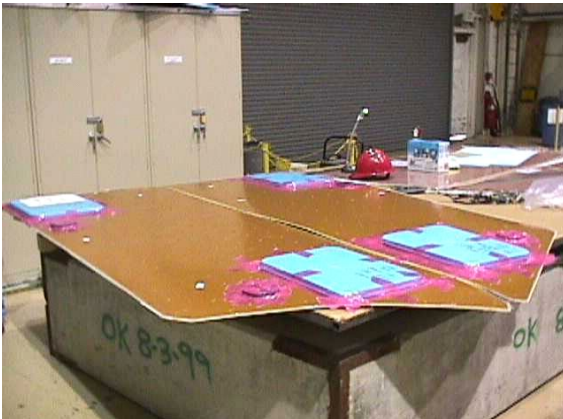
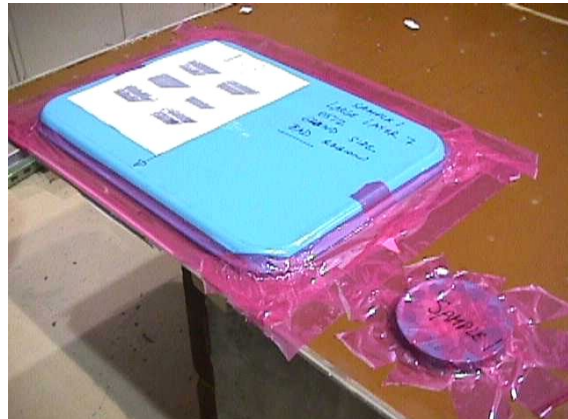
Cut four pieces altogether: (a) from anode & cathode, (b) good & bad section:

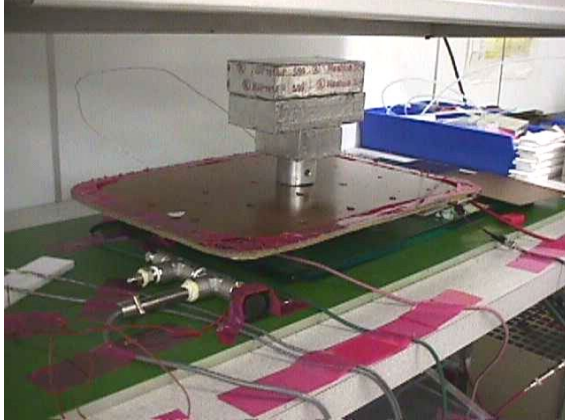
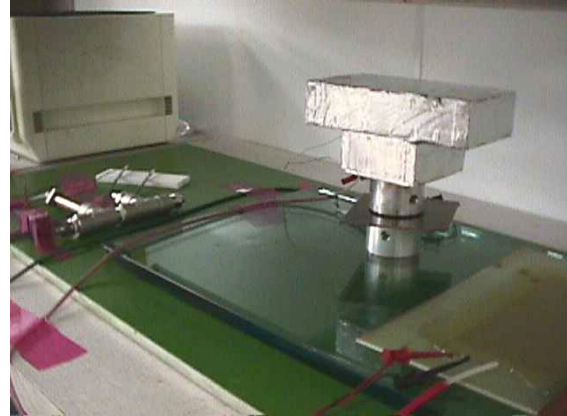
Volume resistivity setup:

RPC electrode is placed between Al electrodes, loaded by lead bricks:

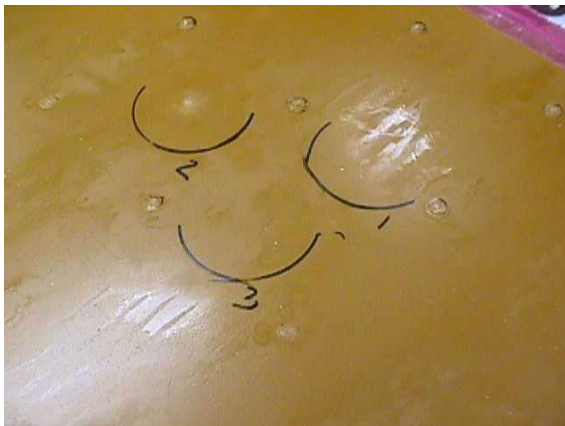
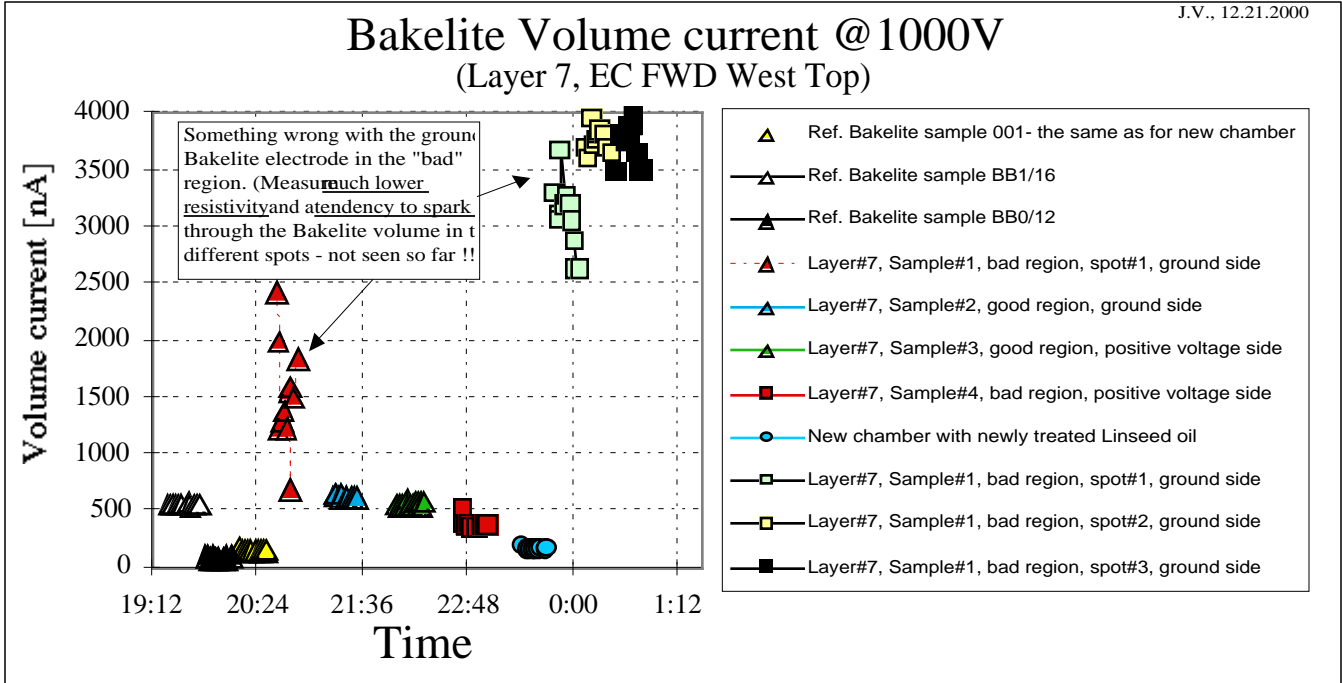
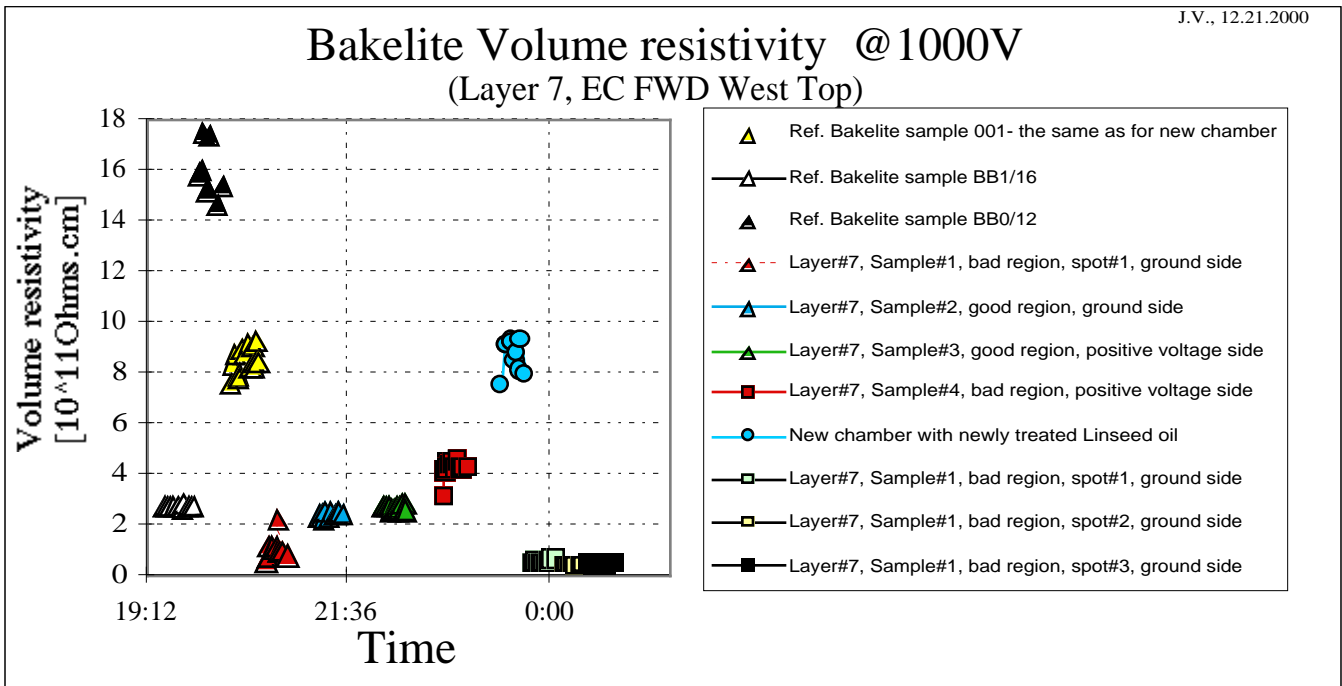
Bad electrode was measured at several different locations:

- Take always a reference run between two measurements involving a sample with the Linseed oil.
- Instability in the current of the sample#1 was caused by a breakdown through Bakelite at 1000Volts.

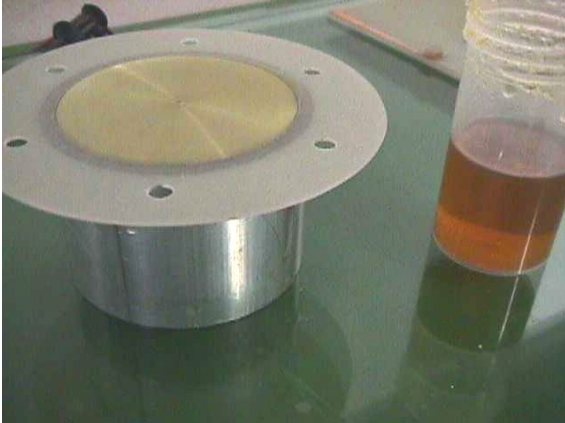
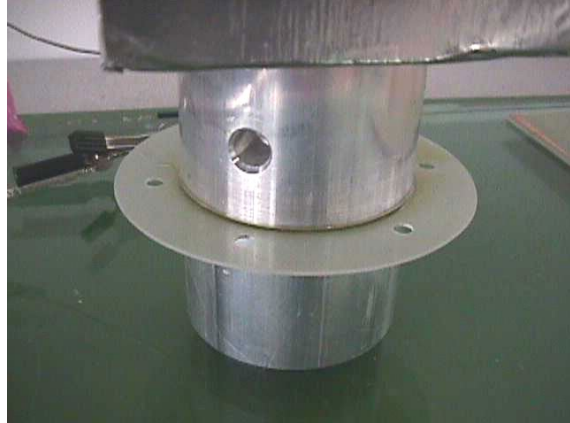
1) Measurement of the fresh Italian Linseed oil:

A G-10 ring, which is glued to aluminum electrode, defines the volume of liquid. The thickness of the Linseed oil is only $\sim 0.032'' \sim 0.75\text{mm}$:

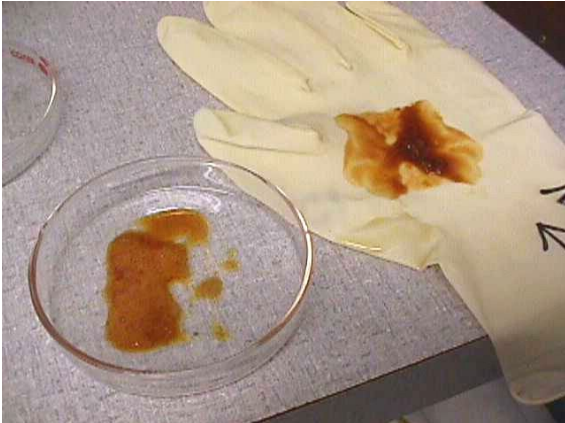
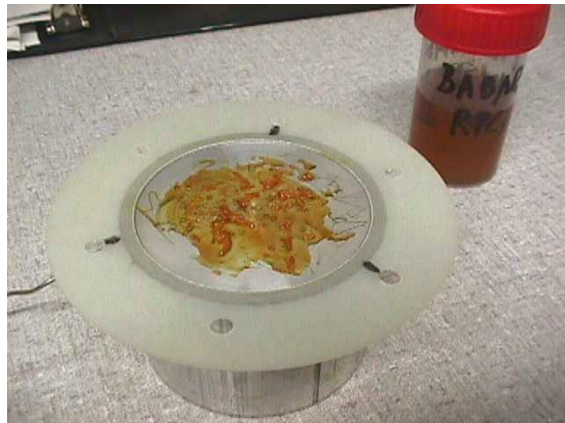
Semi-cured polymerized Linseed oil is placed on the electrodes:

Glue a G-10 ring on the aluminum electrode to create a leak-tight reservoir. Fill the volume with the Linseed oil up to the rim to ensure a good contact with the top electrode.

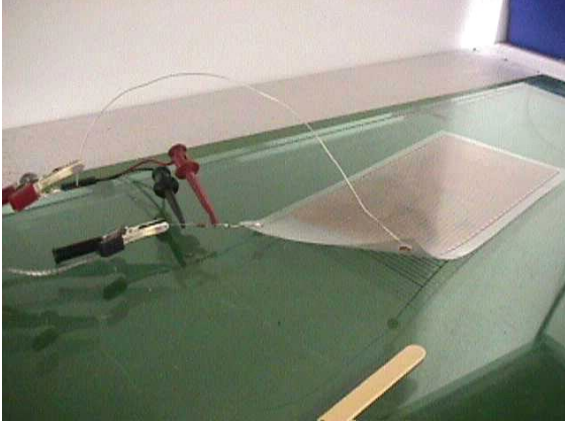
Surface resistivity setup:

Mylar pattern is placed on the RPC electrode and loaded by weight for good adhesion:

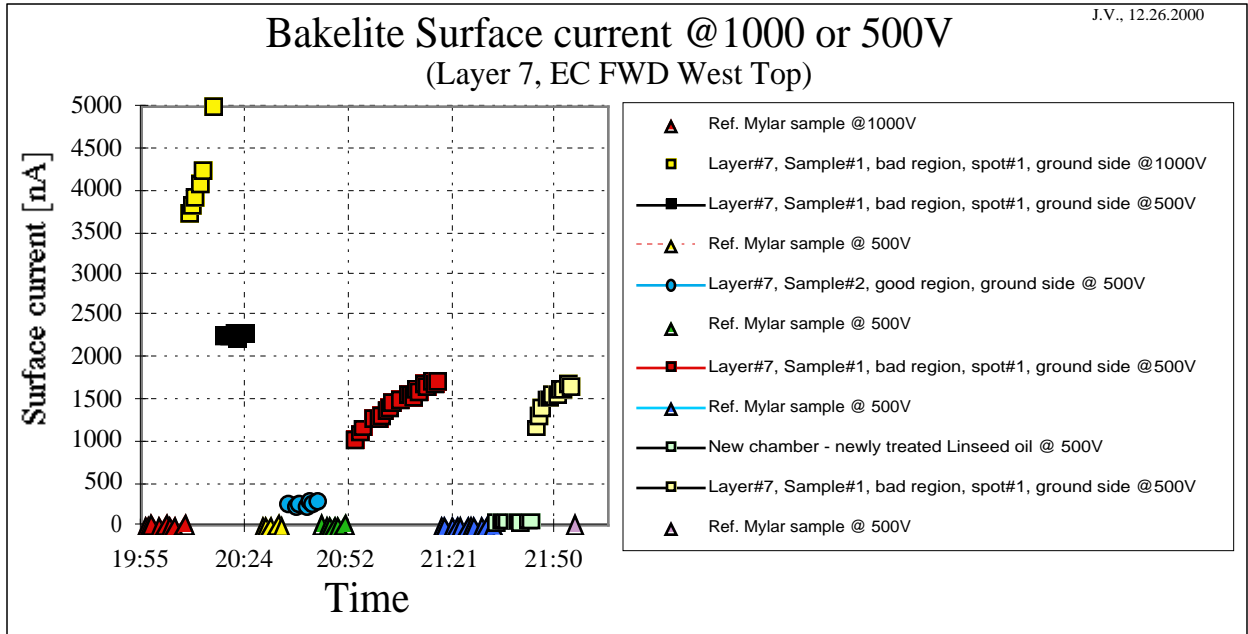
Press the copper finger side of the Mylar sheet towards the RPC electrode surface. Remove any bump on the electrode's surface and load it with a weight.

Always take a reference run between two measurements with samples involving the Linseed oil. To do this, peel off the Mylar foil from the Linseed oil (this was already enough to measure a negligible current).

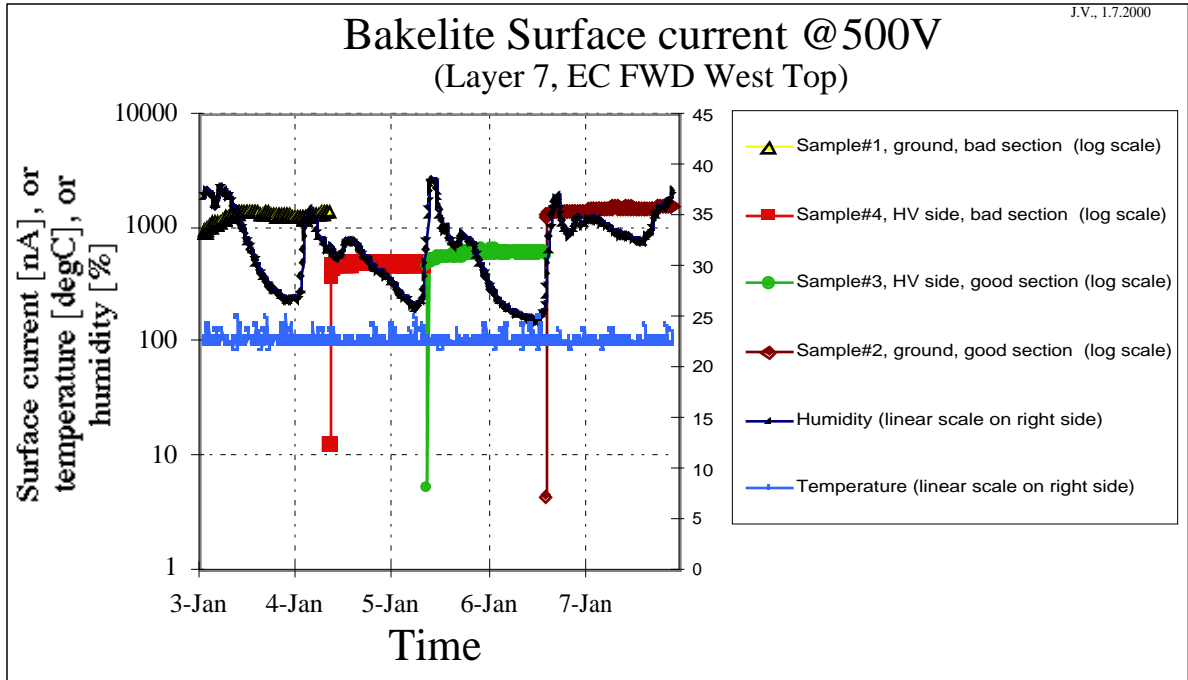
A long term test of the surface resistance of the Bakelite piece from the bad section of the Layer 7. There seems to be a systematic shift in the surface resistance.

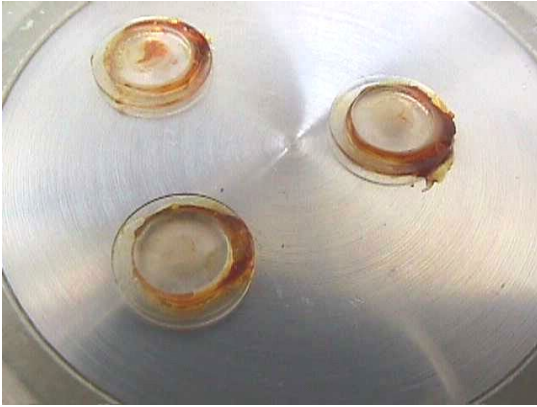
3 buttons from a "bad" section of RPC:

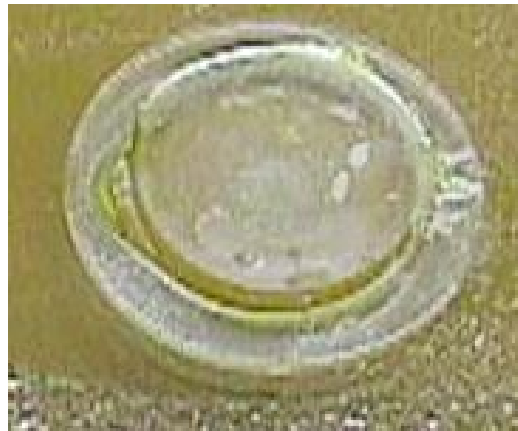
1) A button from a "good" section:

- Resistance of one such button: $R=3 \times V/I \sim 5.6 \times 10^{10} \Omega$

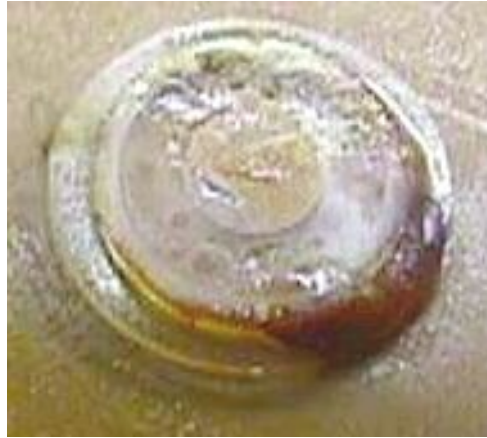
2) A button from a “bad” section:

- Linseed oil from the “bad” section is much darker
- Resistance of one such button: $R=3xV/I \sim 3.5 \times 10^8 \Omega$!!!!

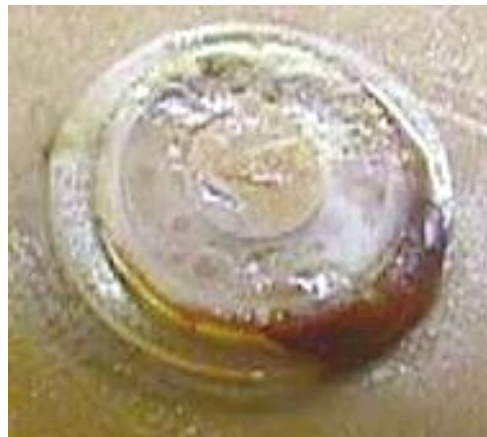
Buttons are shorted by a “gui” Linseed oil:

A button is shorted by the “brown gui Linseed oil blob”:

$$R_{\text{Bakelite}} = \rho_V (t_{\text{gap}} / \text{Area}) \sim 2.5 \times 10^{11} \Omega \cdot \text{cm} \times (0.2\text{cm}/100\text{cm}^2) \sim 5 \times 10^8 \Omega$$

\Rightarrow The chamber may not work with such buttons.

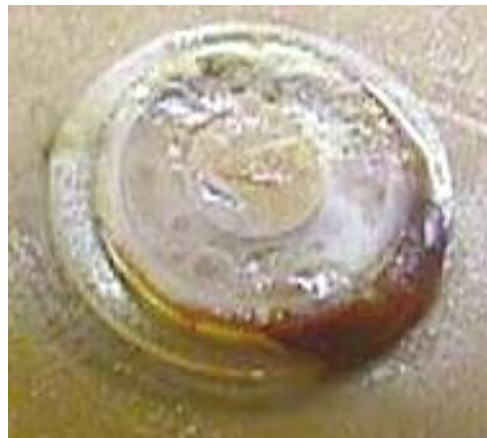
3) Once we get to such low button resistance range, a factor of 2-3 change of Bakelite resistance does indeed matter:

A button is shorted by the “brown gui Linseed oil blob” and the Bakelite resistance changed by a factor of 3x:

$$R_{\text{Bakelite}} = \rho_V (t_{\text{gap}} / \text{Area}) \sim \mathbf{3 \times 2.5 \times 10^{11} \Omega \cdot \text{cm}} \times (0.2\text{cm}/100\text{cm}^2) \sim 1.5 \times 10^9 \Omega$$

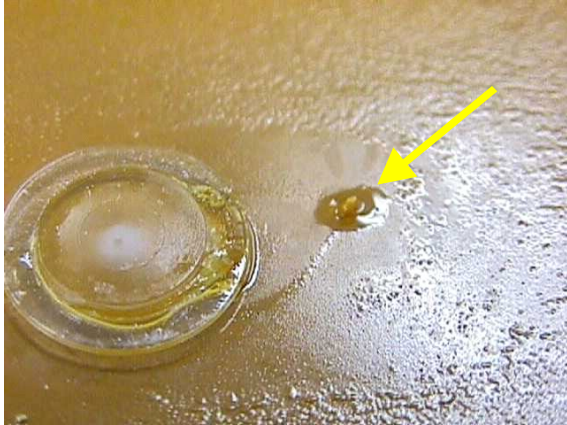
1. A sharp point, which would not go away by the acetone treatment - positive voltage electrode, bad region, sample#4.

A sharp point before acetone treatment:

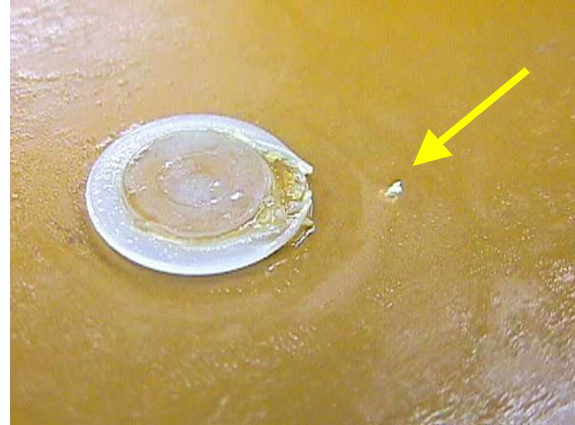
The same point after the treatment:

A piece of dust still sticks out of the surface after the treatment.

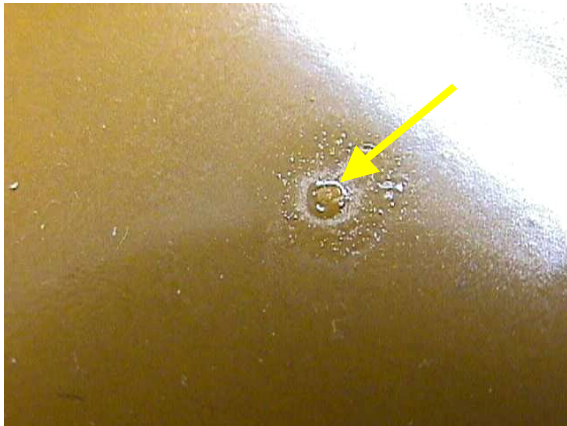
2. Sharp point, which goes away by the acetone treatment – positive voltage electrode, good region, sample#3.

A sharp point before acetone treatment:

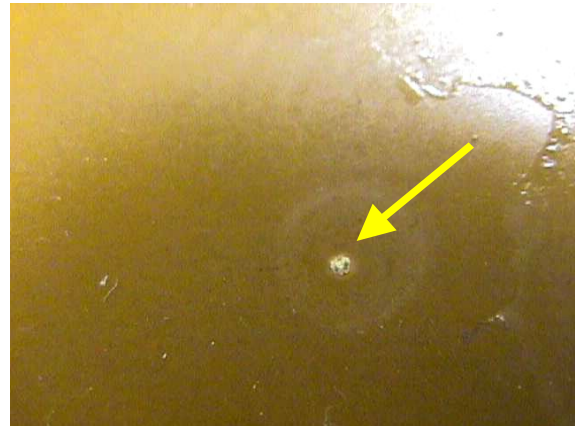
The same point after the treatment:

Linseed oil stalagmite, which was dissolved completely by the acetone, although the spot remains still visible.

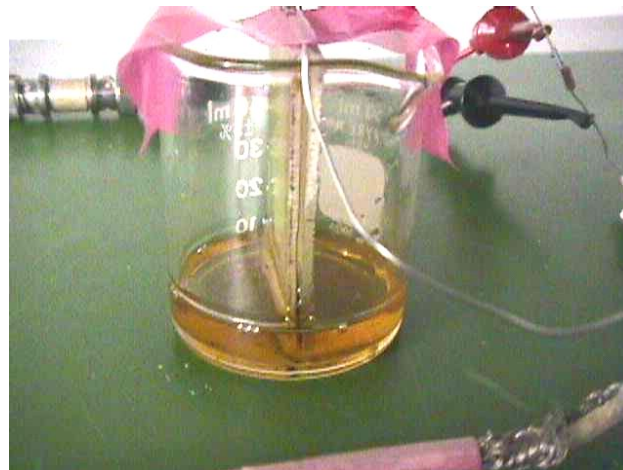
To remove a possibility that a large bubble is forming and thus separating the oil from the electrodes, I changed the setup. The metal part of the electrodes is just about submerged in oil, and there is actually a little gap just above the liquid to allow for any possible gas to escape. The electrolytic setup is shown on next picture:

Running a constant voltage of 3kV across ~1mm gap between electrodes with metal size of ~10mm x ~30mm created a current of ~16 μA . Again, I observe a steady decrease of the current as a function of time. Temperature of the experiment was kept at room temperature and was very constant throughout both measurements.

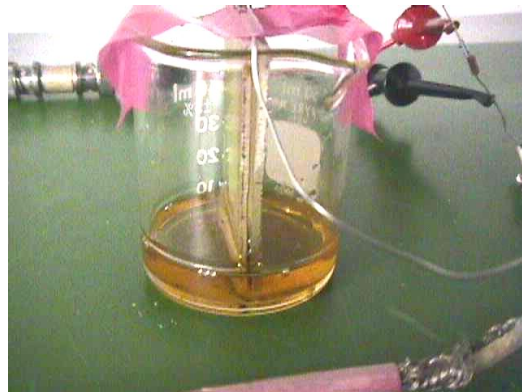
- Test #2: The Linseed oil current decays if we do not add water:

- Total charge in this experiment: ~ 11.4 Coulombs.
- Adding water sharply increases the current.
- Reversal of the voltage does not return the current to the original high value !!
- There is an evidence of an accumulation of some substance on the surface of the Linseed oil (probably related to R-COO). This substance hardens after a few months. A fresh Linseed oil does not do this.

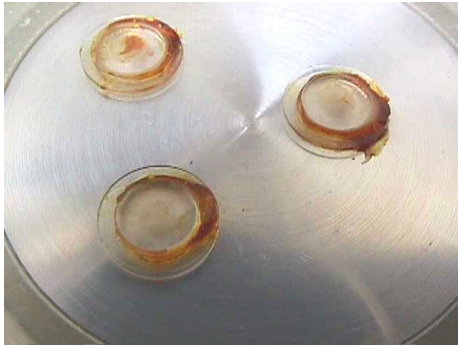
- **Test #3: Curing of the gui brown Linseed oil on the buttons from a bad region of Layer 7:**

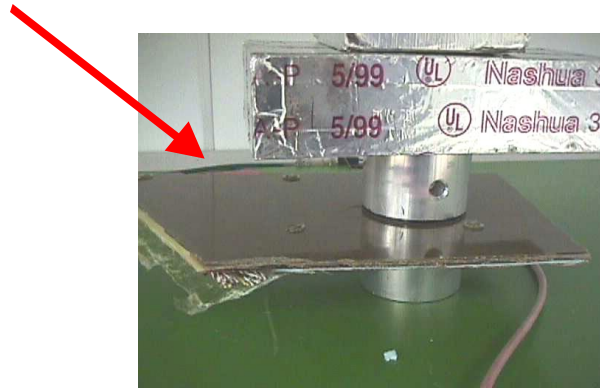
- Bakelite from the new BaBar RPC chamber (LHC equivalent).

- Total charge in this experiment: ~ 20.7 Coulombs (at 5kV).

- Total charge density is: ~ 0.63 Coulombs/cm² (test continues).

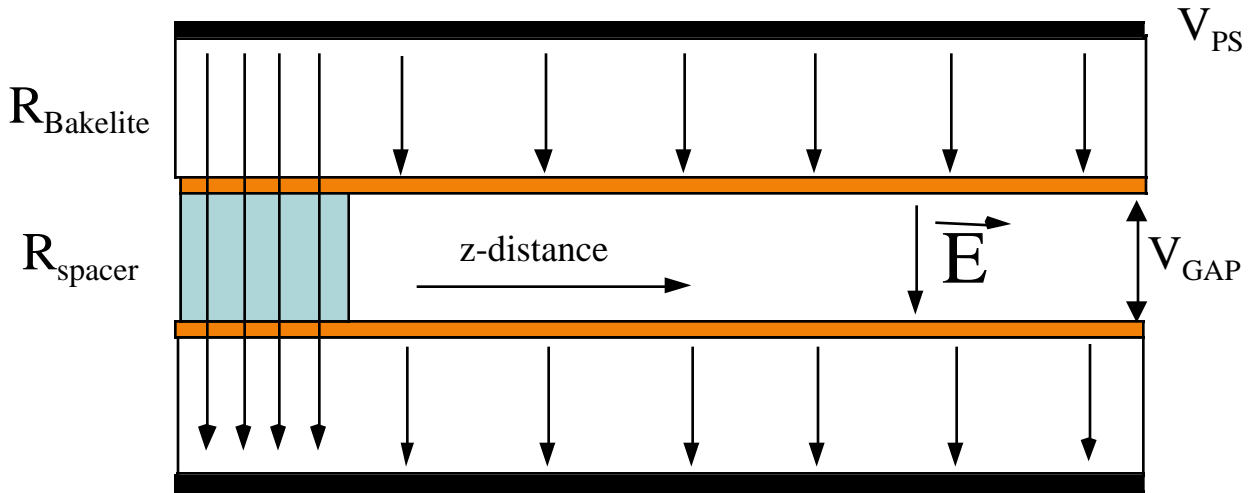
1) Good region of Layer 7:

$$V_{GAP} = V_{PS} / (1 + 2 R_{Bakelite} / R_{Lexan\ spacer}) \sim V_{PS}$$

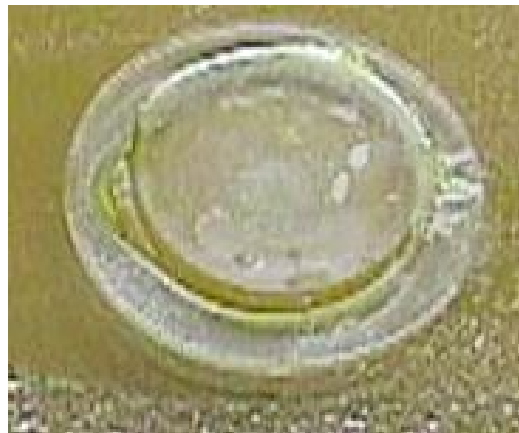
if $R_{Lexan\ spacer} \gg R_{Bakelite}$

In this case, the chamber will work OK:

$$R_{Bakelite} = \rho_V (t_{gap} / Area) \sim 2.5 \times 10^{11} \Omega \cdot cm \times (0.2cm / 100cm^2) \sim 5 \times 10^8 \Omega$$

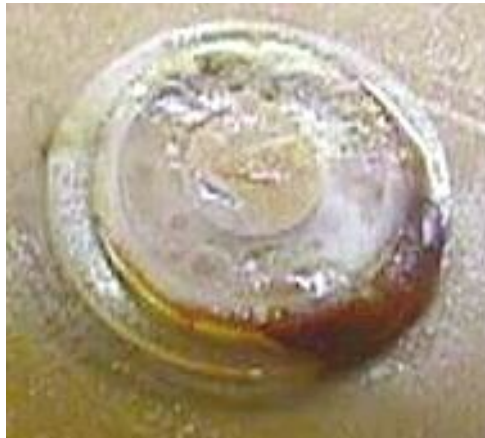
Buttons are shorted by a “gui” Linseed oil:

A button is shorted by the “brown gui Linseed oil blob”:

$$R_{\text{Bakelite}} = \rho_V (t_{\text{gap}} / \text{Area}) \sim 2.5 \times 10^{11} \Omega \cdot \text{cm} \times (0.2 \text{cm} / 100 \text{cm}^2) \sim 5 \times 10^8 \Omega$$

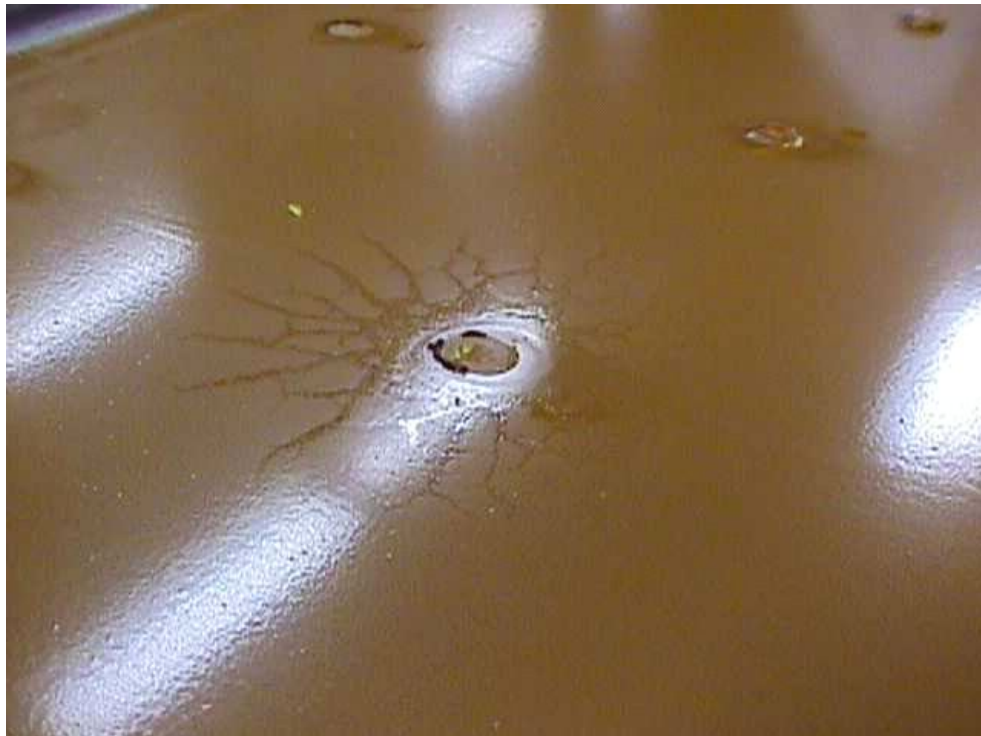
4) However, things are more complicated because it is a 3-D problem, involving the surface resistance of the Linseed oil and volume resistance of the Bakelite:
