BaBar RPC
story, from my
perspective

J. Va'vra

Content

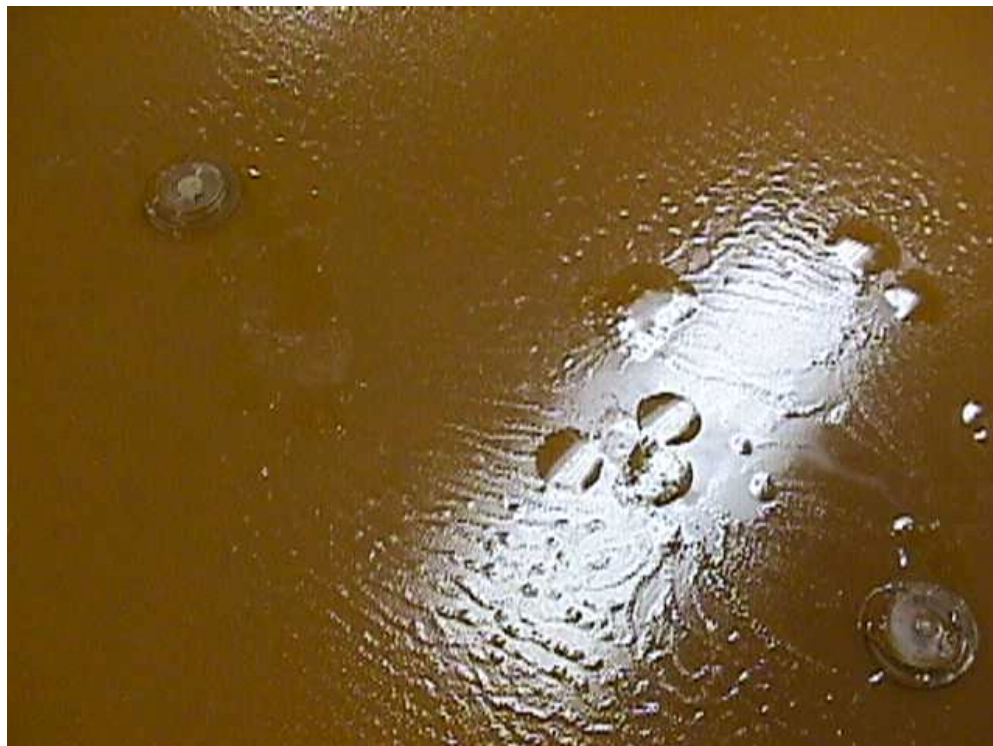
5) For example, an oil droplet creates a large distortion of the electric field, which can cause a permanent breakdown and local currents:

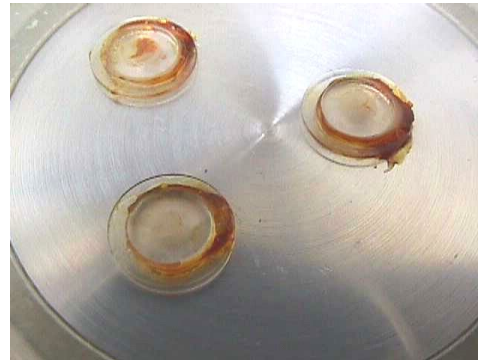
A three-button test:

Total charge:
 $\sim 0.08 \text{ C/button}$

- Typical starting current was $< 1 \mu\text{A}$, i.e., 5-20 smaller than when I did the Layer 7 buttons. After my addition of $\sim 0.08 \text{ C/button}$, the current is reduced to $\sim 0.1 \mu\text{A}$.
- Extremely bad looking surface. This must degrade efficiency.

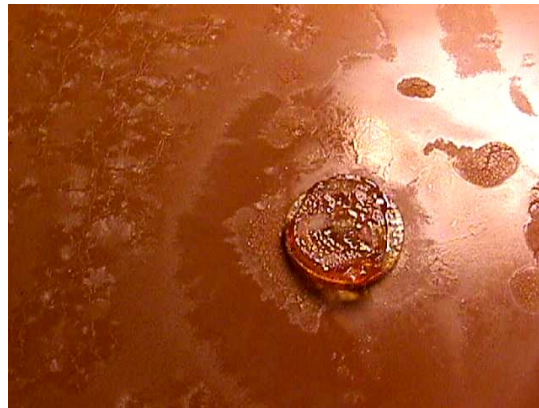
SLAC test chamber - continue:

A button is shorted by the “brown Linseed oil blob”:

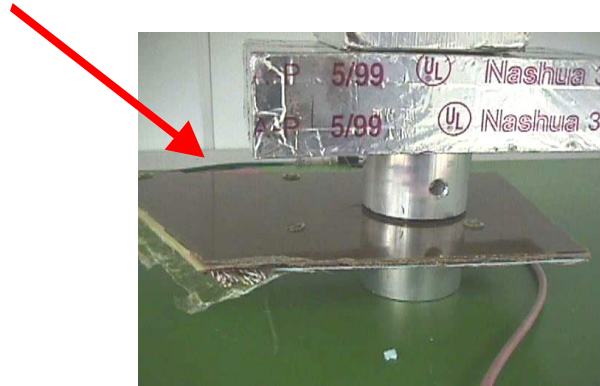
- Bakelite from the new BaBar RPC chamber with graphite layer, but without the Mylar sheet (LHC-like).

- Total charge in this experiment: ~ 24.5 Coulombs (at 5kV).
- Total charge density is: ~ 0.75 Coulombs/cm² (test continues).

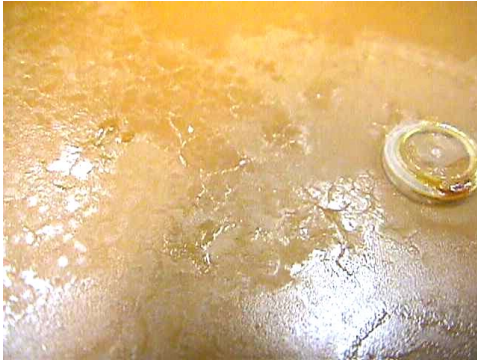
Button #1:

IFR 127 chamber (Barrel “spare”) was subject to:
the Marcello’s remediation procedure: $\epsilon \sim 5\% \rightarrow \sim 75\%$.

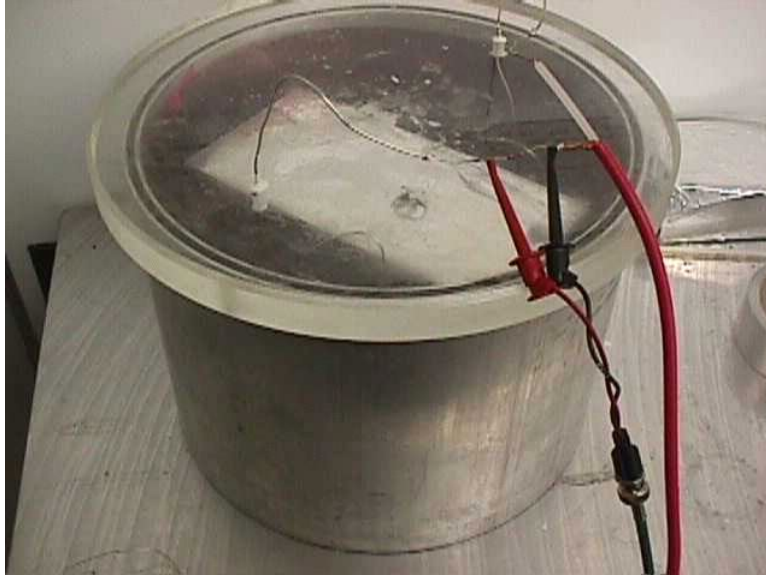
- “New Bakelite with newly treated Linseed oil” – place it in the vacuum vessel.
- Prior to the pumping, it holds $\sim 5\text{kV}$ across the Bakelite sheet.

- Pumping caused a disaster:
 - a) The Bakelite would not hold even $\sim 1\text{kV}$ while pumping.
 - b) After a few days of pumping, it would not hold $\sim 1\text{kV}$ even if one returns to air at 1 bar. This means that the Bakelite sheet is permanently damaged, probably, the pumping created micro-voids.

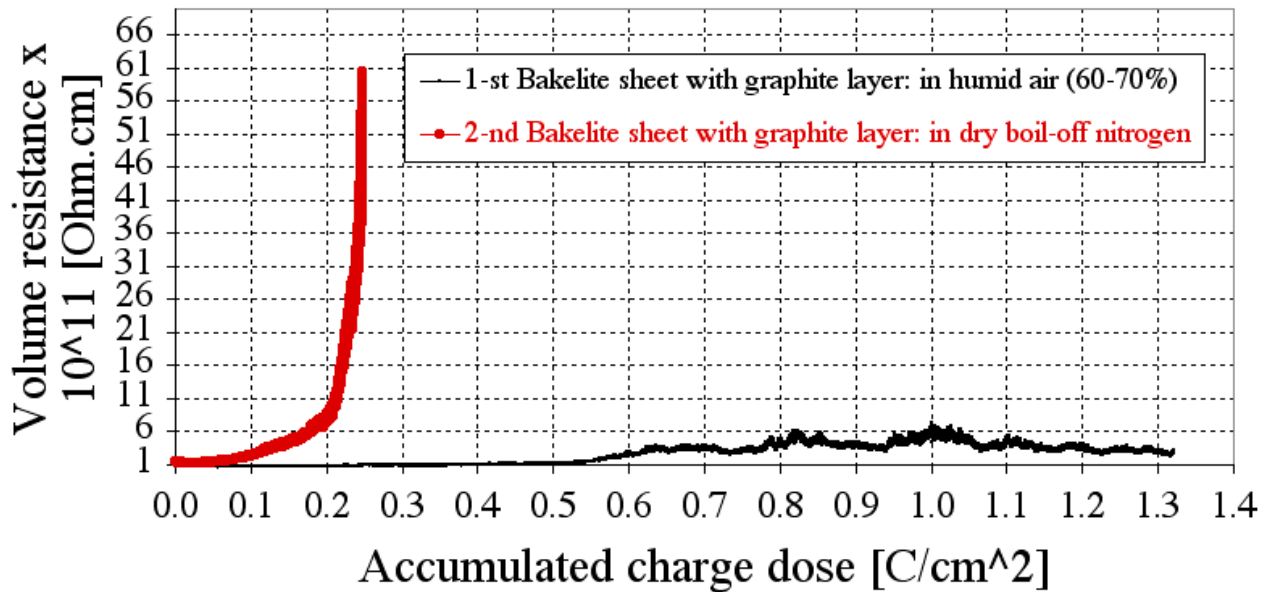
New Bakelite with the new Linseed oil treatment

- The resistance increase of the Bakelite in the dry nitrogen is much larger than that of Bakelite in the humid atmosphere.

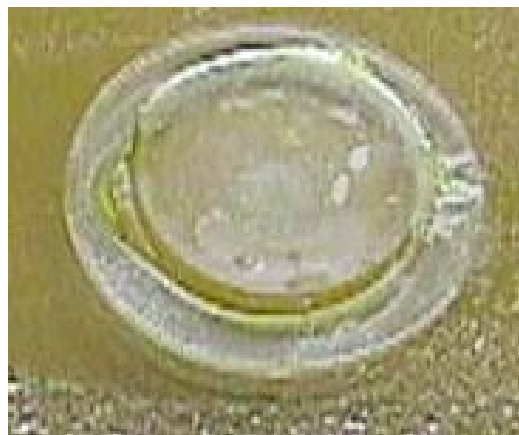
$$V_{GAP} = V_{PS} / (1 + 2 R_{Bakelite} / R_{Lexan\ spacer}) \sim V_{PS}$$

if $R_{Lexan\ spacer} \gg R_{Bakelite}$

A factor of ~60 increase in Bakelite volume resistance is bad !!!!

$$R_{Bakelite} = \rho_V (t_{gap} / Area) \sim 60 \times 2.5 \times 10^{11} \Omega \cdot \text{cm} \times (0.2\text{cm}/100\text{cm}^2) \sim 2 \times 10^{10} \Omega$$

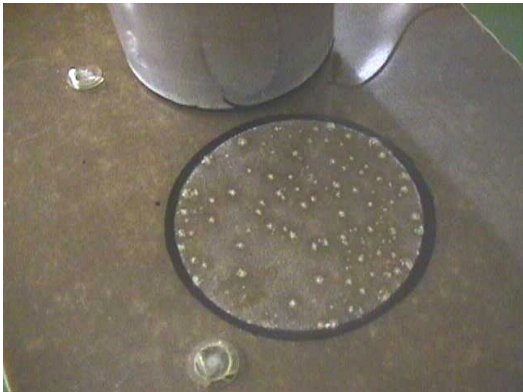
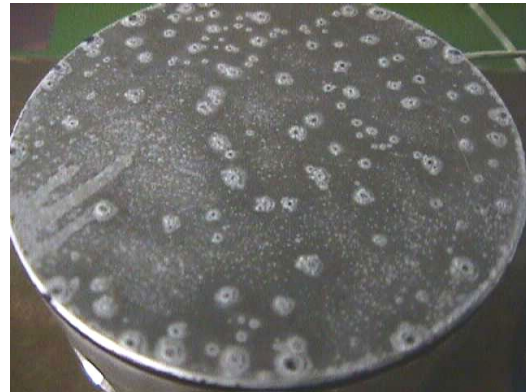
- Cathode's side of the Bakelite is full of blisters. They appear similar to what we usually identify as sparking spots. On the mating aluminum surface we see bumps, each corresponding to the Bakelite spot. The bumps seem to be clear sign of a chemical reaction with aluminum.
- Anode looks fine to me - just compressed graphite (no picture).

Cathode's side – Spots on the Bakelite surface and on the mating Aluminum electrode:

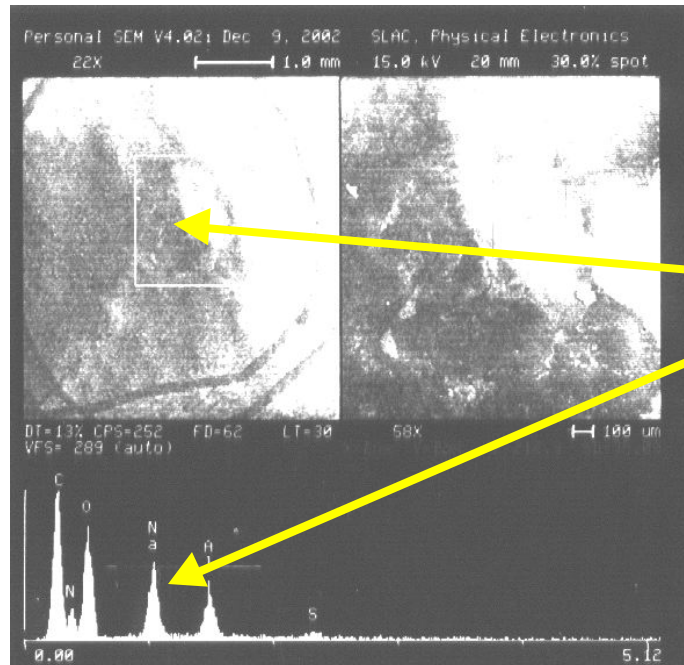
- Cathode's side of the Bakelite has also blisters. Again, they appear similar to what we usually identify as sparking spots.
- Anode looks fine to me - just compressed graphite (no picture).
