# Some Comments on Assembly and Performance of pre-series RE2/2 chambers

The 3 Chambers were received at CERN on the 2nd June 2005.

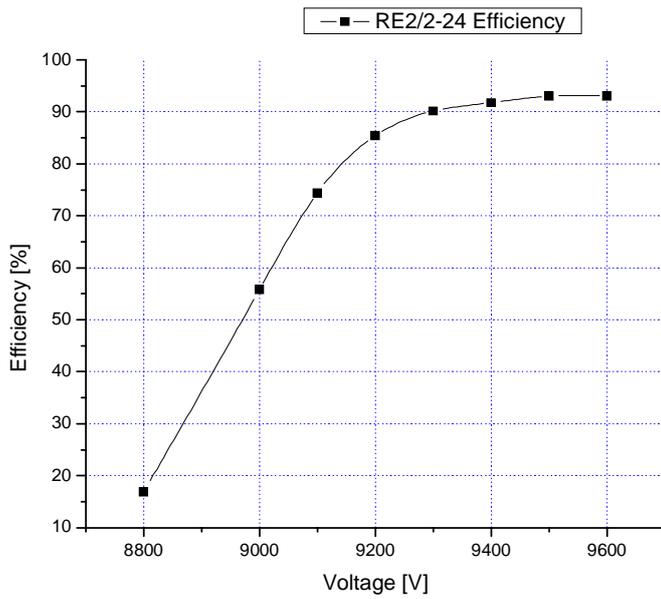
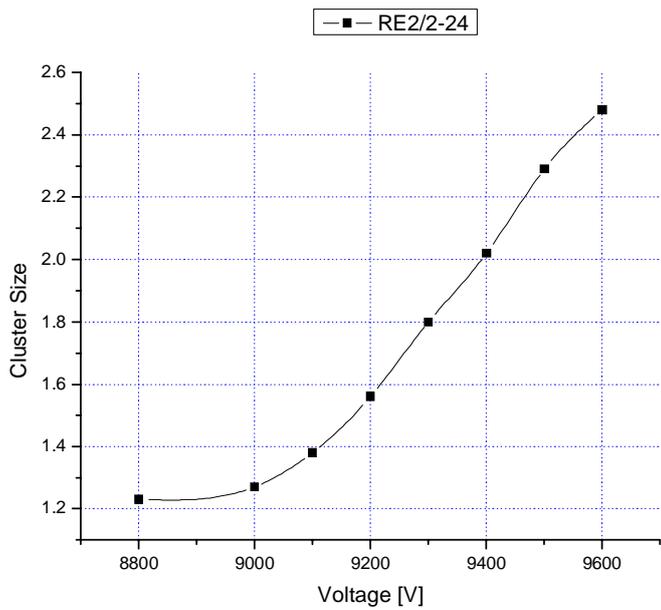
After some corrections and improvements of grounds in preparation for the cosmic stand we can report that the RE22 chamber number 24, is at least 92-93%.efficient The low value may be due to geometrical acceptance which has been optimized for RE1/2 and RE1/3. Overall, the chamber is fine and behaves just like any RE1 chamber. Some plots are shown below. Strips 32 and 64 (edges) are noisy, as is the case of RE1 and RB chambers.

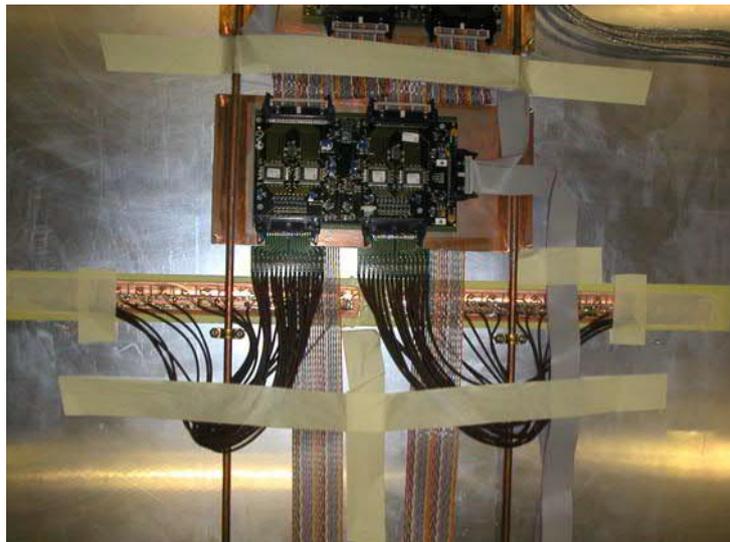
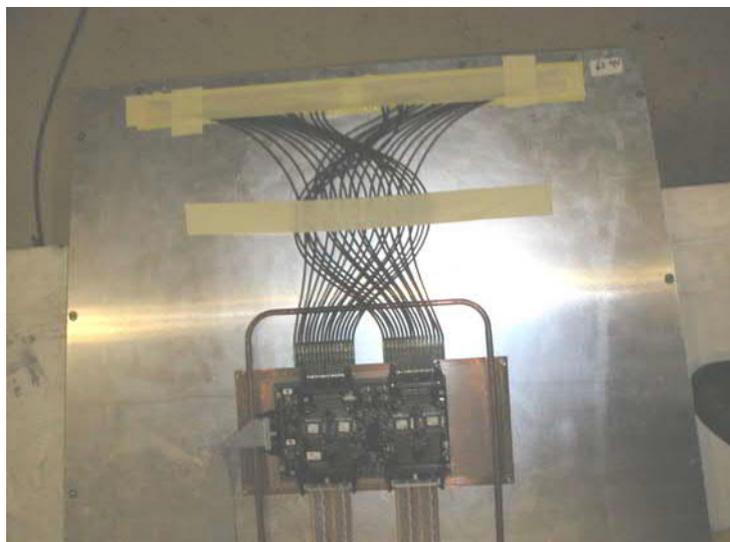
We recommend revisiting the routing to obtain a more repeatable result as illustrated below on these RE1 chambers.

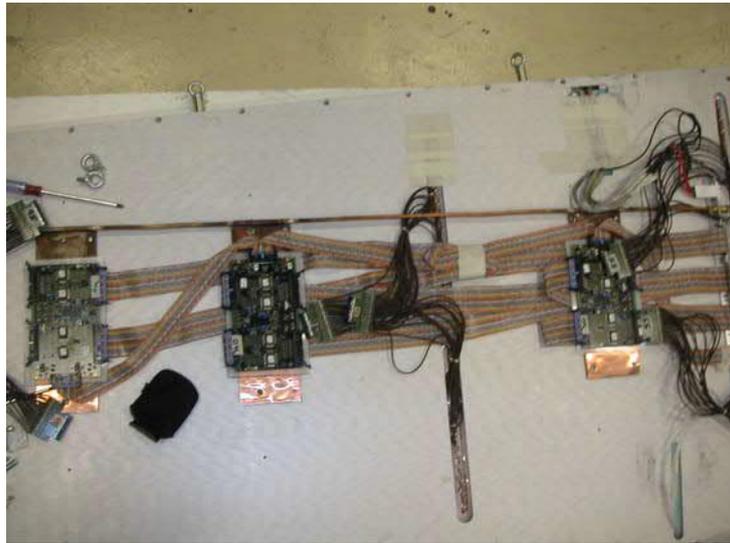
The placement of the FEB can be offset in phi so as to obtain parallel paths for the flat cables with no crossover and little excess length. This is the reason why the Cu cooling plates are so ‘wide’ in phi.

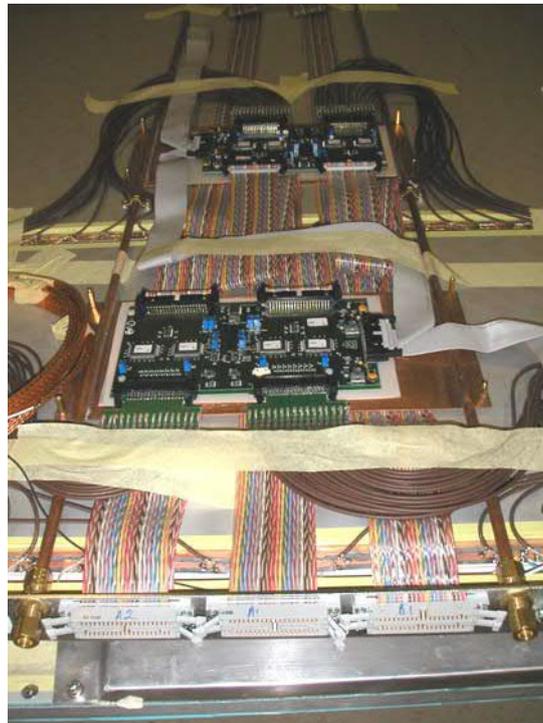
Here the cables run parallel with no crossing and only 2 thicknesses under the Cu cooling plates.

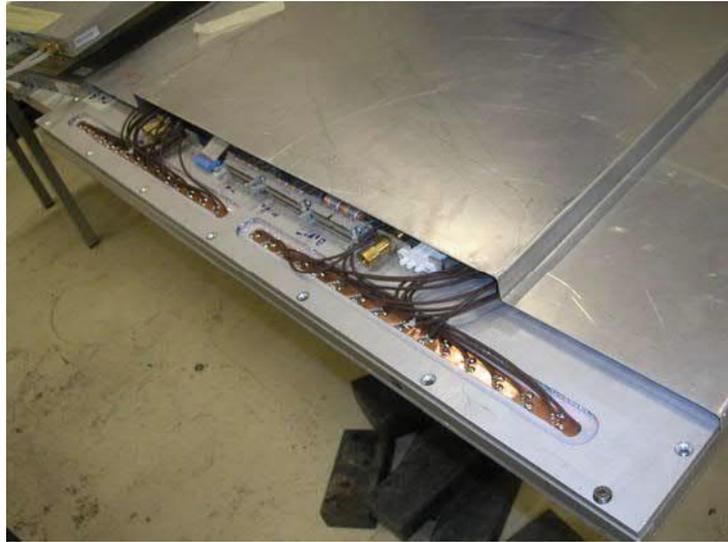
Clearly at this high 'R' side we must face the patch panel termination on RE2/3.

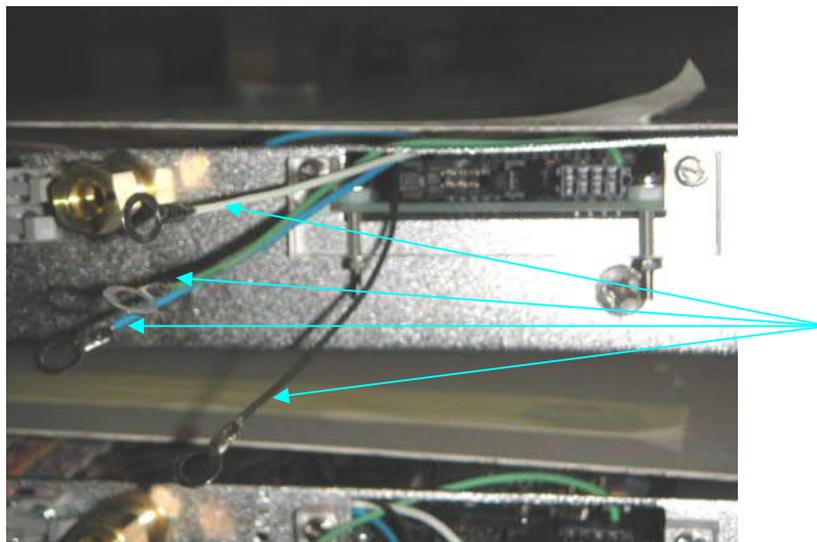
Introduced this year, separate leads from the following must be taken out to the patch panel;

1	Farady cage/sig ref	Blue
2	0V (-ve) of LV	Green
3	HV 0V	Black
4	HV shield	white

The final connection of these will be determined by trial and error as a function of ground loops generating noise, although today in the Cosmic stand all of them are connected, including the lab ground.

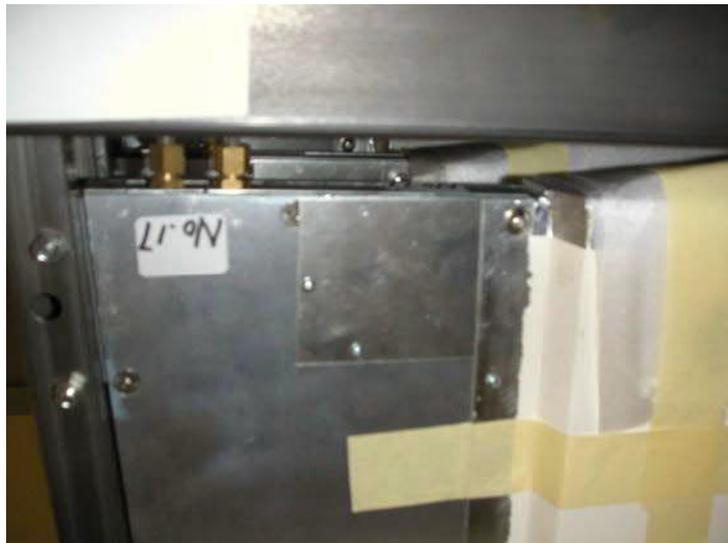
In the case of RE1 the areas of coaxial cabling outside the shield box have been covered with 0.5mm alu sheet. Secured by self tapping screws 2.9 x 4.5
