# **Some Comments on Assembly and Performance of pre-series RE2/2 chambers**

With input and comments from colleagues in the ISR lab and PH-CMM

The 3 Chambers were received at CERN on the 2nd June 2005.

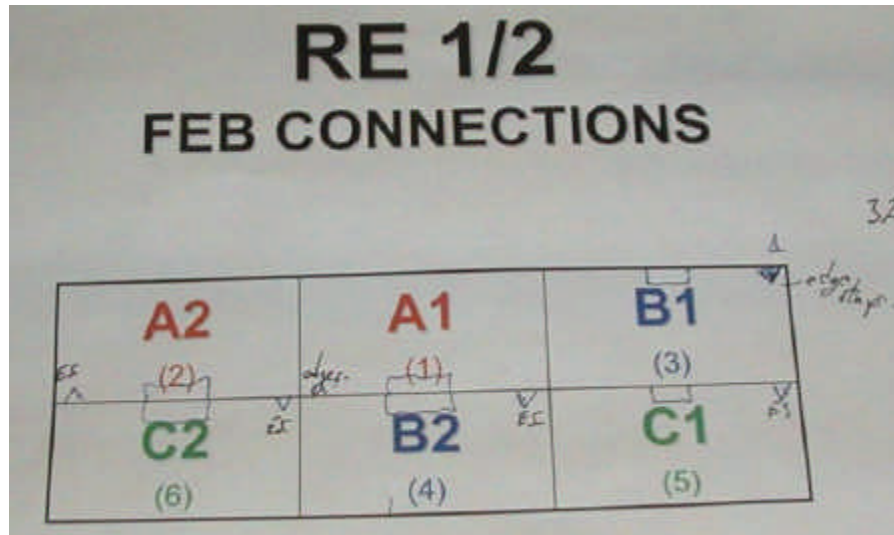
The routing of the flat cables is not trivial and if at all possible must agree with those chambers already made, namely RE1. This is necessary as the read out is entirely dependant upon the cable routing and consequent connector layout on the patch panel.

The diagram of connector to FEB allocation should be kept in mind.

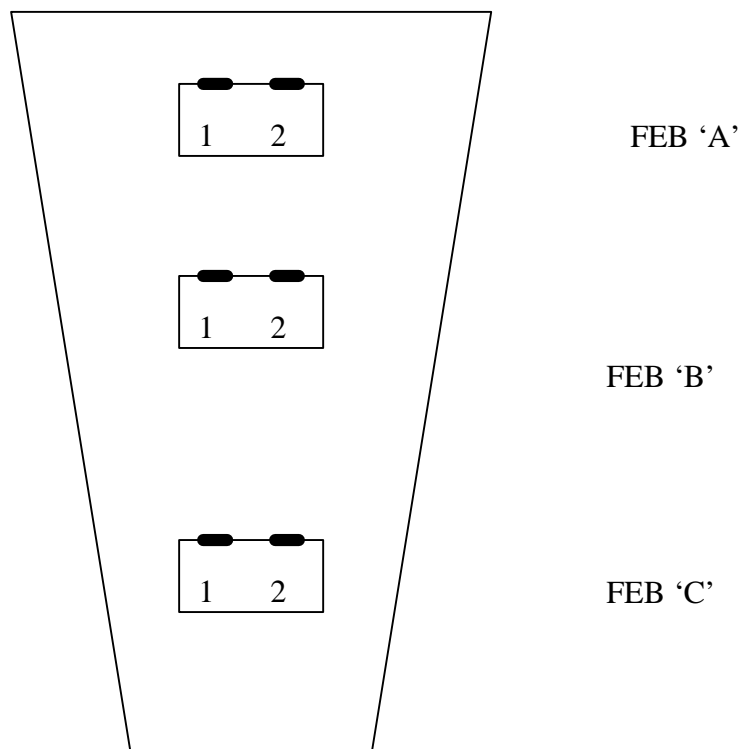
### Chamber FEB layout

As viewed from the front face of the chamber in all cases inc RE1 and RE2

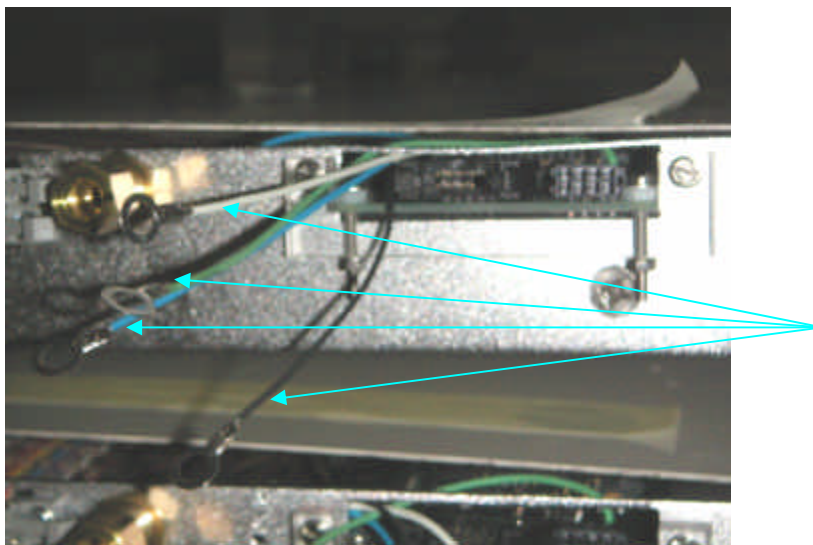
1	Farady cage/sig ref	Blue
2	0V (-ve) of LV	Green
3	HV 0V	Black
4	HV shield	white

The final connection of these will be determined by trial and error as a function of ground loops generating noise, although today in the Cosmic stand all of them are connected, including the lab ground.
