Report of Jan 23

ME+1/1/13

Chamber extraction

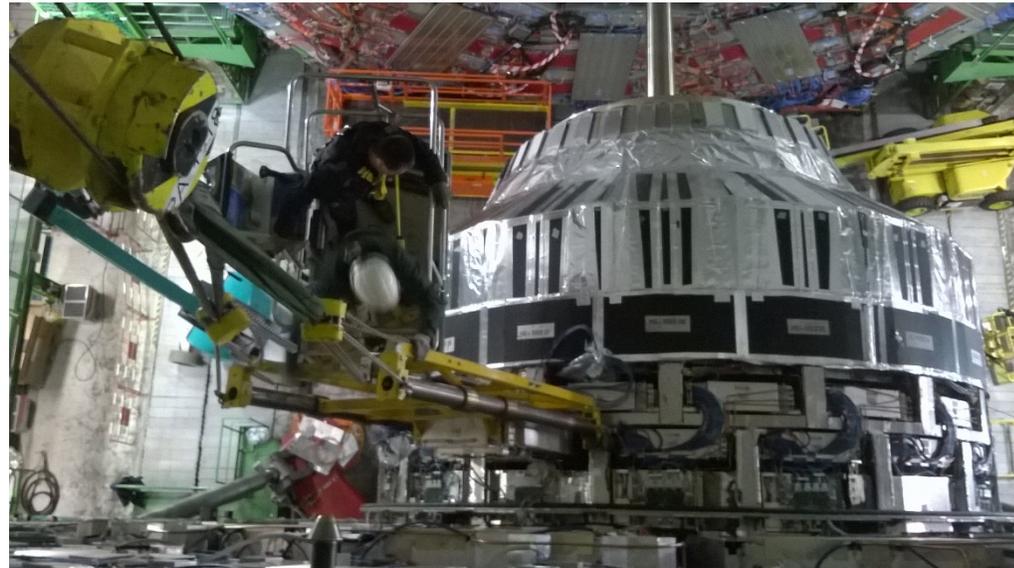
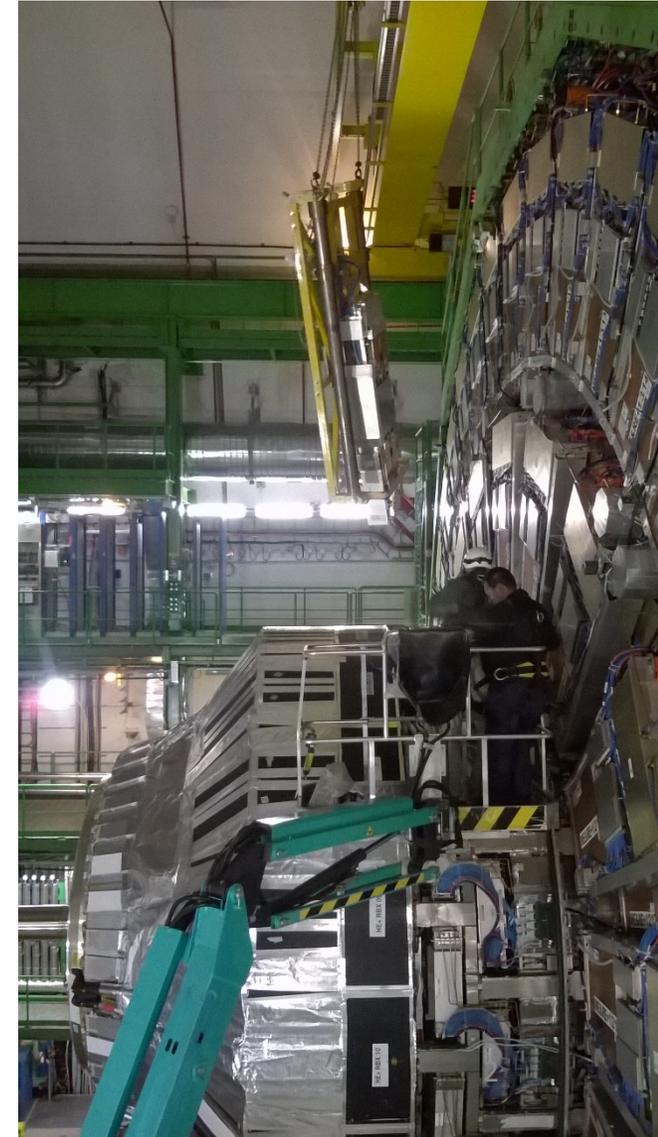
23/01/2016

Chamber on the floor of UXC55

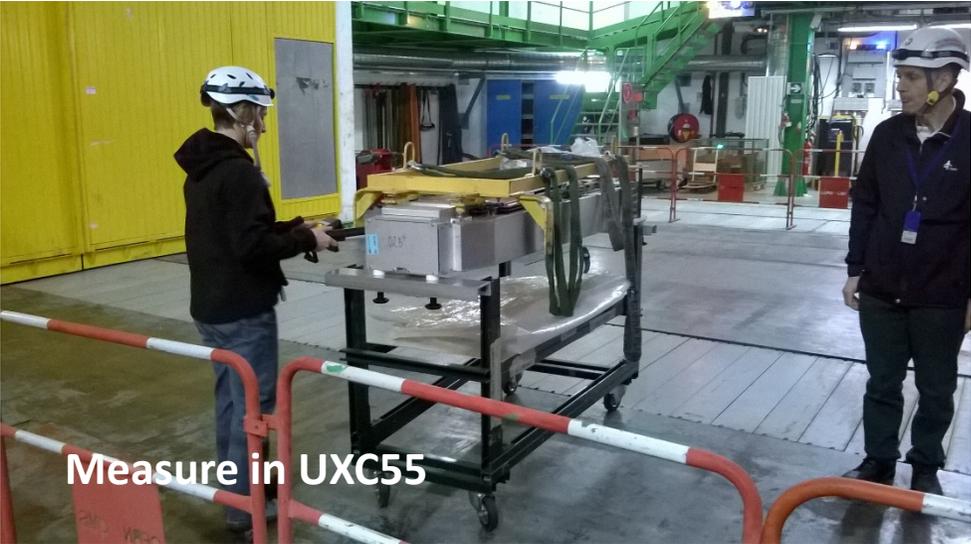
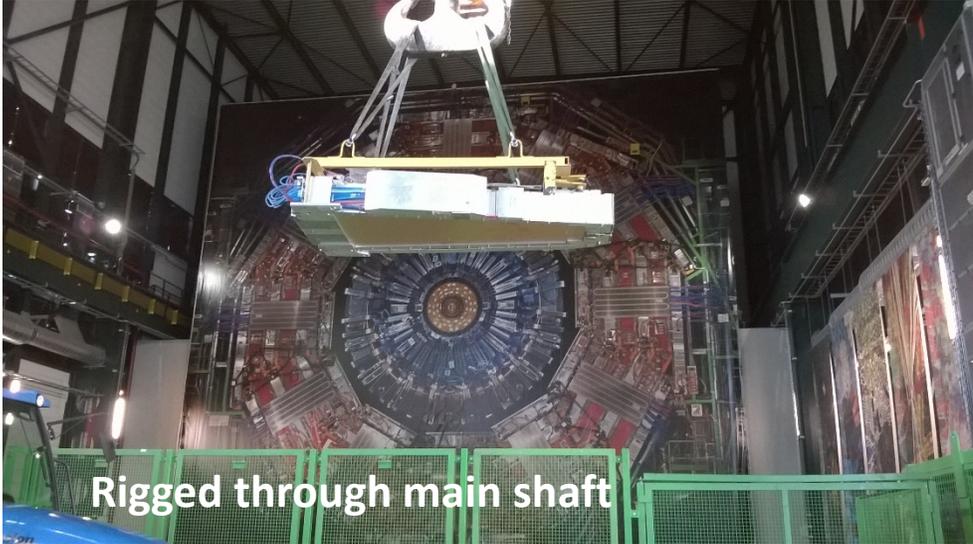
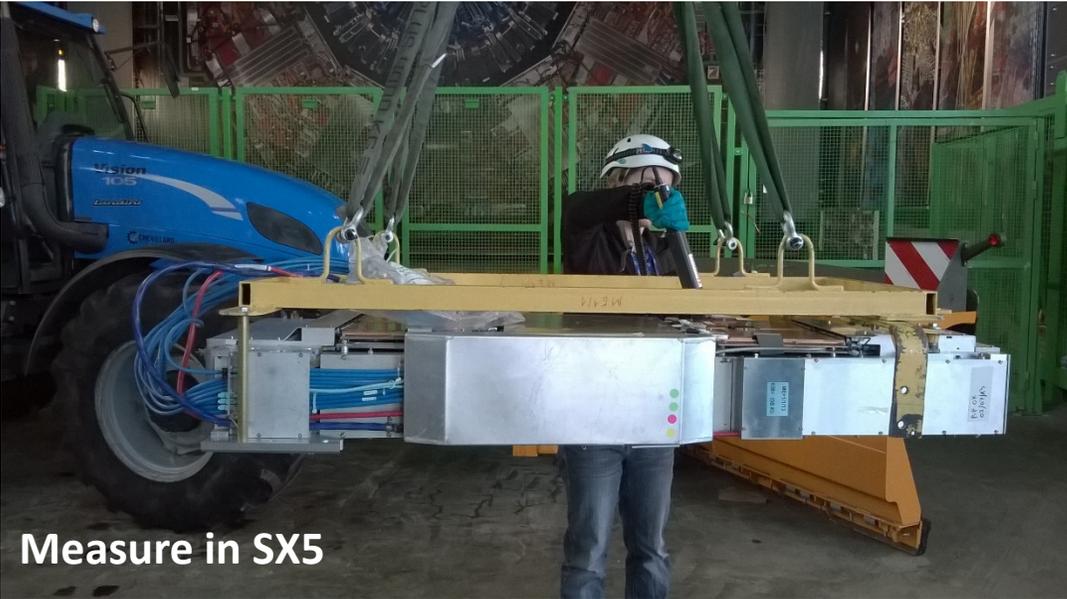
RP measurement and rigging to SX5 via PM56 shaft

11AM Rad levels are comparable to background contamination in UXC55. Chamber can be moved to ME1/1 lab area and disassembled
