# EXPERIENCE WITH LONG TERM OPERATION WITH DEMINERALIZED WATER SYSTEMS AT DAANE

L. Pellegrino, LNF – INFN, Frascati (Roma) - Italia

During eight years operation of the DAANE water cooling system some critical situations have been successfully managed by upgrading the demineralized water system. The collected data and the experience gained in the field of copper corrosion and related water treatment are critically revised.

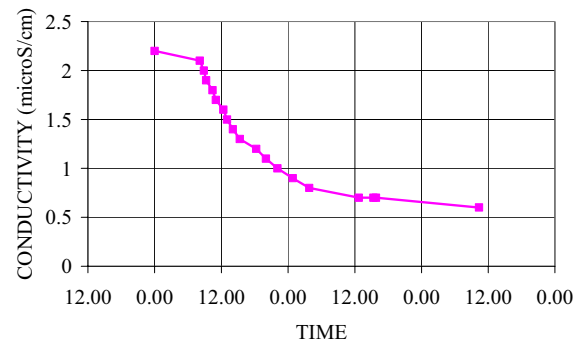
Figure 2: water conductivity vs. time after a shut-down.

Reduced polishing stage efficiency during accelerator operation produces a fast increase of the circulating water conductivity, some 0.1 µS/cm in few days. Because we experienced failure as those reported in the next chapter when conductivity rise towards 1 µS/cm, the main maintenance threshold is set to 0.5 µS/cm. Before reaching this stage, the replacement of bottles has to be done.

The time of recovery is quite long, as reported in figure 2, so the full stop, leading in few days to conductivity of more than 2 µS/cm, is limited only to

the case of scheduled long pauses for major accelerator improvements or new experiments set up.
