CERN  
CH1211 Geneva 23  
Switzerland

EDMS NO.  
**2720844**

Date: 26/03/2022

# Microscopy inspection of white residue found on different samples from CMS RPC gas system

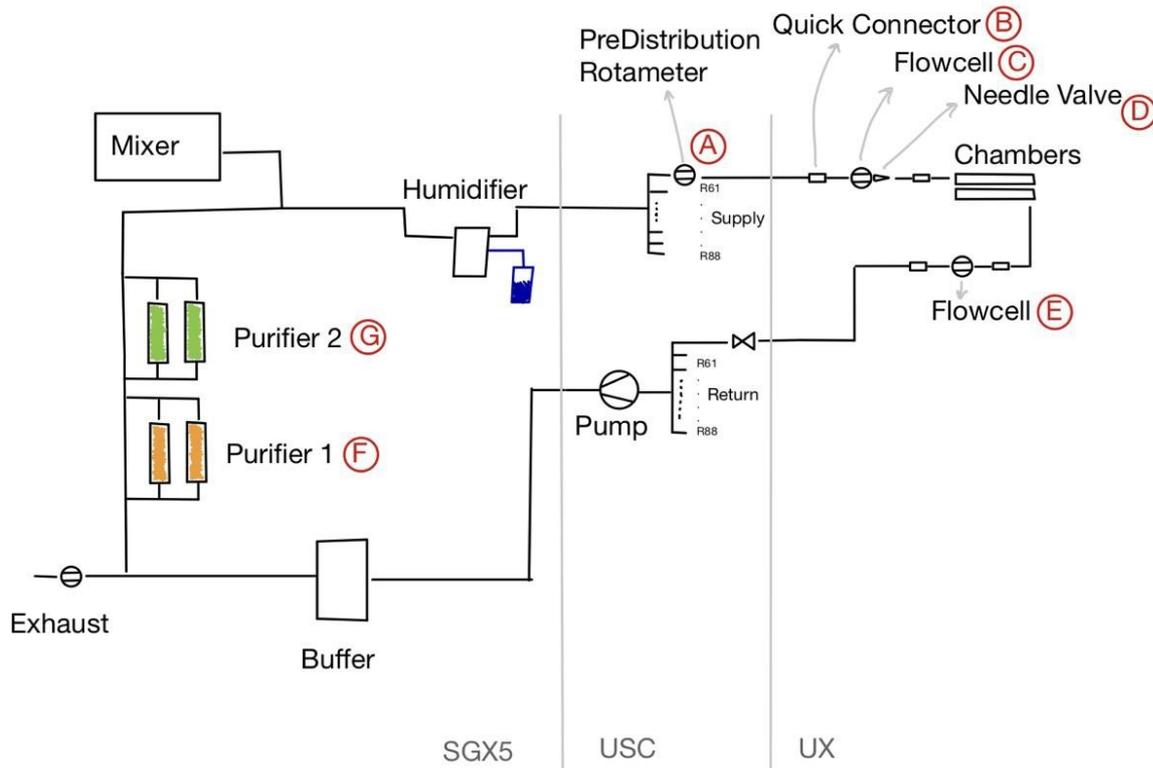
Figure 1 - Samples information and schema of their location

The samples under study were collected from different locations and their information is detailed in Figure 1. Representative images are displayed in Figure 2.

- The metallic ball floats from two different rotameters (ball #1 and ball #2) used to regulate flow at pre-distribution of CMS RPC gas system;
- Residue collected from ball #1 and from the inner surface of the quick supply connector #26. To collect the particles on a carbon sticker of known composition was employed (84.6 wt. % C, 14.6 wt. % O, 0.4 wt. % Na and 0.4 wt. % S);
- Resistance type PT100 of the flowcells used to read the flow in different sectors of the gas line for the CMS RPC gas system and a reference;
- Additional material from different locations (24MS, R3 11, R3 15, Al Ni 65);
- Needle valve from supply #26 that presents a region with a whitish residue.
