Chemical analyses of deposits in the RPC chambers

Dayron Ramos Lopez
Polytechnic and INFN of Bari

Layout of RPC prototype-1 for CMS Upgrade project (iRPC)

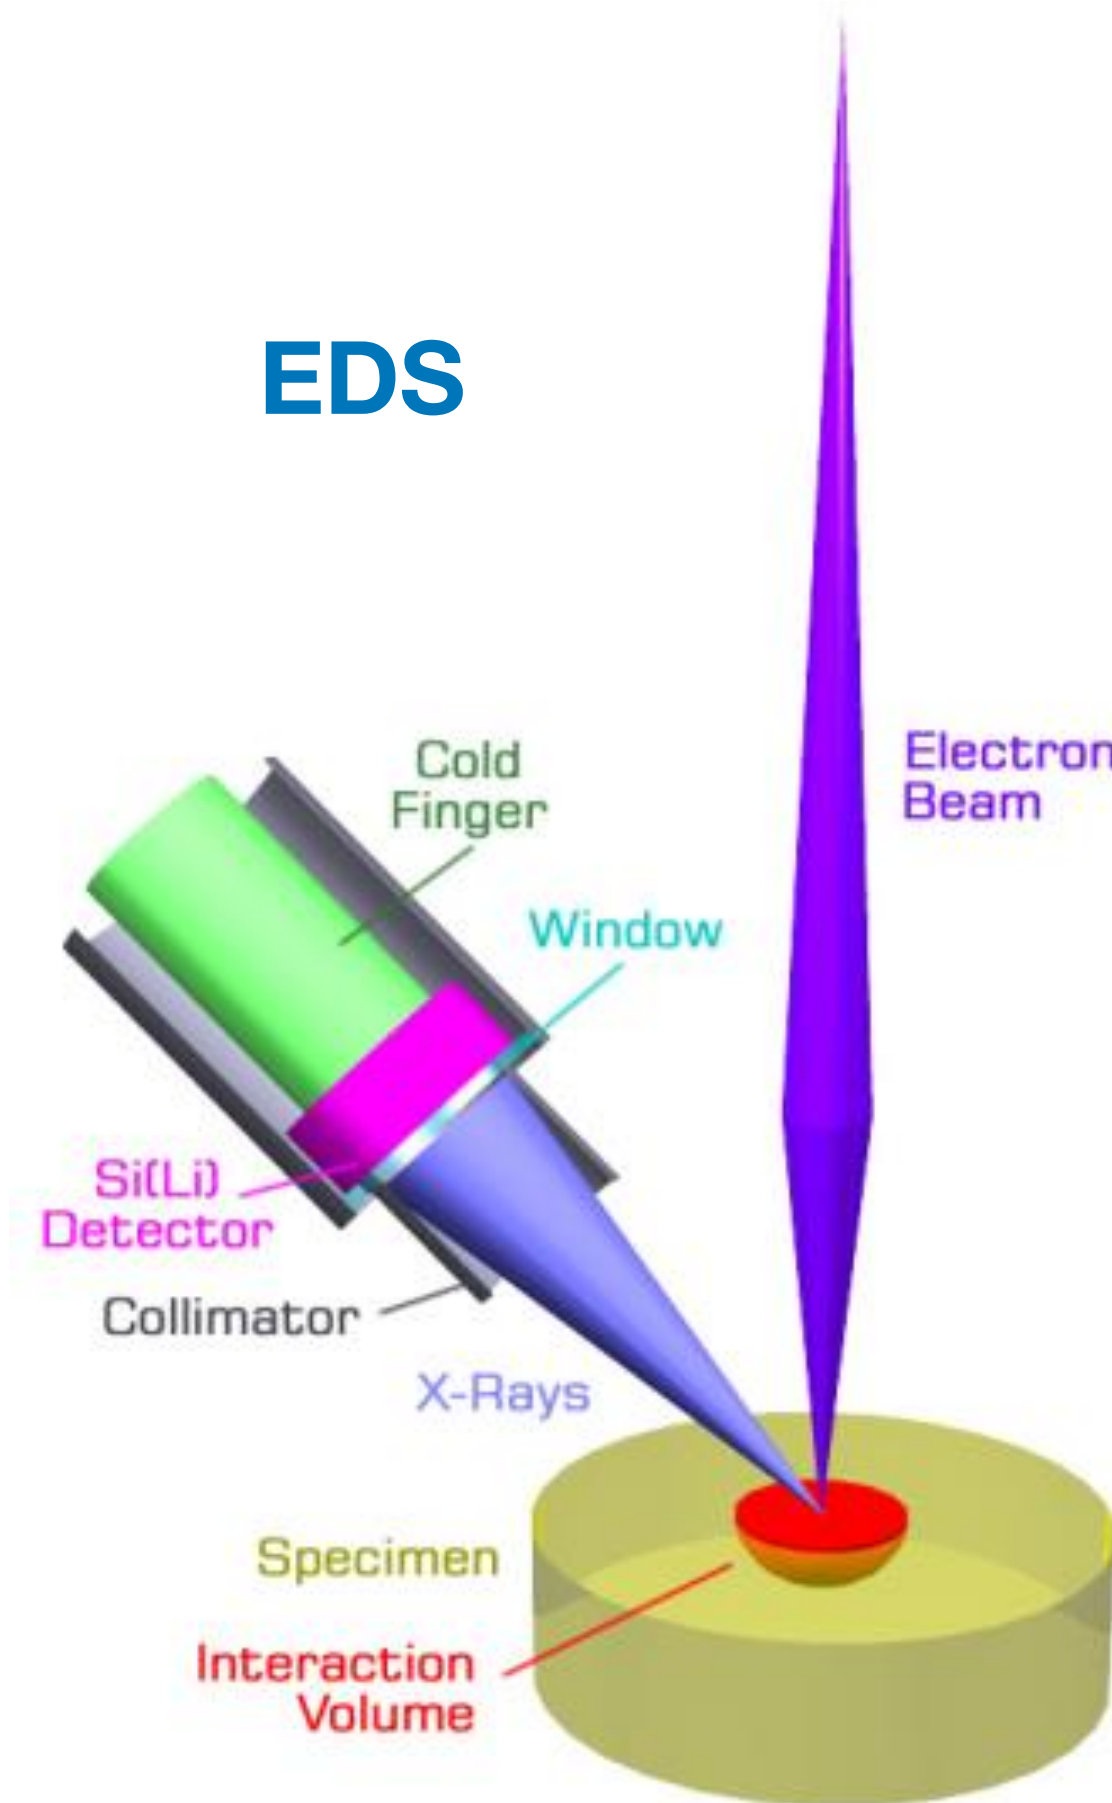
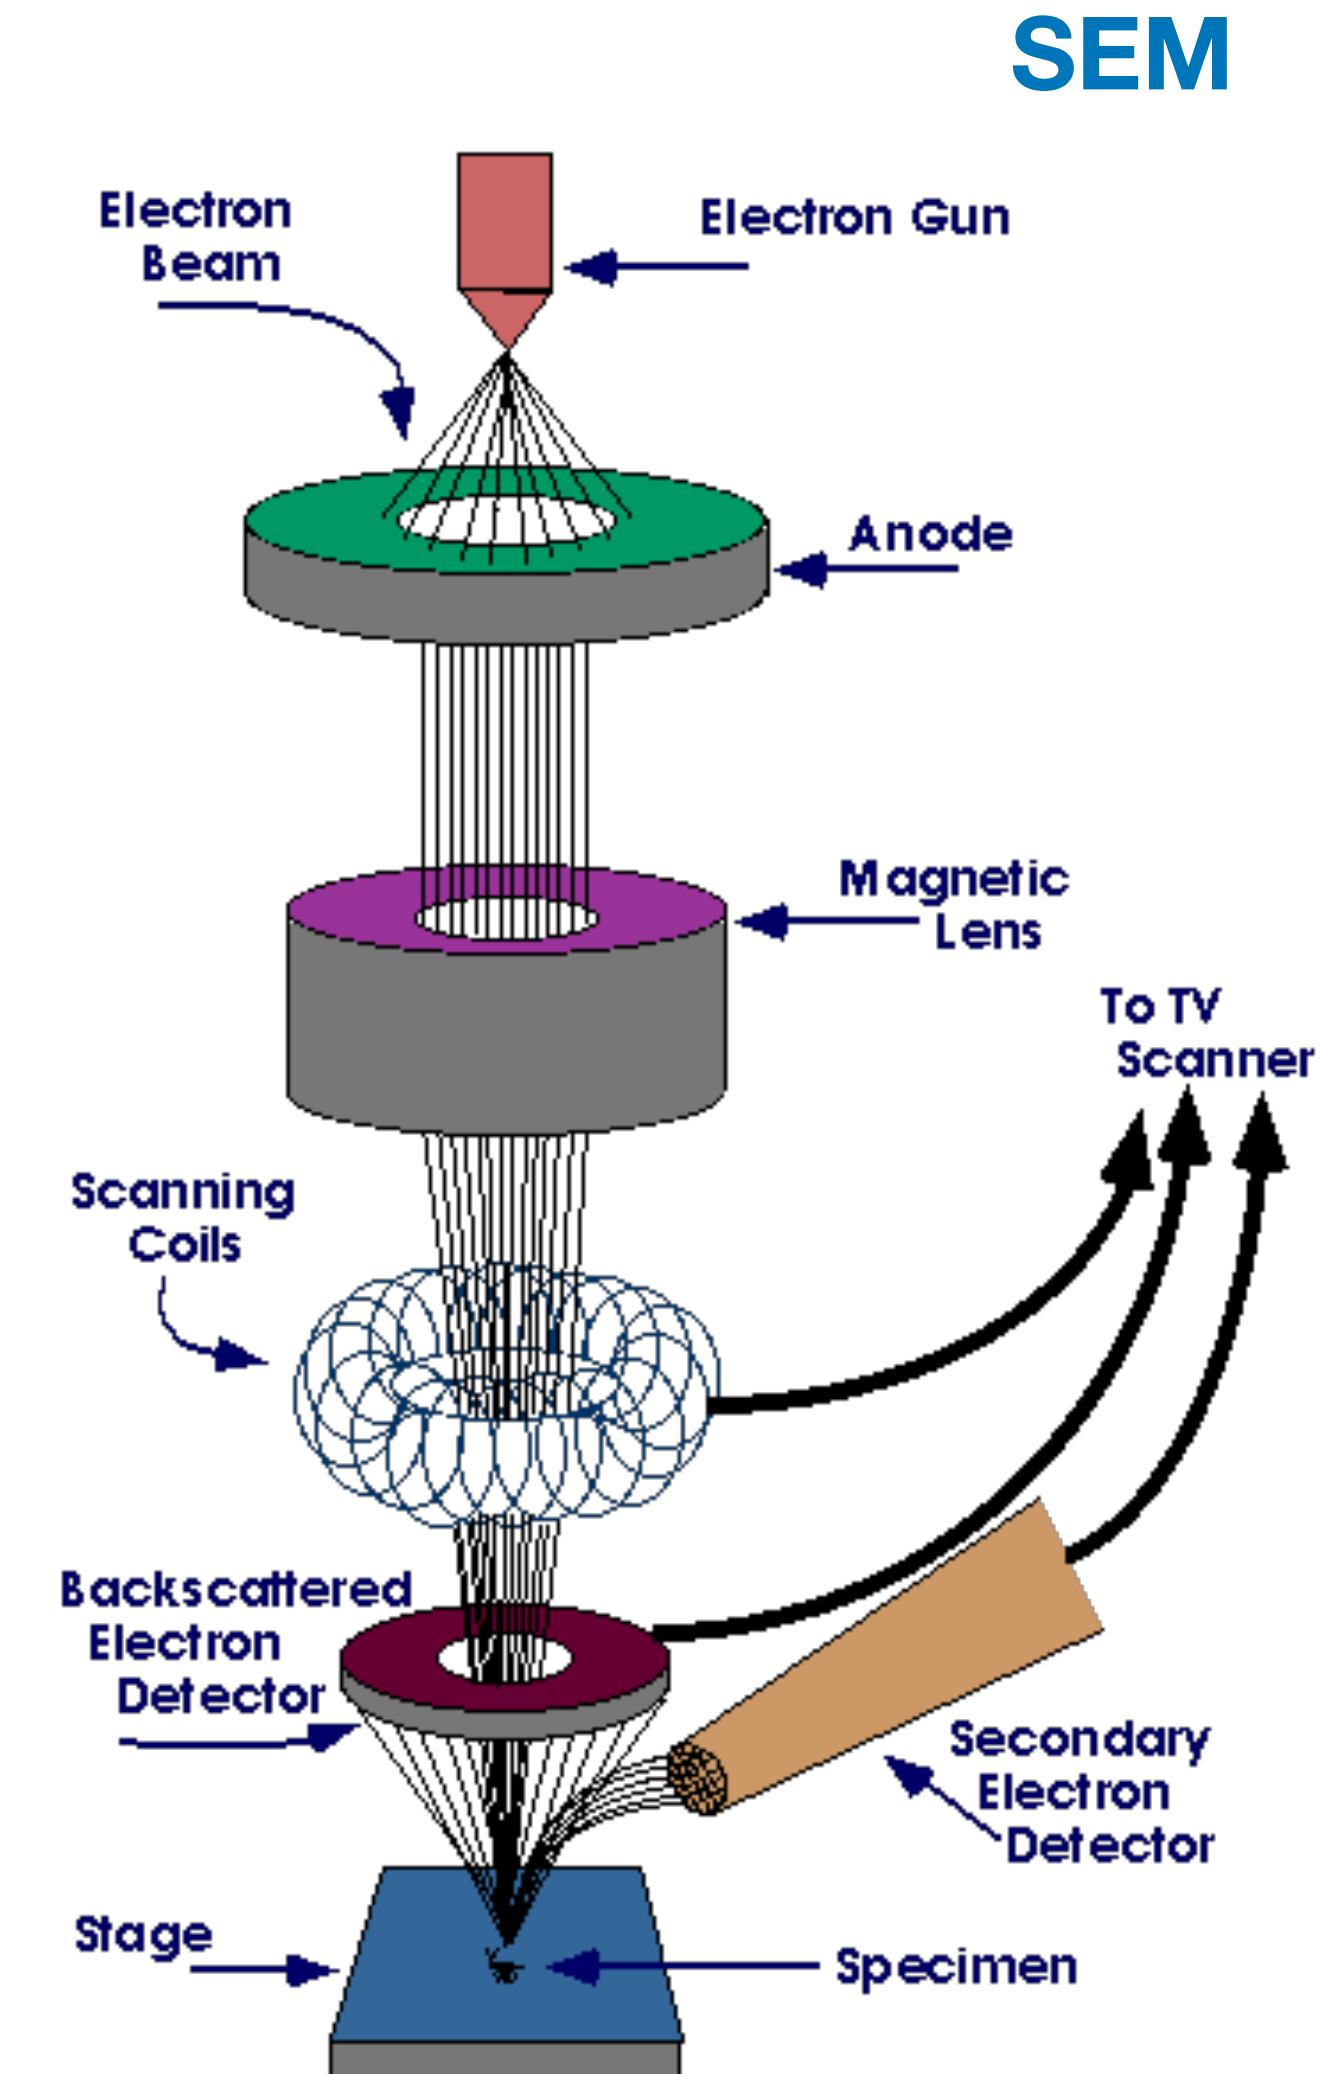
Hypothesis

Bad oil polymerization

Glue reaction

- EDS (Energy Dispersive X-Ray Spectroscopy) @ chemistry Lab
- SEM (Scanning Electron Microscope) @ chemistry Lab

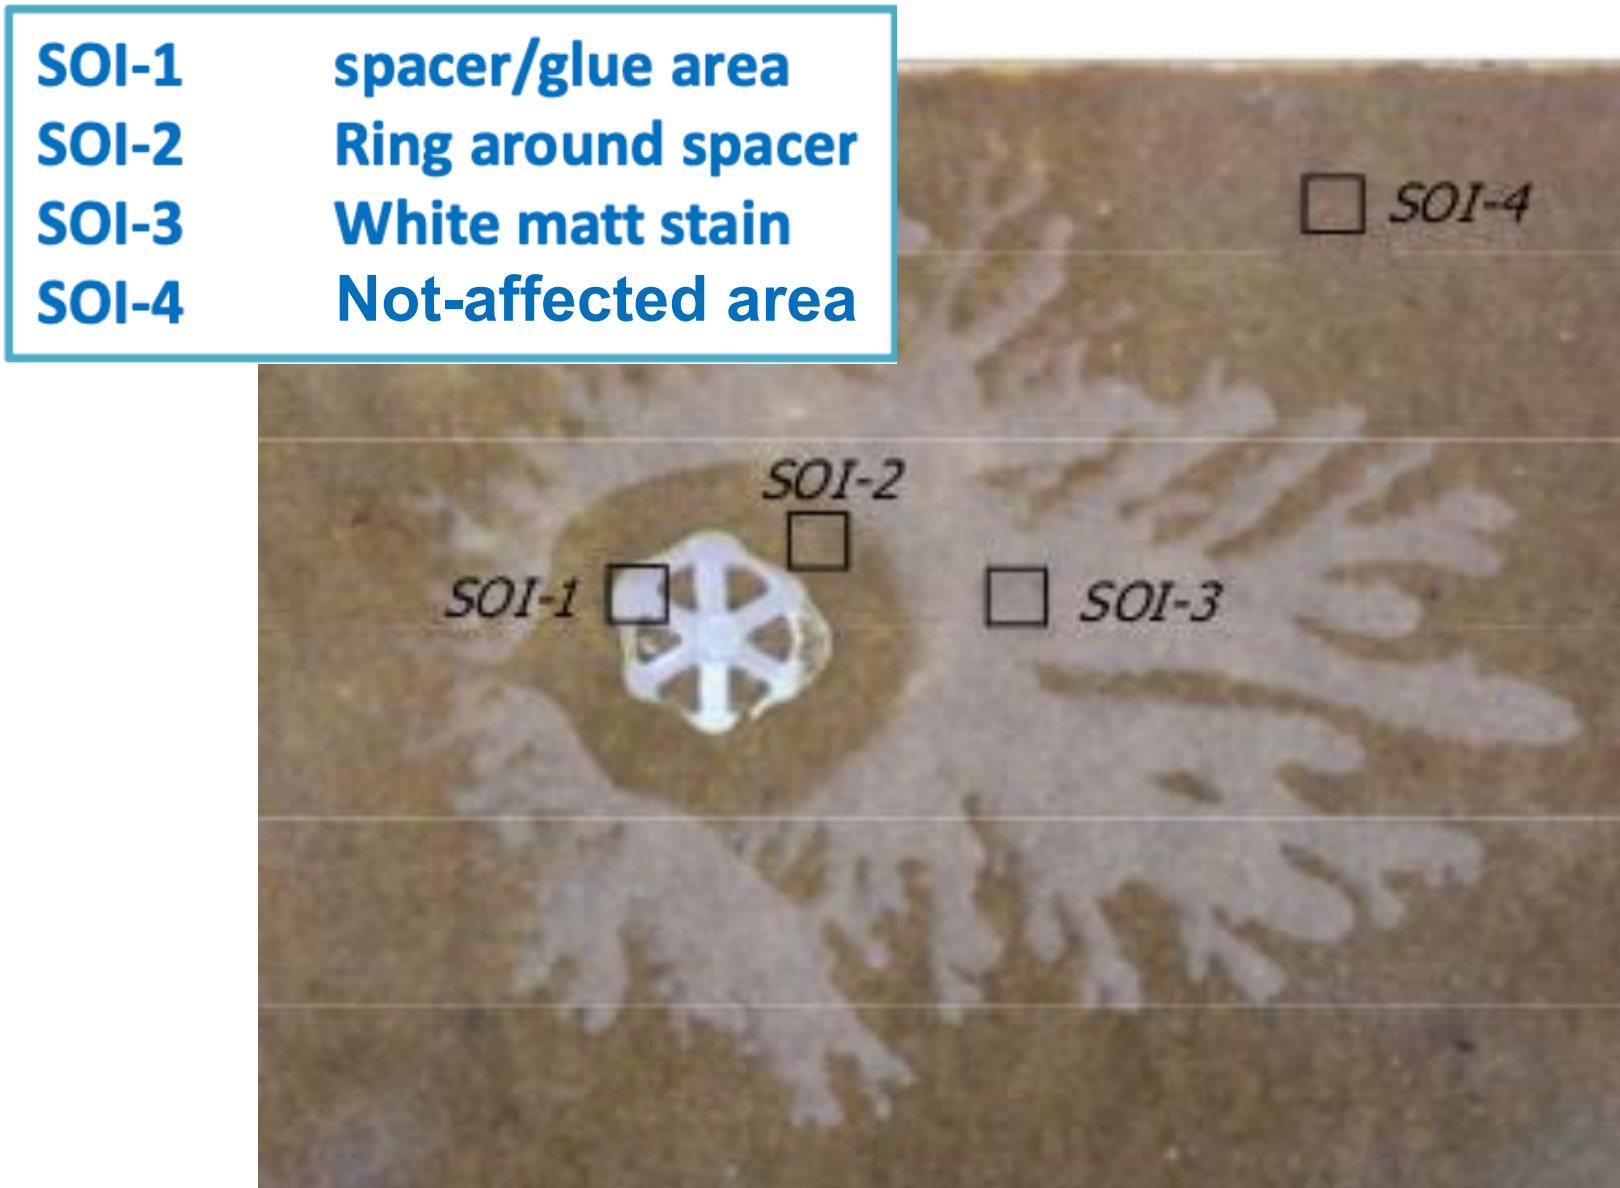
Irradiated chamber view

- Fluorine presence in IRR SOI
- Less N in SOI-3 and 4 IRR
- Similar composition SOI-4 IRR and SOI-3 REF

*SOI = site of interest

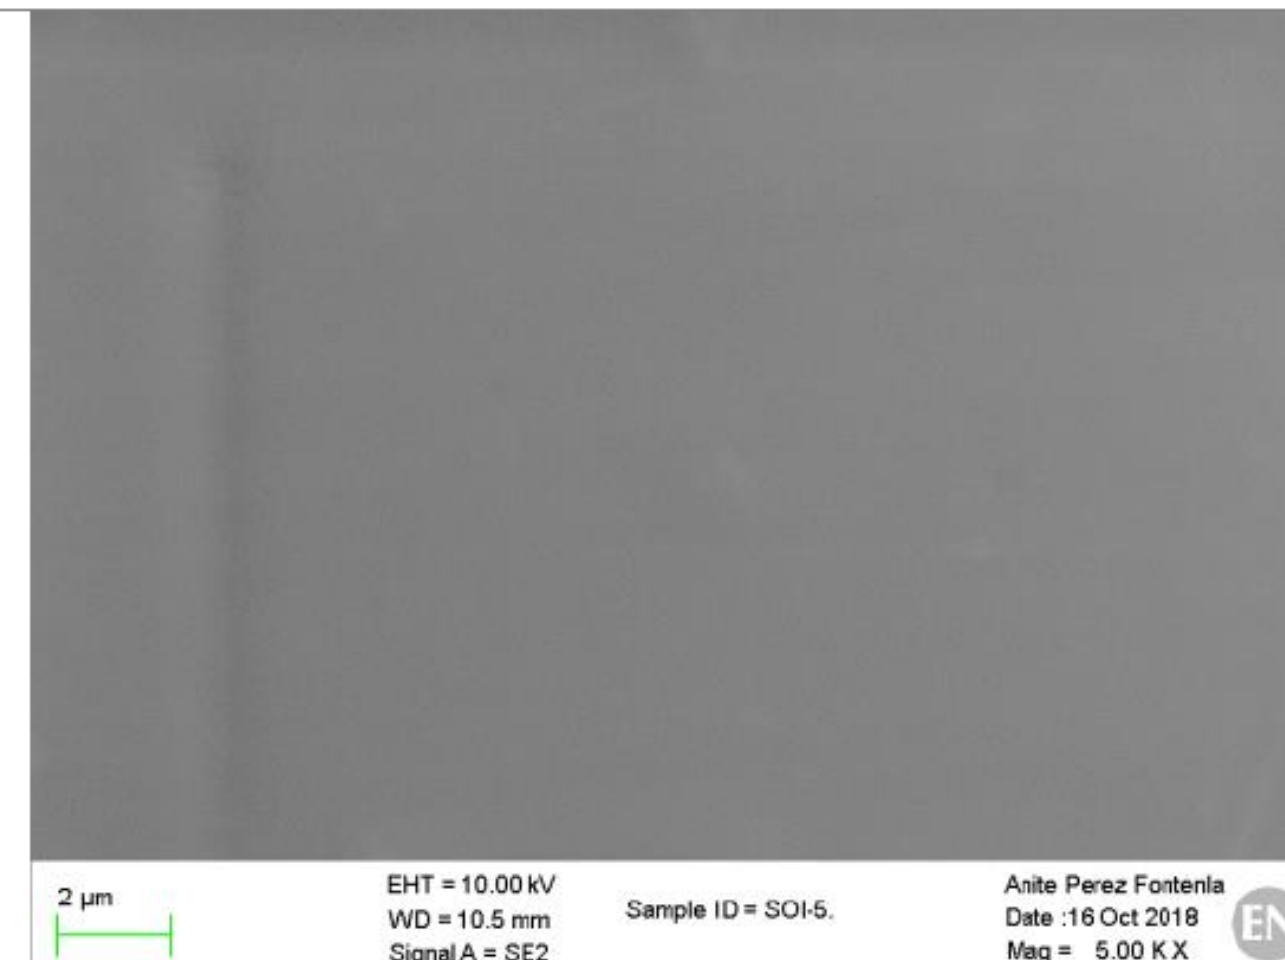
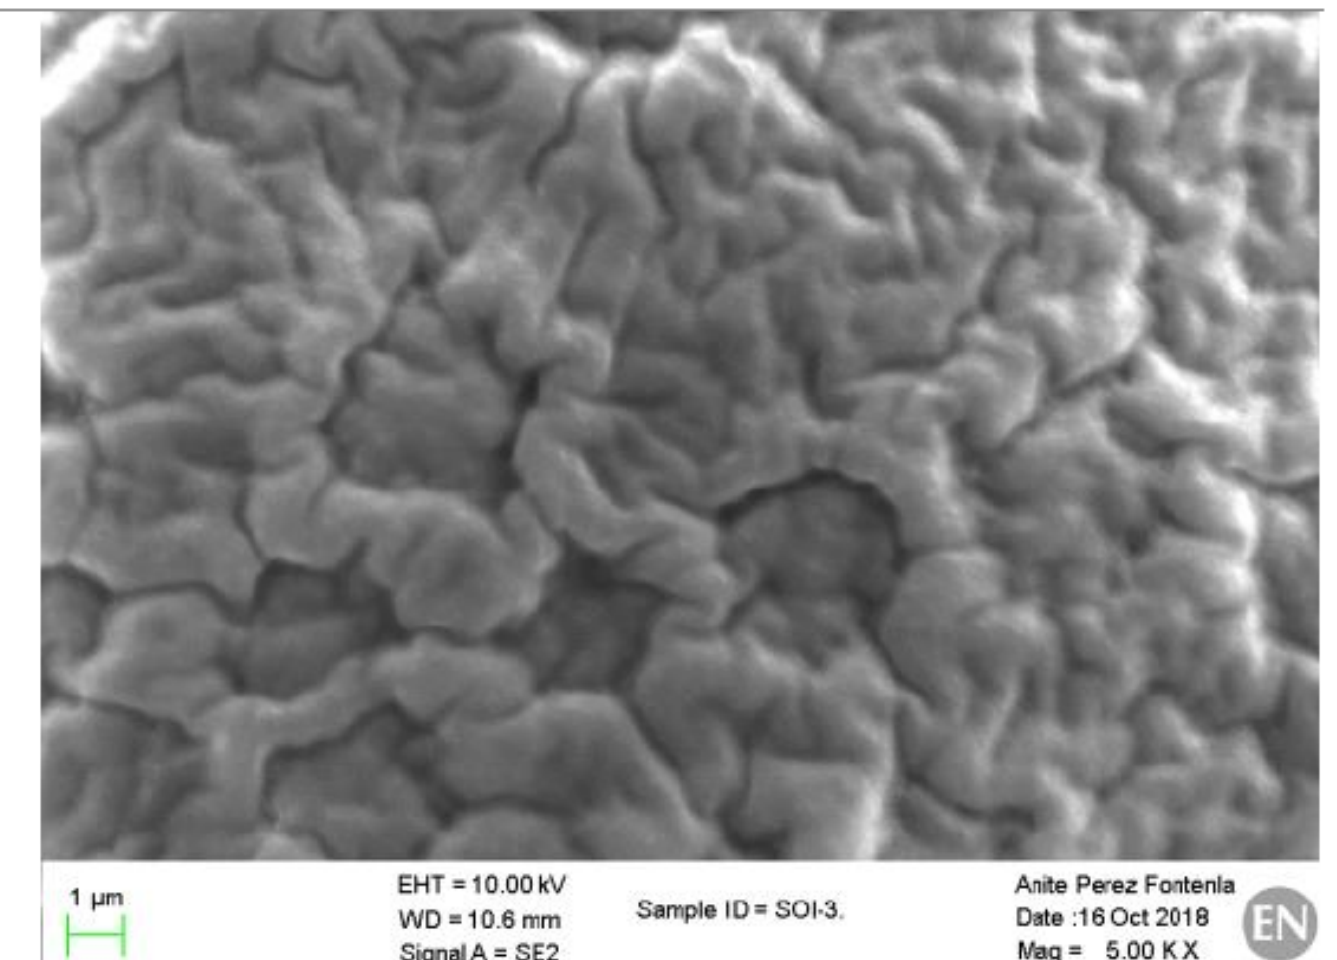
Decomposition of the C₂H₂F₄ molecules, induced by the relatively high-energy photons (i.e. UV) -> F⁻, then:

- *HF* high chemical reactivity
- HPL surface damaging by polymerized oil layer
- Surface resistivity decreasing by *HF* deposition, creating a thin conductive layer

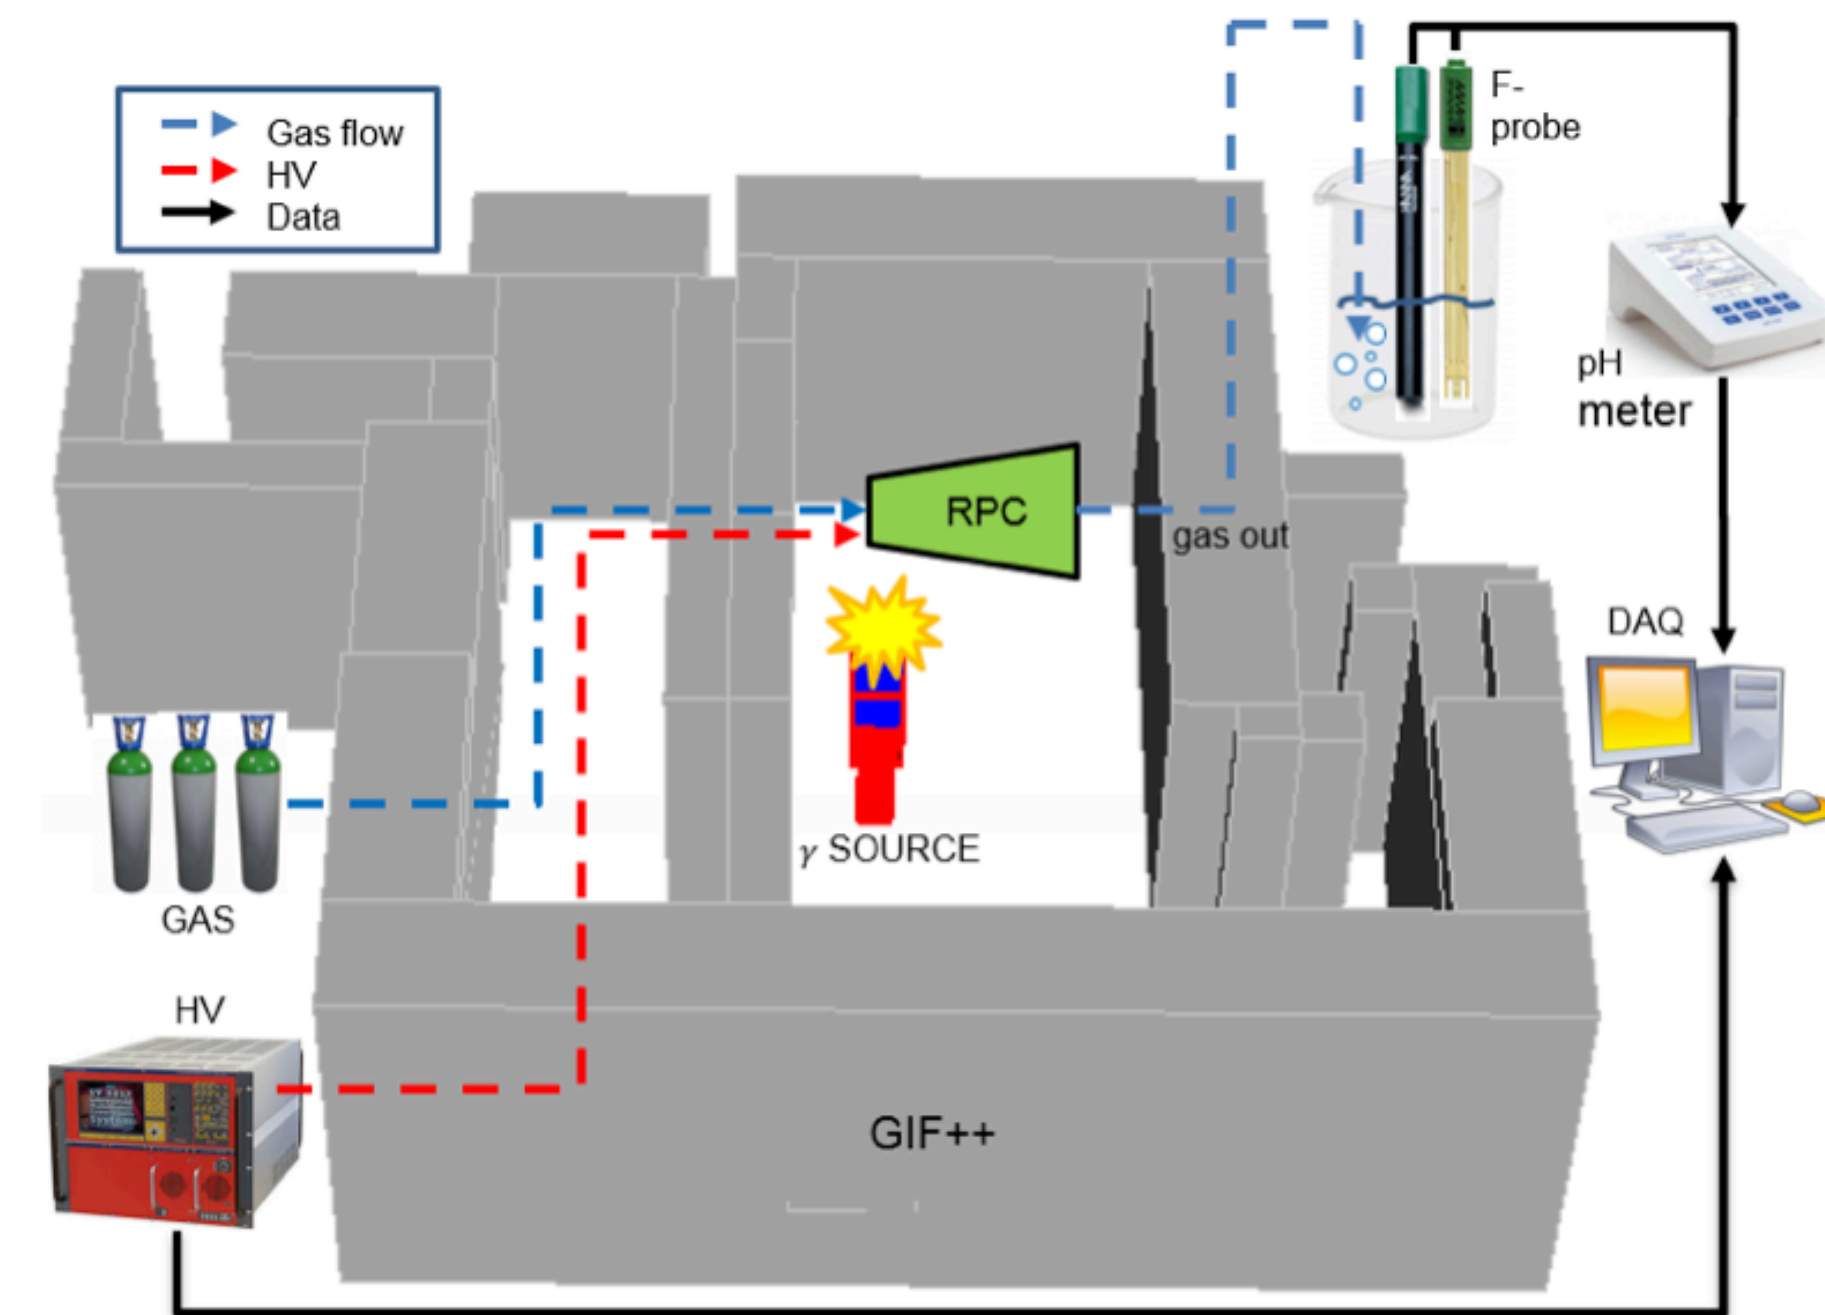
HF concentration measured by **ion-selective electrode (ISE)** using **TISAB (Total Ionic Strength Adjustment Buffer)** and distilled water solution in the exhaust gas line

RPC operated at ≈ 9.8 kV and
gas flow fraction analysed 0.5 l/h

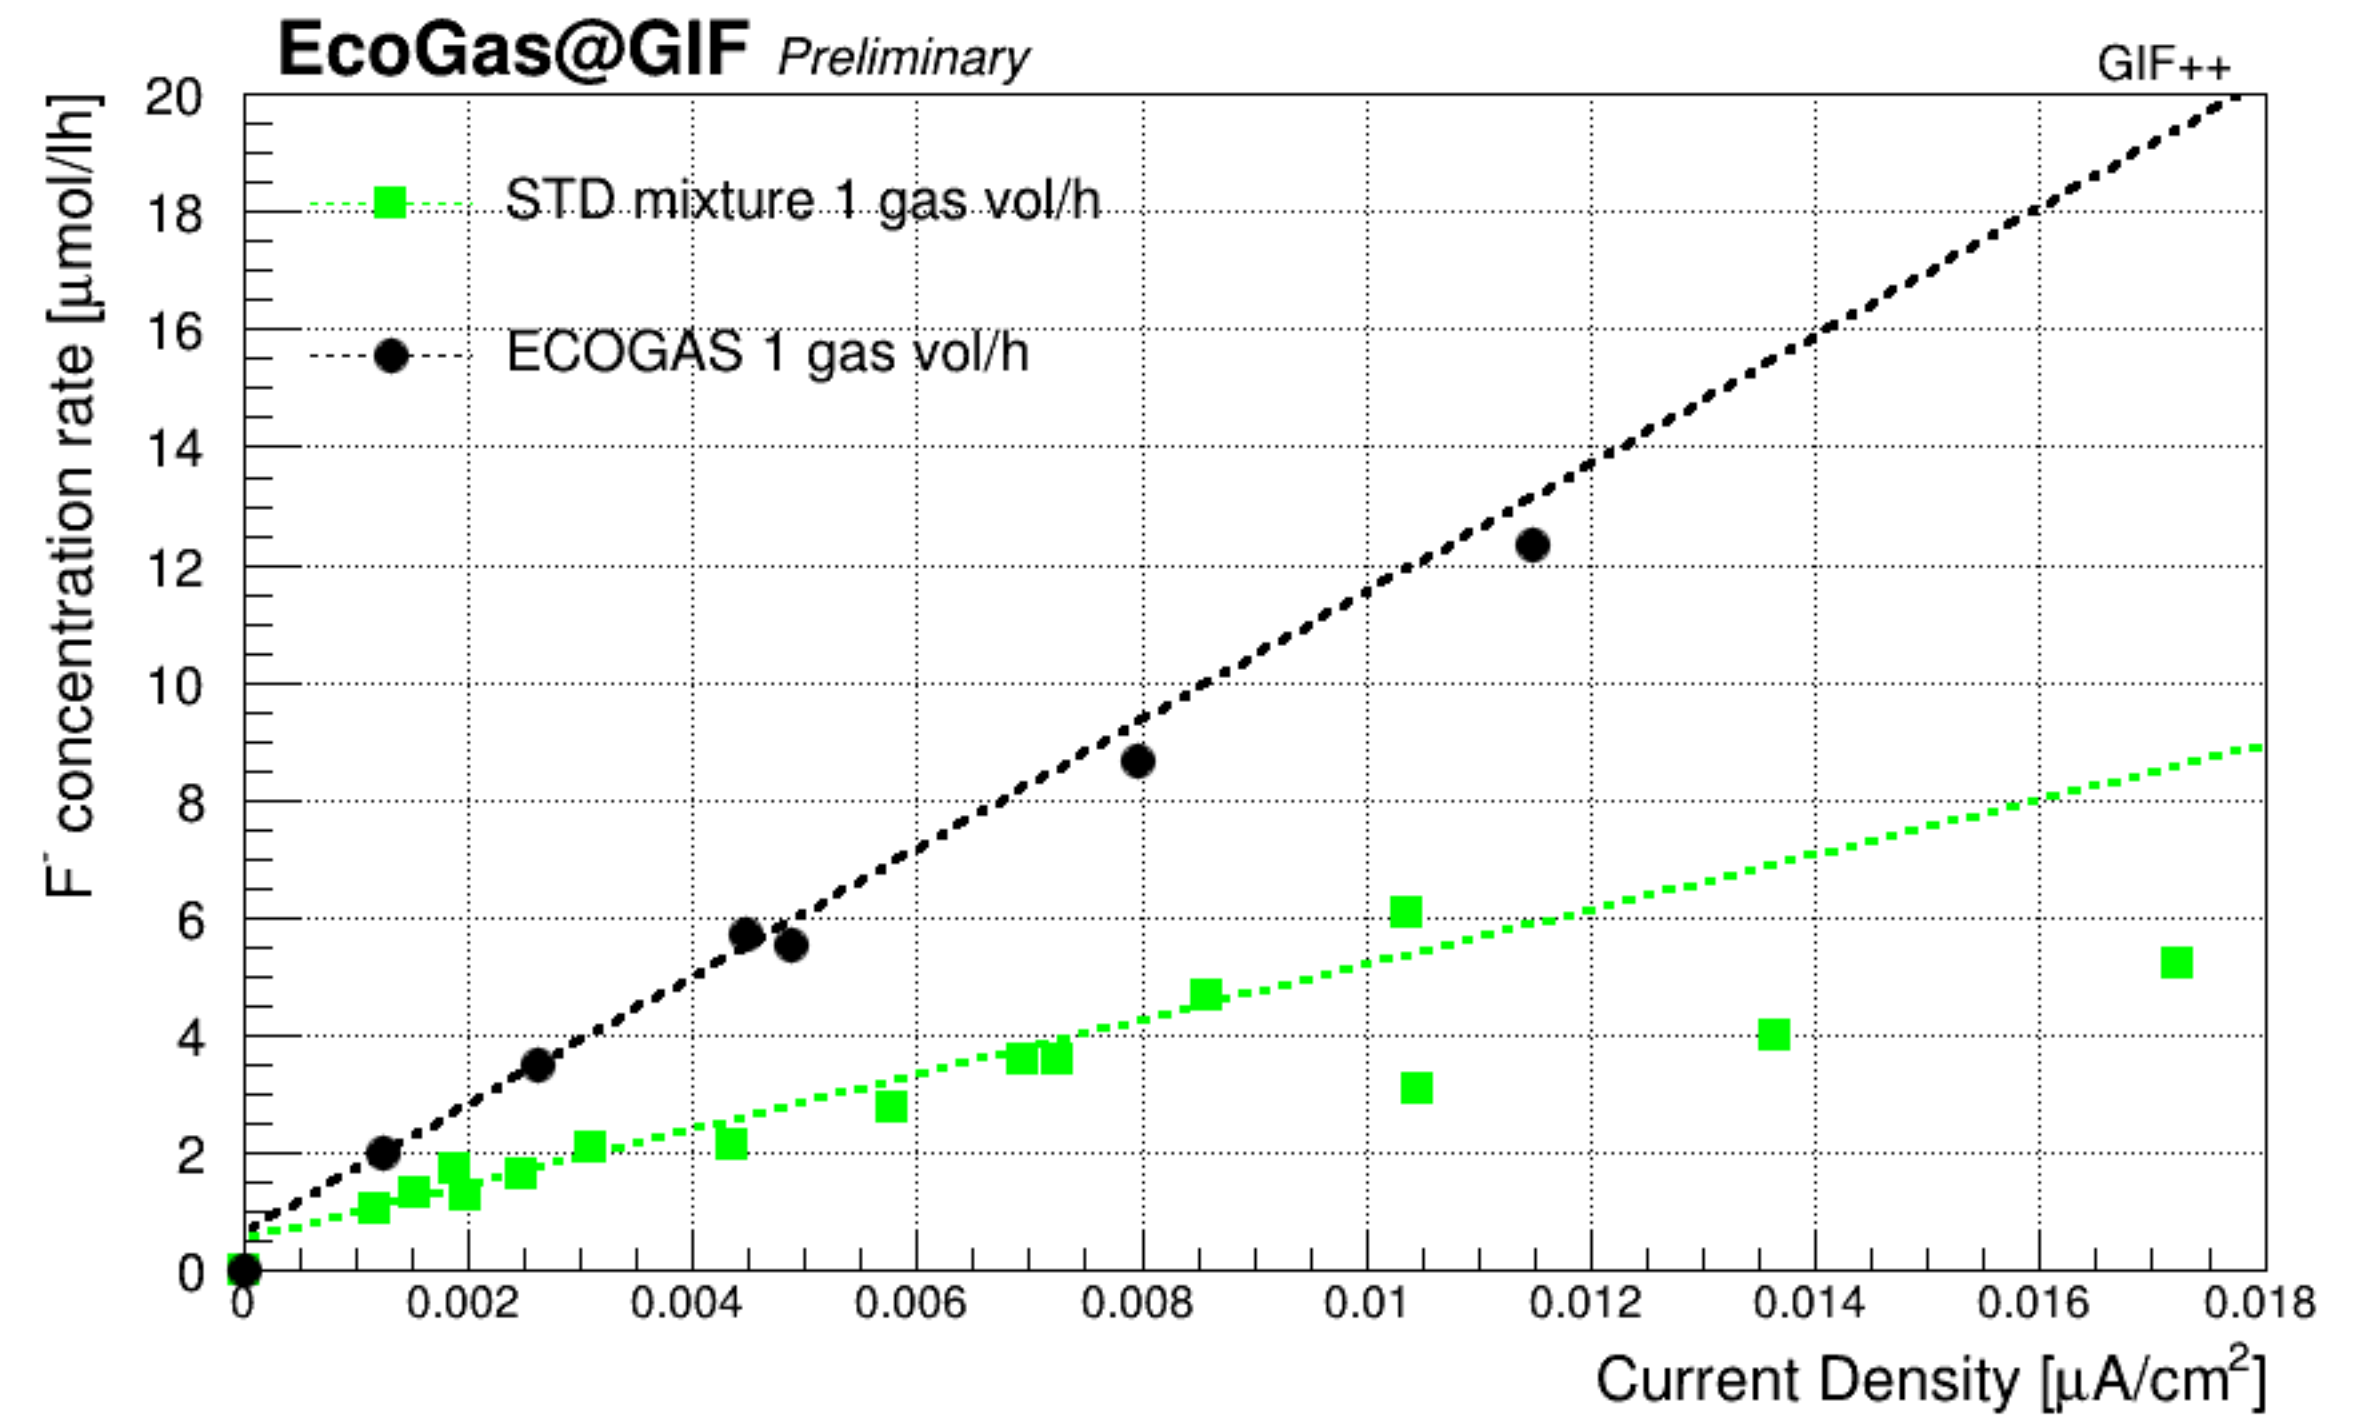
Fluoride concentration rate HFO-based mix

STD: 95.2% C₂H₂F₄, 4.5% iC₄H₁₀ and 0.3% SF₆

ECOgas: 45% HFO-1234ze, 50% CO₂, 4% iC₄H₁₀ and 1% SF₆.

- HF concentration using the ecogas mixture is around 2.5 times greater than the standard
- HFO breaks five times more easily than C₂H₂F₄

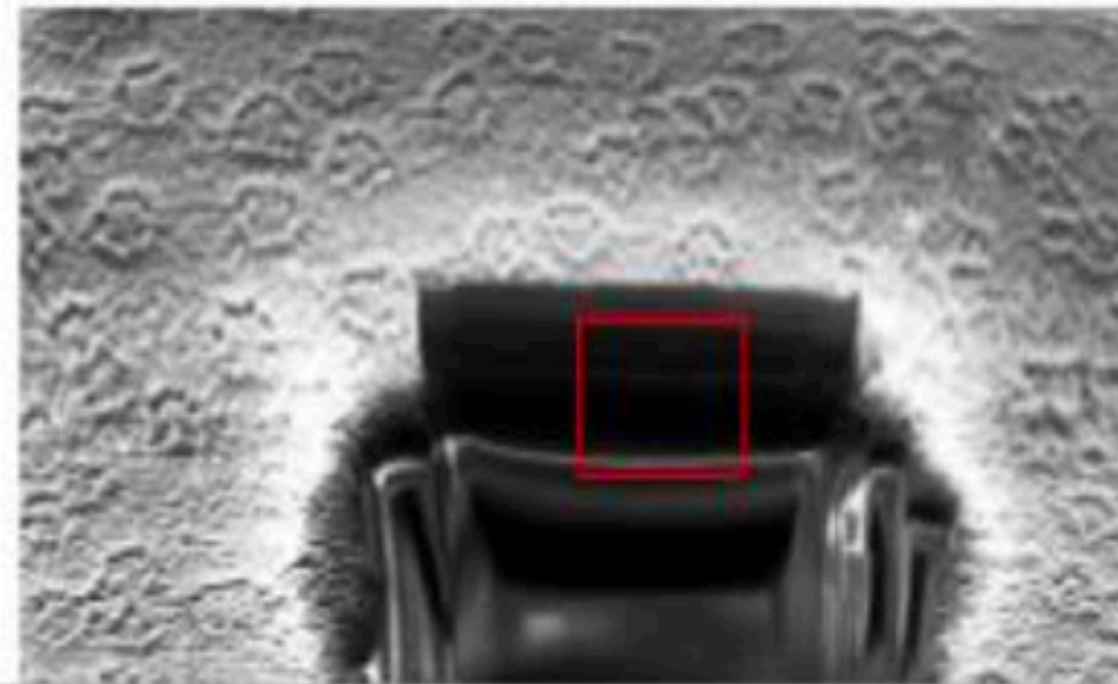
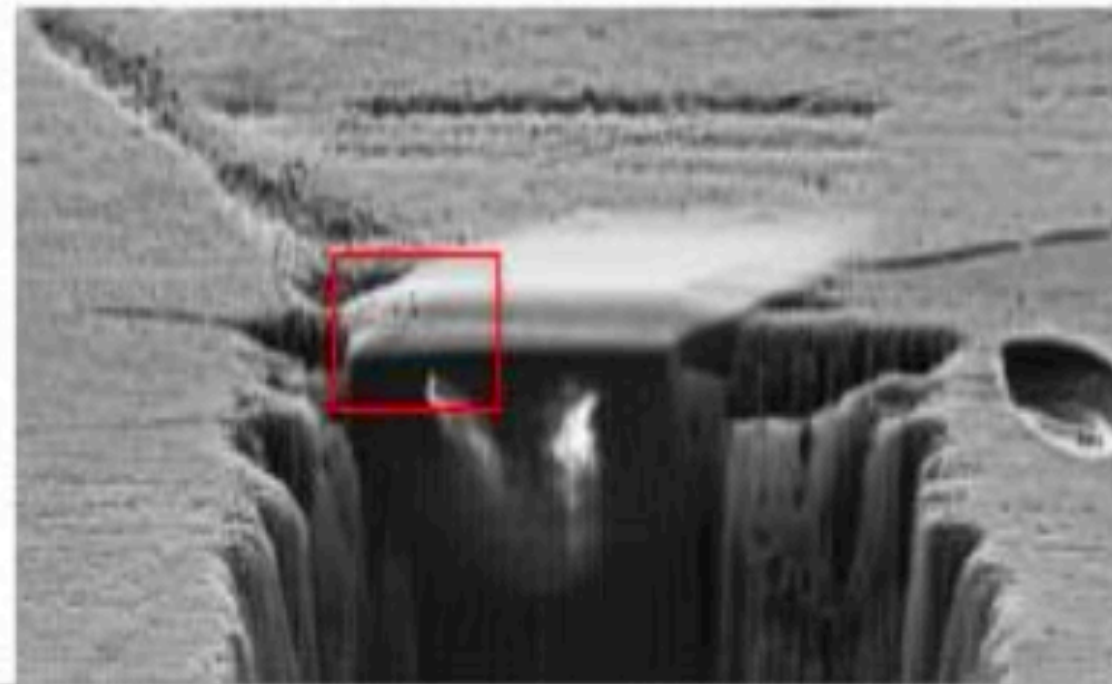
FIB (Focused Ion beam)

Test to verify the **inner bakelite composition and aspect**

- FIB used to remove material layers
- SEM for visual inspection
- EDS to check the chemical composition
